Lot 192 Hale Road

Wattle Grove

Preliminary Arborist Report

September 2023

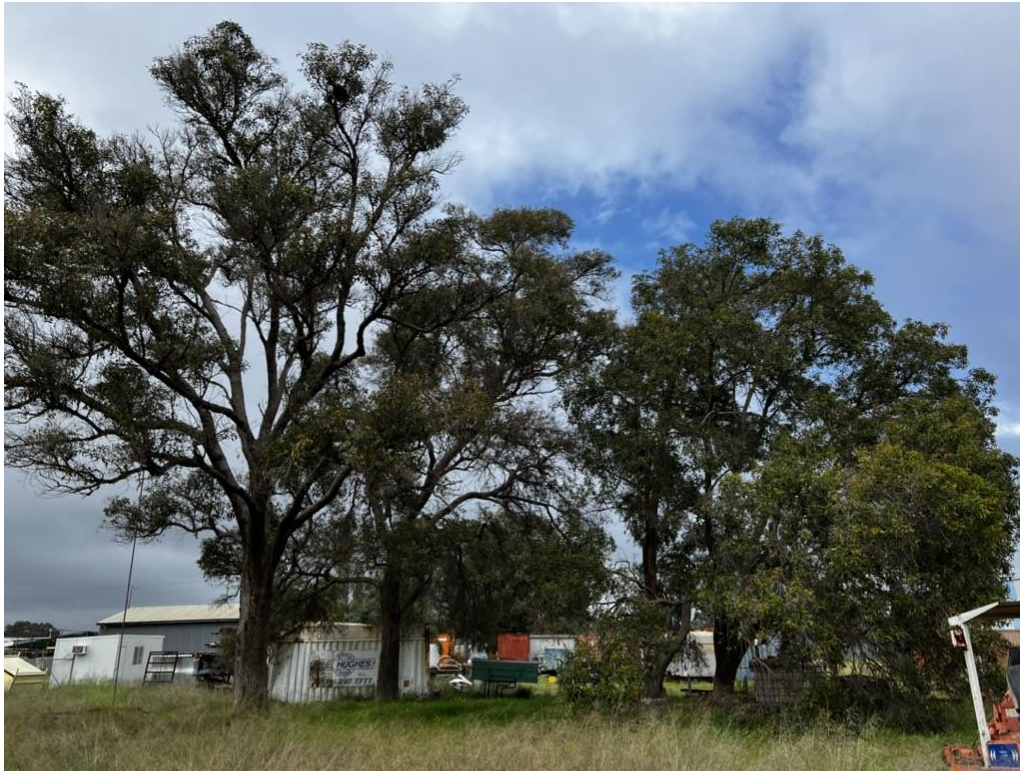
Trees 23-26 are a group of 4 marri (*Corymbia calophylla*), which are endemic natives. These trees have been deemed to have high retention value primarily due to their size and that they are endemic. However, they are currently only in fair condition with sparse canopy and excessive twig dieback, and are likely suffering stress from excess water, either from high water table or a legacy of the nursery next door. The retention of these is compatible with the current design if they are carefully managed during the construction process. These trees are however located in the area earmarked for a potential expansion of the building. There doesn't appear to be a straightforward design alternative to retain these trees should the proposed building expansion proceed. Consideration should be given to pre-emptive replacement planting as soon as practical if these are being considered for removal. This will allow for the replacement canopy to become established which in turn will minimise any canopy loss during the transition.

Figure 3 Trees 23-26 showing sparse, inconsistent canopy

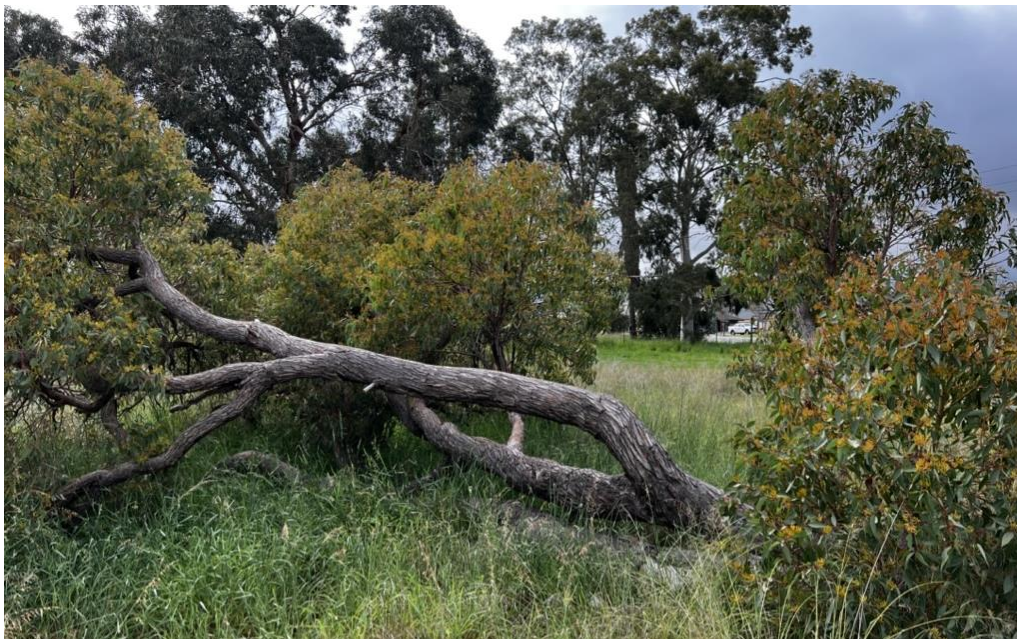
Tree 29 is a jarrah (*Eucalyptus marginata*) that is in good health with great vigour but has poor structure having failed whole and is now prostrate. It would make an interesting feature if it were able to be incorporated into the soft landscape but doesn't appear to be compatible with the current design.

Figure 4 Tree 29 - Vigorous but failed jarrah

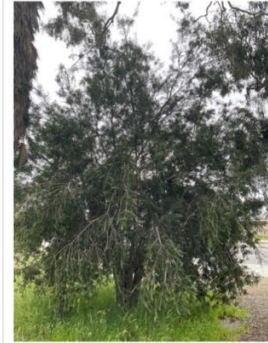
Weeping Bottlebrush Tree ID 02**Tree Details**

Botanical Name:	Callistemon viminalis
Common Name:	Weeping Bottlebrush
Height (m):	5
Spread (m):	5
Health:	Good
Structure:	Very Poor
Age:	Mature
SULE:	1-5 yrs
Retention Value:	Low
Comments (assessment):	Lopped with vigorous regrowth
DBH (mm):	300
Tree Protection Zone (TPZ) (m):	3.6
Structural Root Zone (SRZ) (m):	2.0

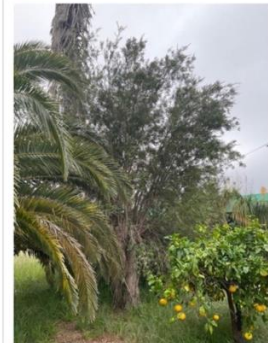
Weeping Bottlebrush Tree ID 04**Tree Details**

Botanical Name:	Callistemon viminalis
Common Name:	Weeping Bottlebrush
Height (m):	5
Spread (m):	5
Health:	Good
Structure:	Very Poor
Age:	Mature
SULE:	1-5 yrs
Retention Value:	Low
Comments (assessment):	Lopped with acceptable regrowth
DBH (mm):	327
Tree Protection Zone (TPZ) (m):	3.92
Structural Root Zone (SRZ) (m):	2.05

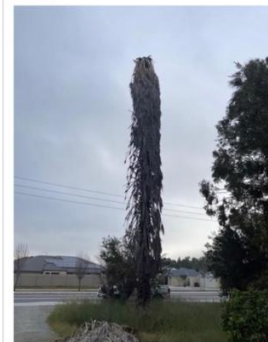
Cotton Palm Tree ID 06**Tree Details**

Botanical Name:	Washingtonia filifera
Common Name:	Cotton Palm
Height (m):	13
Spread (m):	1
Health:	Dead
Structure:	Poor
Age:	Over Mature
SULE:	9 yrs
Retention Value:	Low
Comments (assessment):	Dead and partially failed, no retention value
DBH (mm):	530
Tree Protection Zone (TPZ) (m):	6.36
Structural Root Zone (SRZ) (m):	2.53

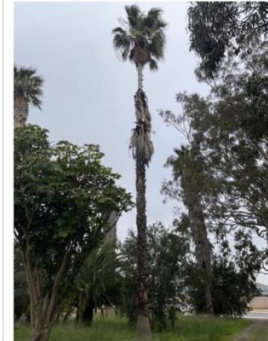
Cotton Palm Tree ID 08**Tree Details**

Botanical Name:	Washingtonia filifera
Common Name:	Cotton Palm
Height (m):	17
Spread (m):	2
Health:	Good
Structure:	Good
Age:	Mature
SULE:	40+ yrs
Retention Value:	Low
Comments (assessment):	Non-native species
DBH (mm):	490
Tree Protection Zone (TPZ)(m):	5.88
Structural Root Zone (SRZ)(m):	2.45

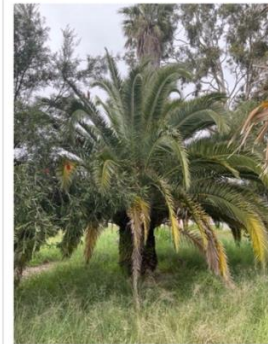
Canary Island Date Palm Tree ID 10**Tree Details**

Botanical Name:	Phoenix canariensis
Common Name:	Canary Island Date Palm
Height (m):	5
Spread (m):	7
Health:	Good
Structure:	Good
Age:	Mature
SULE:	40+ yrs
Retention Value:	Low
Comments (assessment):	Non-native species
DBH (mm):	900
Tree Protection Zone (TPZ)(m):	19.8
Structural Root Zone (SRZ)(m):	3.17

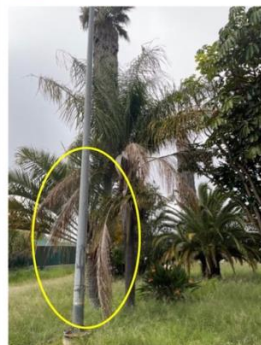
Triangle Palm Tree ID 11**Tree Details**

Botanical Name:	Dypsis decaryi
Common Name:	Triangle Palm
Height (m):	5
Spread (m):	4
Health:	Good
Structure:	Good
Age:	Mature
SULE:	40+ yrs
Retention Value:	Low
Comments (assessment):	Non-native species
DBH (mm):	350
Tree Protection Zone (TPZ)(m):	4.2
Structural Root Zone (SRZ)(m):	2.13

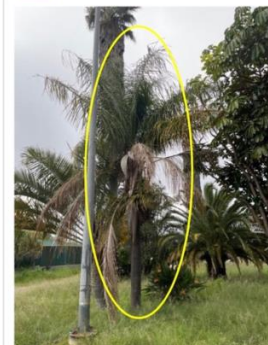
Cocos Palm Tree ID 12**Tree Details**

Botanical Name:	Syagrus romanzoffiana
Common Name:	Cocos Palm
Height (m):	8
Spread (m):	5
Health:	Good
Structure:	Good
Age:	Mature
SULE:	21-40 yrs
Retention Value:	Low
Comments (assessment):	Non-native palm species
DBH (mm):	270
Tree Protection Zone (TPZ)(m):	3.24
Structural Root Zone (SRZ)(m):	1.91

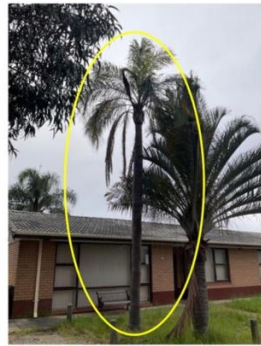
Cocos Palm Tree ID 15**Tree Details**

Botanical Name:	<i>Syagrus romanzoffiana</i>
Common Name:	Cocos Palm
Height (m):	8
Spread (m):	4
Health:	Good
Structure:	Poor
Age:	Mature
SULE:	21-40 yrs
Retention Value:	Low
Comments (assessment):	Non-native palm species
DBH (mm):	270
Tree Protection Zone (TPZ)(m):	3.24
Structural Root Zone (SRZ)(m):	1.91

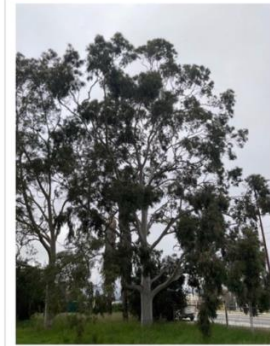
Lemon-scented Gum Tree ID 16**Tree Details**

With one exception all trees with a high or very high retention values have been incorporated into the current design. Trees 16 and 17 are a pair of large lemon scented gums (*Corymbia citriodora*) closest to the road. The current design has a tree 16 on the landscaped verge with tree 17 in a traffic island with driveway on both sides. Both have a minimum deep soil area which is lower than the recommended 64m² recommended in LPP33 Table 1.2 for large trees, but both do meet the recommended 40m² as contained in Table 2.1 Minimum planting area requirements for car parks. There are also rootable soil volumes surrounding these areas and in conjunction with careful use of materials for the driveway this will minimise the impact on these trees and allow them to continue to be a prominent feature in the landscape.

Botanical Name:	<i>Corymbia citridora</i>
Common Name:	Lemon-scented Gum
Height (m):	17
Spread (m):	22
Health:	Good
Structure:	Good
Age:	Mature
SULE:	40+ yrs
Retention Value:	Very High
Comments (assessment):	Excellent specimen. Typical open canopy. Good weight distribution. Minimal deadwood. 5.9 m from adjacent tree.
DBH (mm):	825
Tree Protection Zone (TPZ)(m):	9.9
Structural Root Zone (SRZ)(m):	3.2

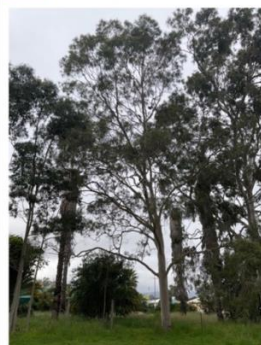
Lemon-scented Gum Tree ID 17**Tree Details**

Botanical Name:	<i>Corymbia citridora</i>
Common Name:	Lemon-scented Gum
Height (m):	13
Spread (m):	17
Health:	Good
Structure:	Fair
Age:	Mature
SULE:	40+ yrs
Retention Value:	High
Comments (assessment):	Slightly sparse canopy. Minimal deadwood. Slightly suppressed by adjacent larger tree.
DBH (mm):	540
Tree Protection Zone (TPZ)(m):	6.48
Structural Root Zone (SRZ)(m):	2.55

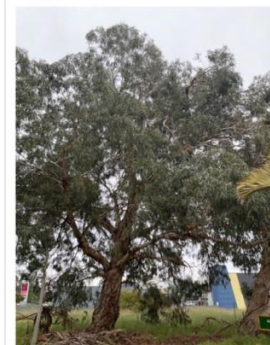
Tasmanian Blue Gum Tree ID 18**Tree Details**

Tree 18 is a large mature Tasmanian blue gum (*Eucalyptus globulus*) which is not compatible with the current design. While the retention of a mature tree such as this is to be preferred there appears to be no practical way to incorporate this tree into the design. This tree is currently in good condition but its longevity is uncertain. It is tree endemic to Tasmania, and like most Tasmanians it prefers a cooler wetter climate than is typical of Perth area. It is likely in good condition currently due to high water availability, which may change with the site development.

Botanical Name:	<i>Eucalyptus globulus</i>
Common Name:	Tasmanian Blue Gum
Height (m):	16
Spread (m):	16
Health:	Good
Structure:	Fair
Age:	Mature
SULE:	21-40 yrs
Retention Value:	High
Comments (assessment):	Slight canopy loss, hollows in trunk, some evidence of failure.
DBH (mm):	1190
Tree Protection Zone (TPZ)(m):	14.28
Structural Root Zone (SRZ)(m):	3.56

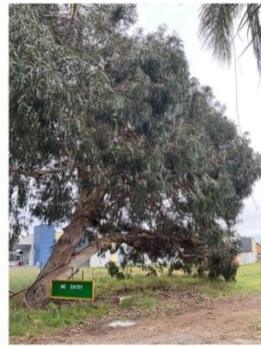
Tasmanian Blue Gum Tree ID 19**Tree Details**

Tree 19 is another Tasmanian bluegum (*E. globulus*), also in good health similar to tree 19 but in worse structural condition. It has a heavy lean, although it appears stable, and has a very large, long, low main scaffold limb making it difficult to prune to achieve useable space around the trees. Again, the retention of this tree would be preferable but does not appear compatible with full effective use of the site.

Botanical Name:	Eucalyptus globulus
Common Name:	Tasmanian Blue Gum
Height (m):	12
Spread (m):	13
Health:	Good
Structure:	Poor
Age:	Mature
SULE:	21-40 yrs
Retention Value:	High
Comments (assessment):	Extended low westerly stem, sound union. Codominant stems. Good branch architecture, no signs root heave.
DBH (mm):	1050
Tree Protection Zone (TPZ)(m):	12.6
Structural Root Zone (SRZ)(m):	3.38

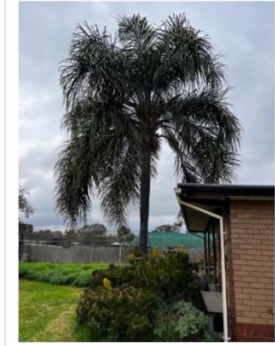
Cocos Palm Tree ID 20**Tree Details**

Botanical Name:	Spargus romanzoffiana
Common Name:	Cocos Palm
Height (m):	7
Spread (m):	3
Health:	Good
Structure:	Good
Age:	Mature
SULE:	11-20 yrs
Retention Value:	Low
Comments (assessment):	Non-native palm specimen.
DBH (mm):	330
Tree Protection Zone (TPZ)(m):	3.96
Structural Root Zone (SRZ)(m):	2.0

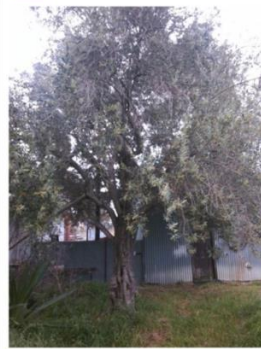
Olive Tree ID 21**Tree Details**

Botanical Name:	Olea europaea
Common Name:	Olive
Height (m):	9
Spread (m):	12
Health:	Good
Structure:	Good
Age:	Mature
SULE:	40+ yrs
Retention Value:	Medium
Comments (assessment):	Even canopy, minor deadwood
DBH (mm):	410
Tree Protection Zone (TPZ)(m):	4.92
Structural Root Zone (SRZ)(m):	2.28

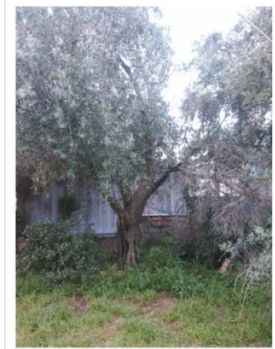
Olive Tree ID 22**Tree Details**

Botanical Name:	Olea europaea
Common Name:	Olive
Height (m):	9
Spread (m):	8.5
Health:	Good
Structure:	Fair
Age:	Mature
SULE:	40+ yrs
Retention Value:	Medium
Comments (assessment):	Some evidence of limb failure
DBH (mm):	500
Tree Protection Zone (TPZ)(m):	6.24
Structural Root Zone (SRZ)(m):	2.51

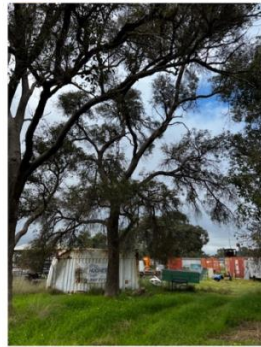
Marri Tree ID 23**Tree Details**

Botanical Name:	Corymbia calophylla
Common Name:	Marri
Height (m):	13
Spread (m):	15
Health:	Fair
Structure:	Good
Age:	Mature
SULE:	40+ yrs
Retention Value:	High
Comments (assessment):	Slight lean south. Closest to high water table, more stress responsive growth. Typical amount of deadwood
DBH (mm):	650
Tree Protection Zone (TPZ)(m):	7.8
Structural Root Zone (SRZ)(m):	2.76

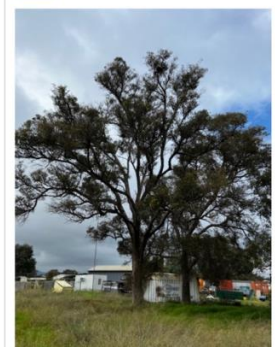
Marri Tree ID 24**Tree Details**

Botanical Name:	Corymbia calophylla
Common Name:	Marri
Height (m):	18
Spread (m):	17
Health:	Fair
Structure:	Good
Age:	Mature
SULE:	40+ yrs
Retention Value:	High
Comments (assessment):	Slight lean east. Closest to high water table, more stress responsive growth. Typical amount of deadwood
DBH (mm):	790
Tree Protection Zone (TPZ)(m):	9.48
Structural Root Zone (SRZ)(m):	3.0

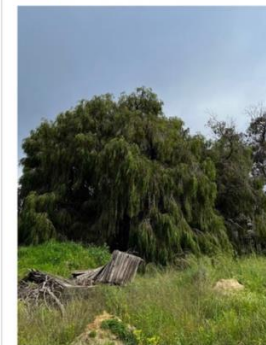
Weeping Peppermint Tree ID 27**Tree Details**

Botanical Name:	Agonis flexuosa
Common Name:	Weeping peppermint
Height (m):	11
Spread (m):	12.5
Health:	Good
Structure:	Fair
Age:	Mature
SULE:	40+ yrs
Retention Value:	Very High
Comments (assessment):	High value tree, well balanced, no work.
DBH (mm):	1910
Tree Protection Zone (TPZ)(m):	15.0
Structural Root Zone (SRZ)(m):	4.34
