ASBESTOS MATERIALS REGISTER

Report ID: 28233r3 – Supersedes
28233r2

**Building 7266 – Maida Vale Netball Building (Hall),
Ridgehill Road, Maida Vale WA 6057**

Reinspection conducted by City of Kalamunda

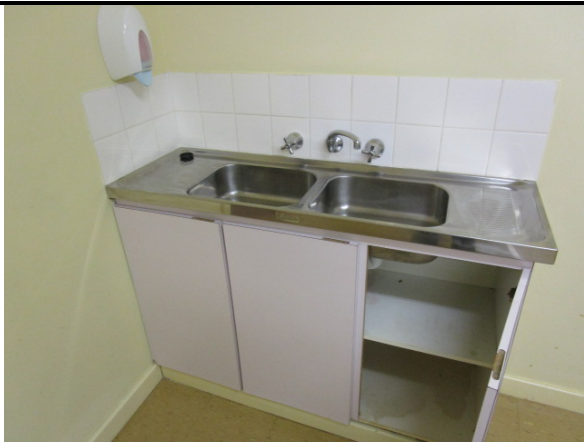
ID 1:- Under Sink Membrane (Removed)

Material	Chrysotile asbestos detected.	
Lab No.	ARL Lab No. 21-05777-D-1.	
QED Sample No.	ID: 32404.	
Locations	Underneath the sink in the Match Office and Umpires Rooms	
Condition	N/A.	
Signage	N/A.	
Potential for Disturbance	N/A.	
Risk	N/A.	<p>Photo from March 2021 inspection.</p>

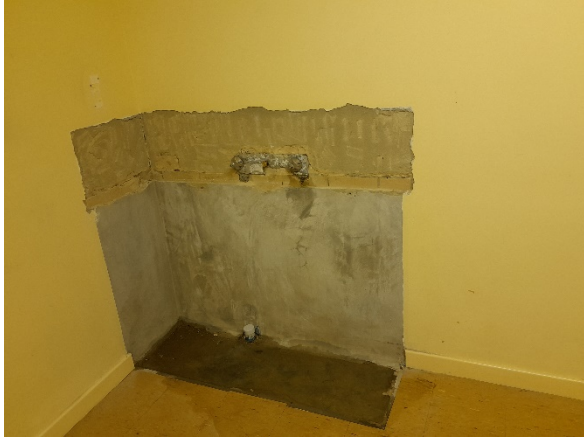
<p>14 January 2022 Photo supplied by City of Kalamunda</p>
Management Actions	N/A.	
References (See Appendices)	N/A.	
Service Record	<p>Information supplied by City of Kalamunda Company: City of Kalamunda's Facility Repair Officer, Travis Kell Date: 14 January 2022 Works: Removal of sink Clearance certificate: None</p>
