# Wattle Grove South

## 2019-2020 Water monitoring report

Prepared for City of Kalamunda

By Urbaqua

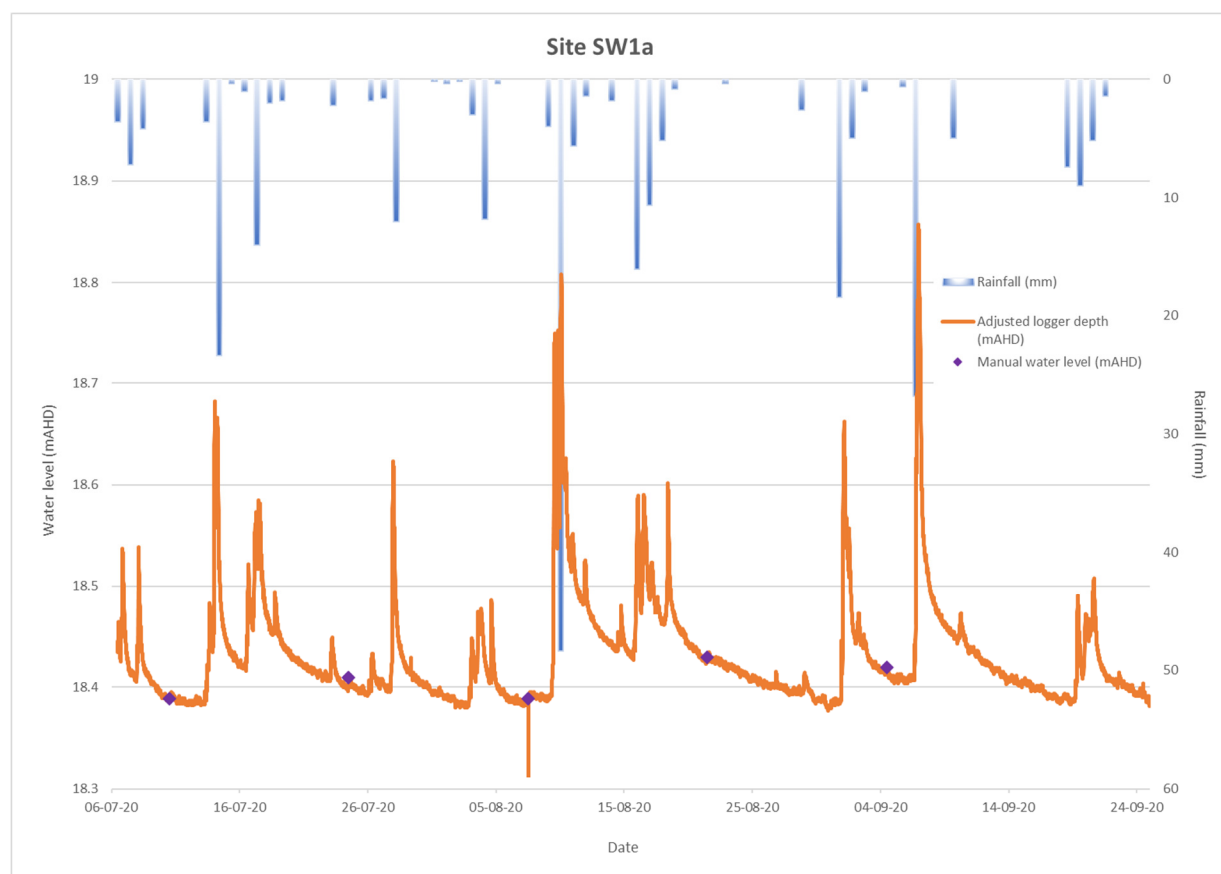
**Figure 3: Logger and manual water level measurements recorded at site SW1a in winter 2020**

Additional in situ manual flow and water level measurements recorded in 2020 during sampling events were used to develop ratings curves for each site, which were then used to convert recorded water level measurements into flow rates. Measurements recorded by the pressure probe installed at site SW1a, manual water level measurements, and rainfall are presented in Figure 3 below. Results demonstrate that changes in water level and flows reflected rainfall patterns with significant peak flows occurring throughout the winter period, and that logger results correlated with those measured manually during sampling events. Results from surface water level measurements at four sites (upstream site SW4, midway sites SW2 and SW5, and discharge site SW1/SW1a), and details regarding ratings curve development and conversions into flow rates are presented in Appendix 4.

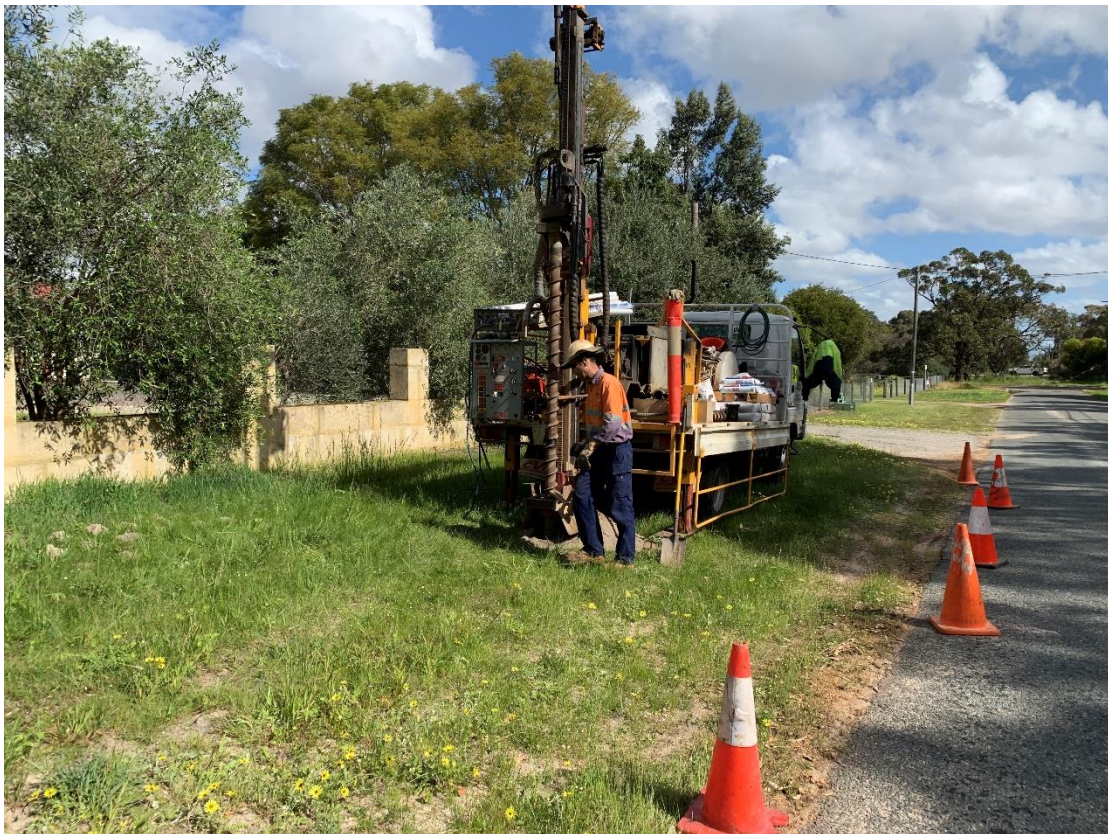
**Figure 2: Drill rig on location**

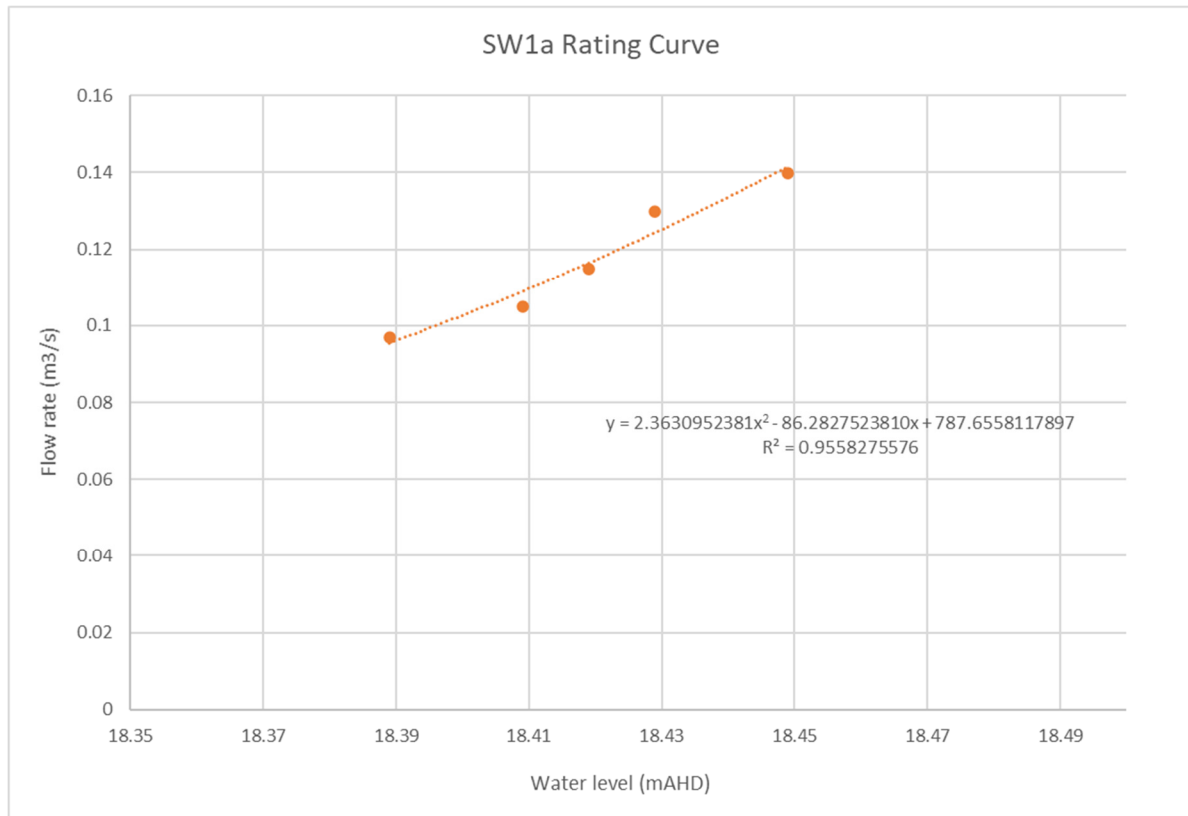
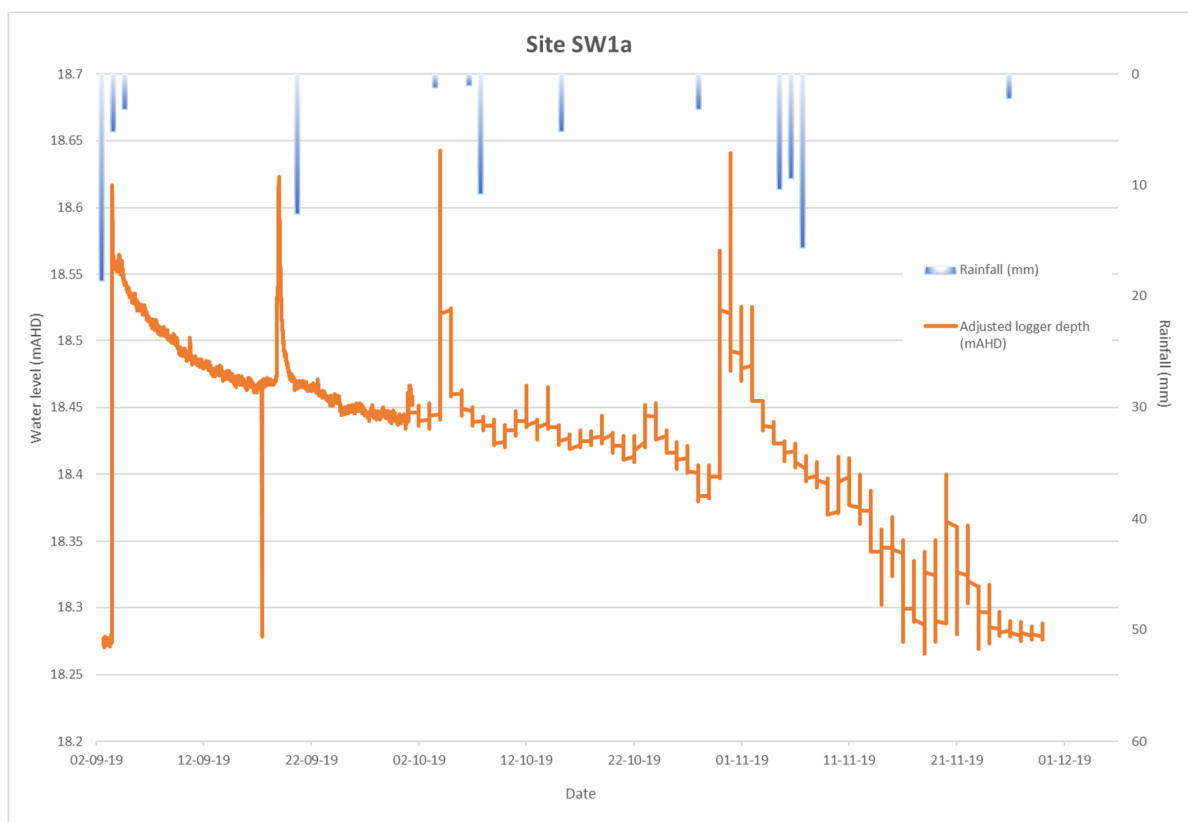
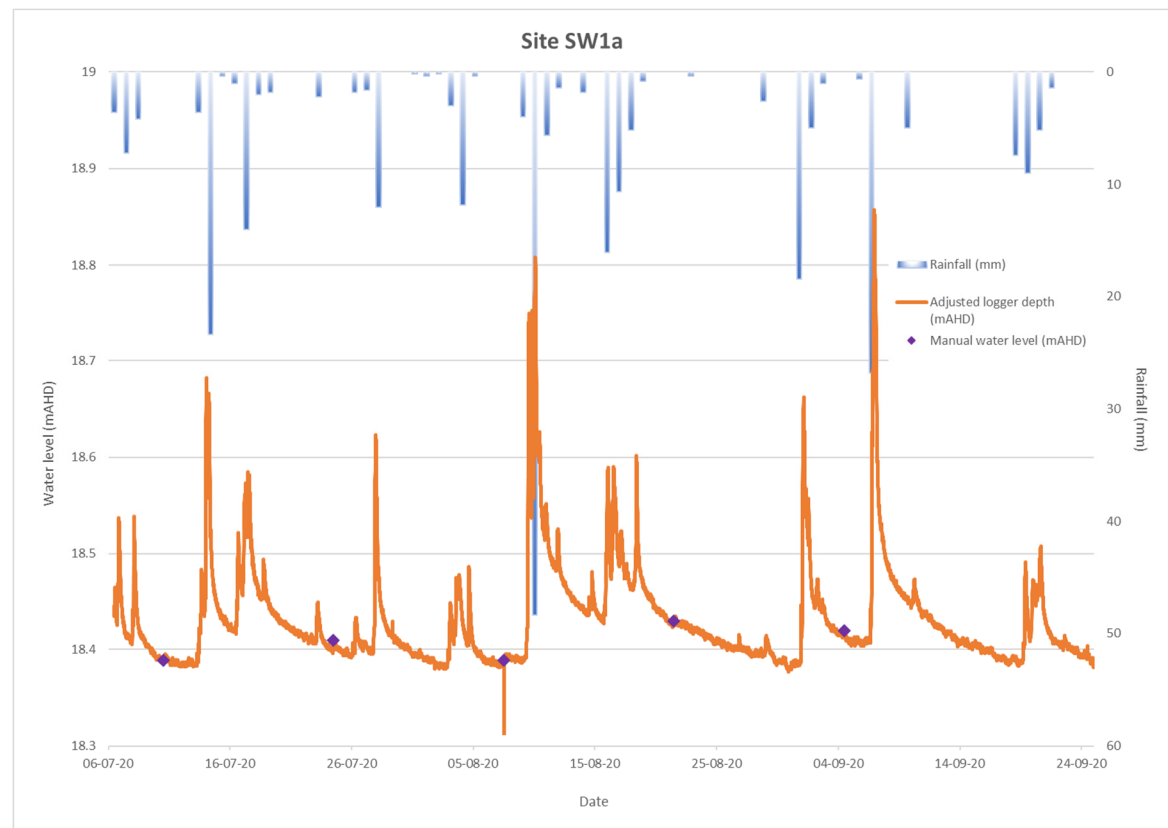
## Site SW1a

Ratings curves developed on the basis of manual water levels measurements and adjusted flow rates are presented for each site below.

Ratings curves were developed for sites SW1a, SW2, SW4, and SW5 (Figure 2) on the basis of manual measurements taken during the six (6) water quality sampling events during the winter of 2020 (see Appendix 3). Manual water levels and flow measurements were recorded at 0.2 m intervals over a cross-section, where the PVC pipe (pressure probe loggers) was installed. The configuration is shown in the cross-section below. Manual water levels measurements in the channel were adjusted to the local datum, the PVC pipe and pressure probe logger that had been surveyed for location and elevation (mAHD). Logger water level readings were also adjusted to the datum (mAHD) using manual water level readings, either in July or August 2020 where flows were near their peak. The manual water level readings used for the logger adjustment are italicized in each table below.

Given the limited set of measurements used to develop the ratings curves, flow results were adjusted within the measured range manual flow measurements to better reflect approximate flow rates at each site corresponding with logger water level data.

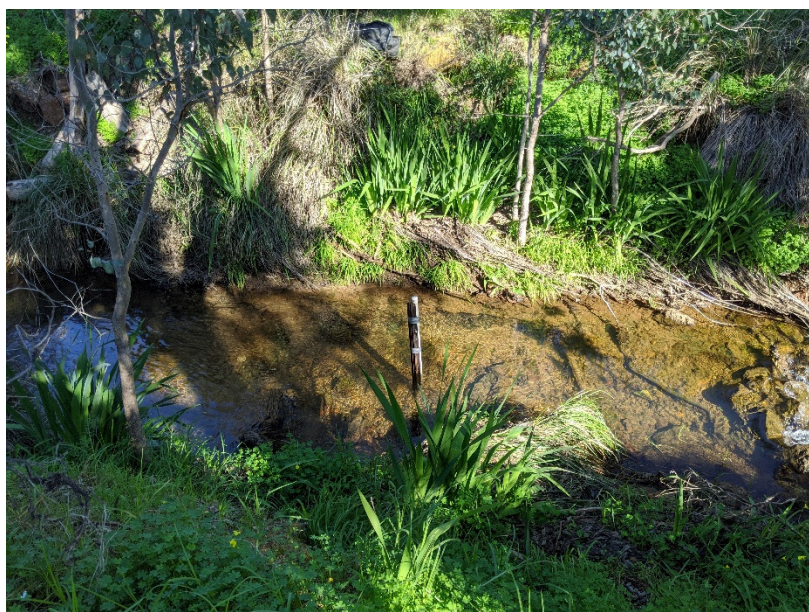
Site SW1a pressure probe

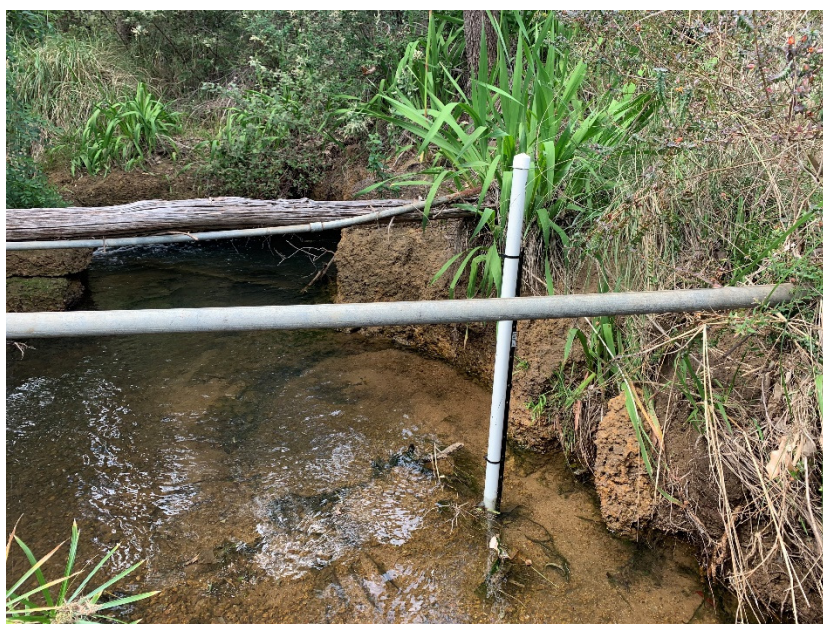
Site SW2 pressure probe

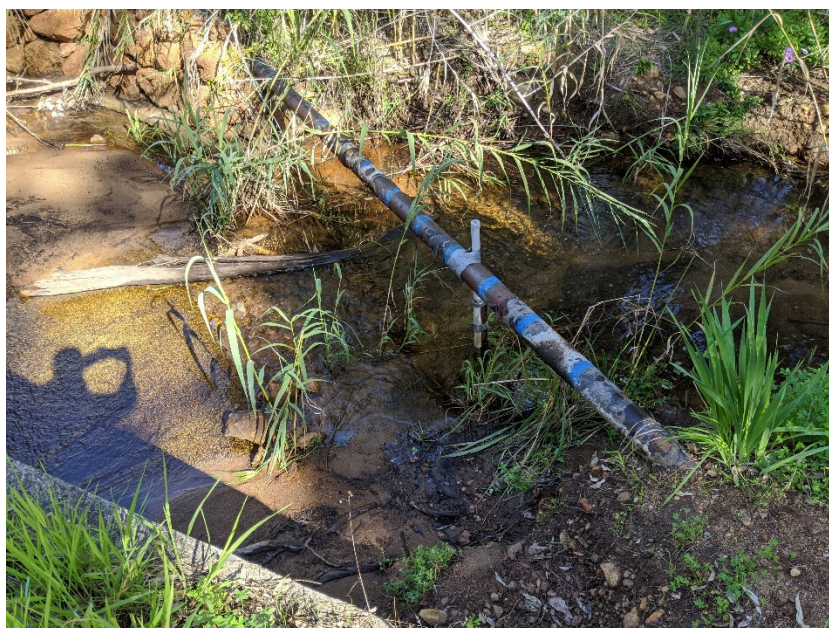
Site SW4 pressure probe

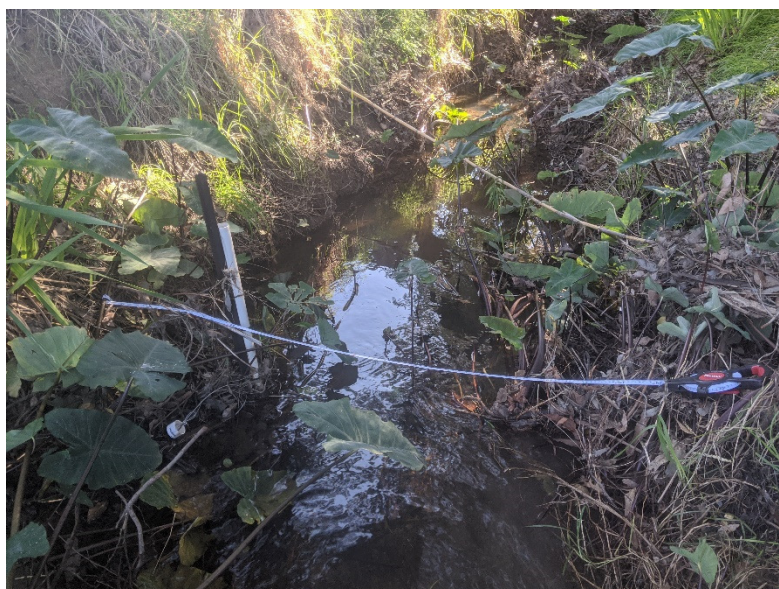
Site SW5 pressure probe
