# ASBESTOS REGISTER

Hartfield Park Recreation Centre, 199 Hale Road, Forrestfield, WA

Report ID: **34735Br0**

Prepared for: **City of Kalamunda**

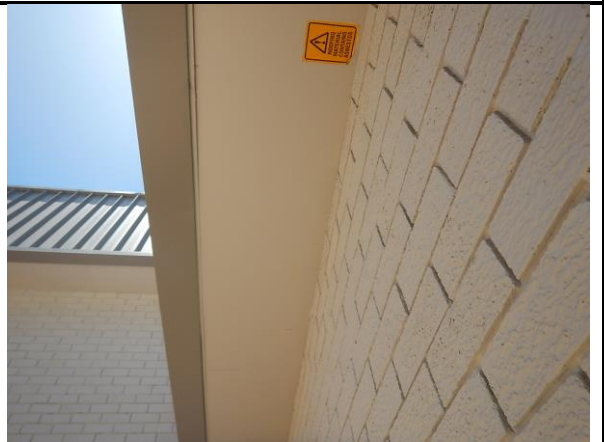
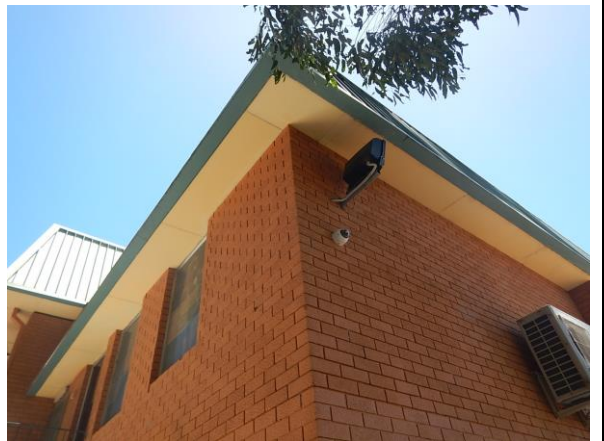
<b>ID 1:- Fibre Cement Eave Panelling (Asbestos Detected)</b>	
Material	Chrysotile asbestos detected.
Lab No.	ARL Lab No's; 20-07224-15 (Northwest elevation); 20-07224-16 (Northeast elevation); 20-07224-17 (Main Oval side of soccer club stand) 20-07224-18 (rear near emergency staircase).
QED Sample No.	ID: Sampled by City of Kalamunda.
Locations	External – Building perimeter, eaves lining.
Condition	Typically good, sealed, non-friable.
Signage	Labelled.
Potential for Disturbance	Low.
<b>Risk</b>	<p><b>The ACM are not friable and are in stable condition. Ensure that they remain clearly labelled and regularly inspect to ensure they are not deteriorating or otherwise contributing to an unacceptable health risk.</b></p>
Management Actions	<p>May remain in-situ until replacement is required.</p> <p>Manage as per <b>Asbestos Management Plan</b>.</p> <p>Administrative – Follow safe work procedures during removal and maintenance.</p> <p>Personal protective equipment – P2 facemask and coveralls required when working on material.</p>

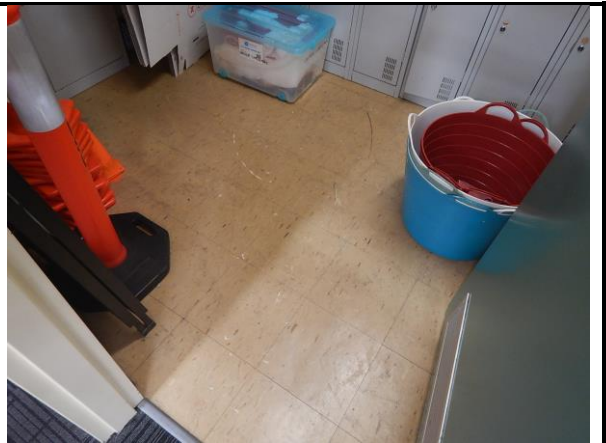
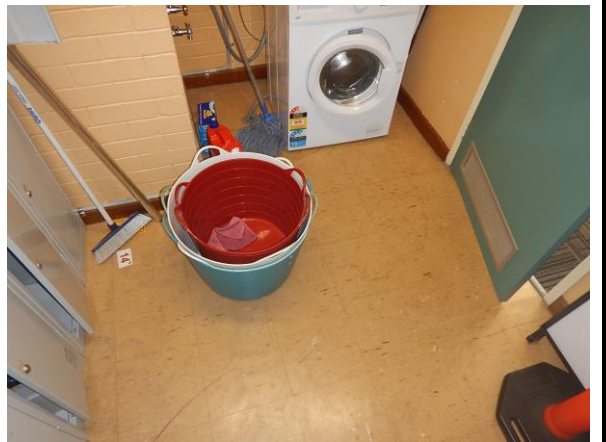
<b>ID 2:- Beige Vinyl Floor Tiles (Asbestos Detected)</b>	
Material	Chrysotile asbestos detected.
Lab No.	ARL Lab no. 20-07224-21.
QED Sample No.	ID: Sample by City of Kalamunda.
Locations	Internal – Staff locker room and first Aid room, floor.
Condition	Good to fair, intact, non-friable.
Signage	Labelled.
Potential for Disturbance	Low to Medium.
<b>Risk</b>	<p>The ACM are not friable and are in stable condition. Ensure that they remain clearly labelled and regularly inspect to ensure they are not deteriorating or otherwise contributing to an unacceptable health risk.</p>
Management Actions	<p>May remain in-situ until replacement is required.                  Manage as per <b>Asbestos Management Plan</b>.                  Administrative – Follow safe work procedures during removal and maintenance.                  Personal protective equipment – P2 facemask and coveralls required when working on material.</p>

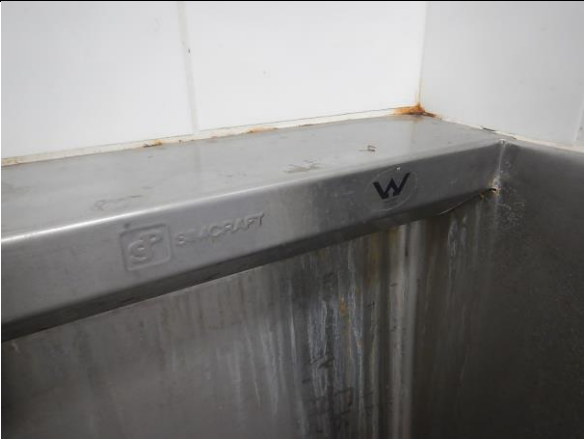
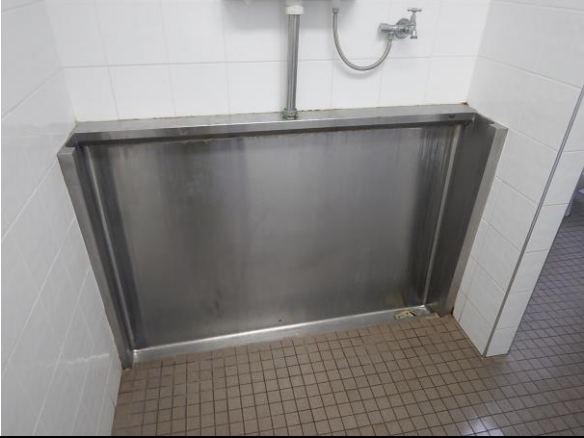
<b>ID 3:- Urinal Backing Membrane (Simcraft) (Suspected Asbestos Containing Material)</b>

Material	Suspected asbestos containing material.		
Lab No.	Unable to sample (encapsulated)		
QED Sample No.	ID: N/A.		
Locations	Internal – Central male toilets, urinal.		
Condition	Encased, intact, non-friable.		
Signage	Unable to adequately label.		
Potential for Disturbance	Low.		
<b>Risk</b>	<p><b>The ACM are not friable and are in stable condition. Ensure that they are regularly inspected to ensure they are not deteriorating or otherwise contributing to an unacceptable health risk.</b></p>

Management Actions	<p>May remain in-situ until replacement is required.                  Manage as per <b>Asbestos Management Plan</b>.                  Administrative – Follow safe work procedures during removal and maintenance.                  Personal protective equipment – P2 facemask and coveralls required when working on material.</p>

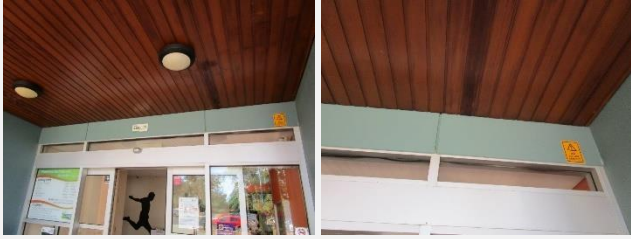
Item Description	Lab No.	Location	Photo	Comments
<b>Main entry Cover board above auto doors</b>	ARL Lab No. 20-07224-14.  Sampled by City of Kalamunda.	Main entry.

No asbestos detected.  Information taken from city of Kalamunda Asbestos register:  Building: Hartfield Park Recreation Centre  Asset ID: BD_5031-00 & 01 & BD_5113-00 & 01 Date Inspected: 18-Dec-2019
<b>Eaves of the new section of the building</b>	Previously identified as non-asbestos containing.	Eaves surrounding the new section of the building.

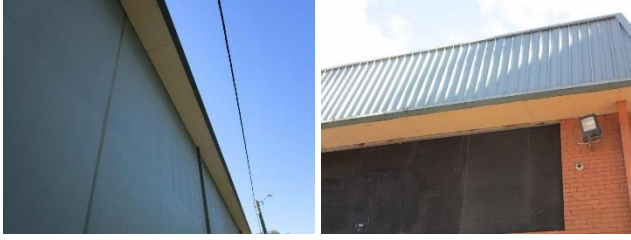
No asbestos detected.  Information taken from city of Kalamunda Asbestos register:  Building: Hartfield Park Recreation Centre  Asset ID: BD_5031-00 & 01 & BD_5113-00 & 01 Date Inspected: 18-Dec-2019
<b>Cover plate behind downpipe outside of gym wall</b>	ARL Lab No. 20-07224-19.  Sampled by City of Kalamunda.	Right of Main entry.

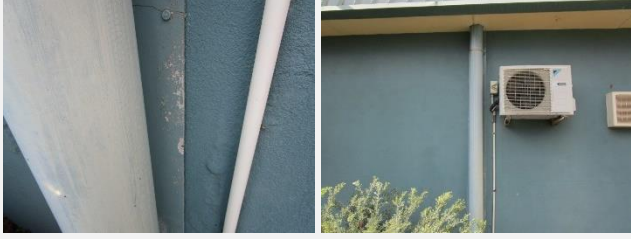
No asbestos detected.  Information taken from city of Kalamunda Asbestos register:  Building: Hartfield Park Recreation Centre  Asset ID: BD_5031-00 & 01 & BD_5113-00 & 01 Date Inspected: 18-Dec-2019

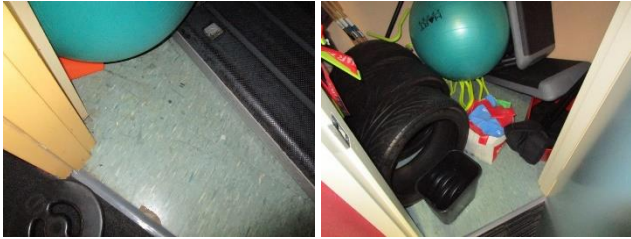
Item Description	Lab No.	Location	Photo	Comments
<b>Green vinyl Floor Tiles</b>	ARL Lab No. 13-7823-3  Sampled by City of Kalamunda	Group fitness storeroom floor within Fitness room 1st floor  Rm #44, Group fitness storeroom floor, outside Fitness room, left side 1st floor Rm #43, and RPM studio

No asbestos detected.  Information taken from city of Kalamunda Asbestos register:  Building: Hartfield Park Recreation Centre  Asset ID: BD_5031-00 & 01 & BD_5113-00 & 01 Date Inspected: 18-Dec-2019
<b>Vermiculite ceiling coating</b>	ARL Lab No. 20-07224-20 (Room 20) 20-07224-22 (Room 14) 20-07224-26 (Outside Changerooms) 20-07224-28 (Understairs) 20-07224-30 (Reception) 20-07224-31 (Reception) 20-07224-32 (Reception) 20-07224-33 (Outside first aid) 20-07224-34(Plumbing duct)	Ceiling finishing's throughout.

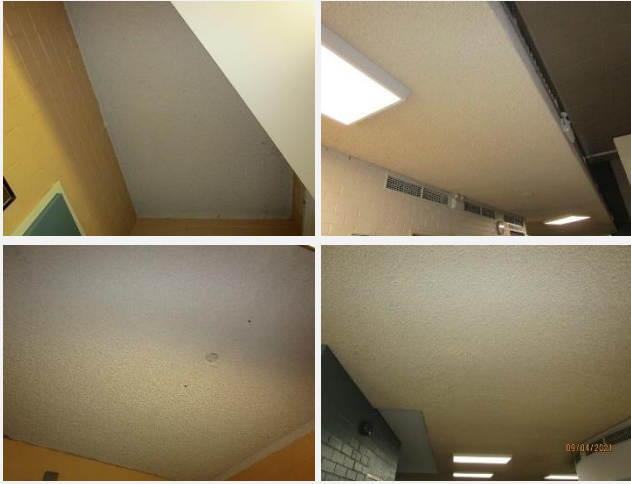
No asbestos detected.  Sampled by City of Kalamunda.  Information taken from city of Kalamunda Asbestos register:  Building: Hartfield Park Recreation Centre  Asset ID: BD_5031-00 & 01 & BD_5113-00 & 01 Date Inspected: 18-Dec-2019
