ASBESTOS REGISTER

Headingly Road House, 11 Headingly Road, Kalamunda, WA

Report ID: **34745Br1**

Prepared for: **City of Kalamunda**

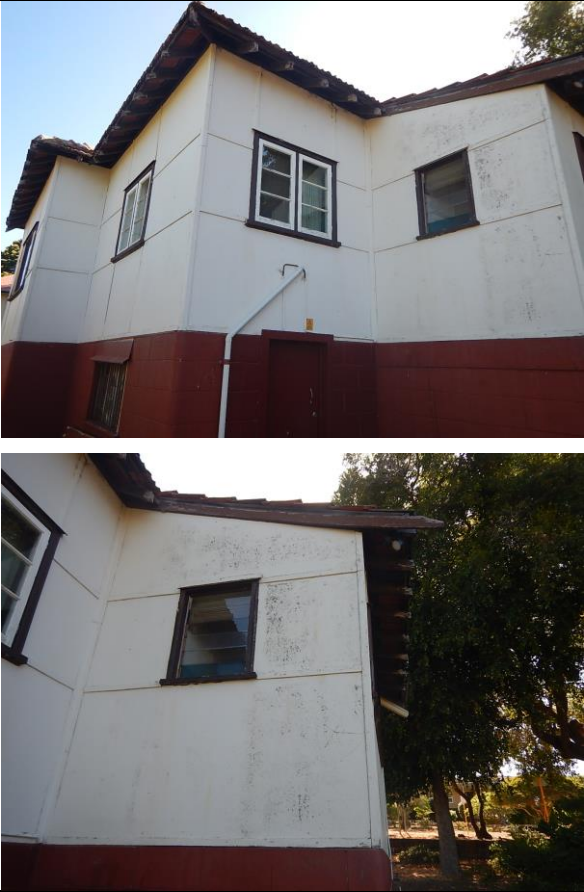
ID 1:- Fibre Cement Wall Panelling (Including Jointing Strips) (Asbestos Detected)

Material	Chrysotile asbestos detected.	
Lab No.	ARL Lab no. 21-04932-C-1.	
QED Sample No.	ID: 32418.	
Locations	External – External walls of building (including jointing strips).	
Condition	Good to fair, typically sealed, non-friable.	
Signage	Labelled.	
Potential for Disturbance	Low to medium.	
Risk	<p>The ACM are not friable and are in stable condition. Ensure that they remain clearly labelled and regularly inspect to ensure they are not deteriorating or otherwise contributing to an unacceptable health risk.</p>	
Management Actions	<p>Ideally material would be removed. However, if this is not practical, encapsulation of exposed edges/breaks is recommended. May remain in-situ until replacement is required. Manage as per Asbestos Management Plan. Administrative – Follow safe work procedures during removal and maintenance. Personal protective equipment – P2 facemask and coveralls required when working on material.</p>

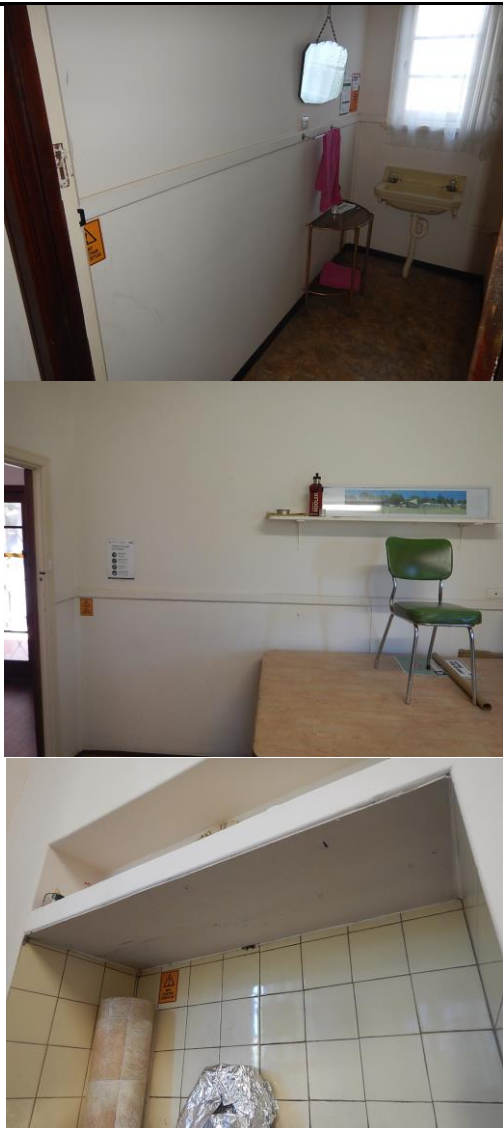
ID 2:- Fibre Cement Wall Panelling (Including Jointing Strips) (Asbestos Detected)

Material	Chrysotile and amosite asbestos detected.	
Lab No.	ARL Lab no. 21-04932-C-2.	
QED Sample No.	ID: 32419.	
Locations	Internal – Kitchen, storeroom behind kitchen and bathroom, wall panels (including jointing strips).	
Condition	Good to fair, typically sealed, non-friable.	
Signage	Labelled.	
Potential for Disturbance	Low to medium.	
Risk	<p>The ACM are not friable and are in stable condition. Ensure that they remain clearly labelled and regularly inspect to ensure they are not deteriorating or otherwise contributing to an unacceptable health risk.</p>	
Management Actions	Ideally material would be removed. However, if this is not practical, encapsulation of exposed edges/breaks is recommended. May remain in-situ until replacement is required. Manage as per Asbestos Management Plan . Administrative – Follow safe work procedures during removal and maintenance. Personal protective equipment – P2 facemask and coveralls required when working on material.

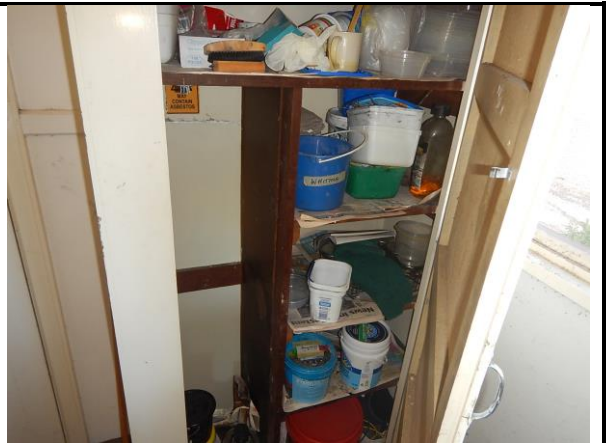
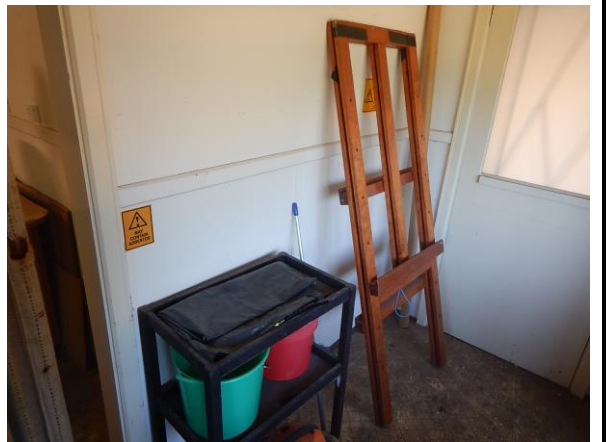
ID 3:- Fibre Cement Wall Panelling (Asbestos Detected)	
Material	Chrysotile and amosite asbestos detected.
Lab No.	ARL Lab no. 21-04932-C-2.
QED Sample No.	ID: 32419.
Locations	Internal – Kitchen, cabinet and adjacent room wall panels.
Condition	Fair, typically sealed, non-friable.
Signage	Labelled.
Potential for Disturbance	Low to medium.
Risk	<p>The ACM are not friable but are unsealed. Removal of material is desired, however, encapsulation of material would reduce the risk and extend the serviceable life of the material. Ensure that they remain clearly labelled and regularly inspect to ensure they are not deteriorating or otherwise contributing to an unacceptable health risk.</p>
Management Actions	<p>Ideally material would be removed. However, if this is not practical, encapsulation of exposed areas is recommended.</p> <p>During the inspection it was noted that some of the materials seem to have been encapsulated. If information could be provided to ensure this process has occurred, the risk/actions required would decrease.</p> <p>May remain in-situ until replacement is required.</p> <p>Manage as per Asbestos Management Plan.</p> <p>Administrative – Follow safe work procedures during removal and maintenance.</p> <p>Personal protective equipment – P2 facemask and coveralls required when working on material.</p>

ID #	Product	Location
3	Fibre Cement Wall Panelling.	Internal – Kitchen, cabinet and adjacent room wall panels.
<i>Recommendations:</i> Ideally material would be removed. However, if this is not practical, encapsulation of exposed areas is recommended. During the inspection it was noted that some of the materials seem to have been encapsulated. If information could be provided to ensure this process has occurred, the risk/actions required would decrease. Refer to Management Actions.		
6	Asbestos Cement Fragments.	External – Western elevation of building, to ground/s.
<i>Recommendations:</i> The cement fragments should be removed via hand picking, including if practical, gently fine raking of wetted soil to 10 cm depth to expose ACM fragments as per Management of Small-Scale Low-Risk Soil Asbestos Contamination by a removalist with a Class B asbestos removal license. Further investigation should be conducted to determine the extent of any soil contamination to establish appropriate remediation recommendations. Refer to Management Actions.

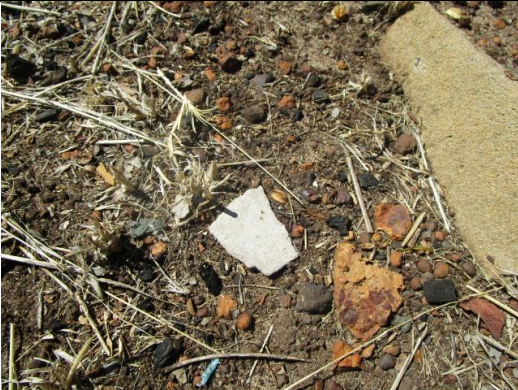
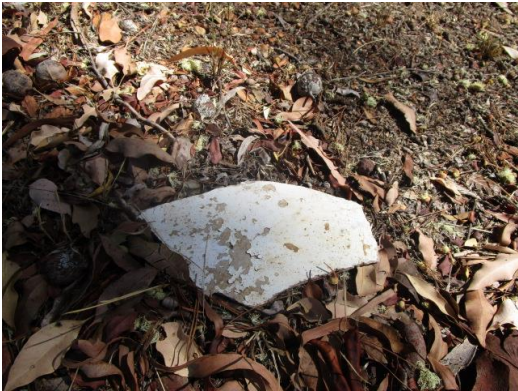
ID 6:- Asbestos Cement Fragments (Asbestos Detected)

Material	Chrysotile asbestos detected.	
Lab No.	ARL Lab no. 21-04932-C-1.	
QED Sample No.	ID: 32418.	
Location	External – Western elevation of building, to ground/s.	
Condition	Fair, non-friable.	
Signage	Labelling not practicable.	
Potential for Disturbance	Medium.	
Risk	<p>IMMEDIATE ACTION REQUIRED. The ACM are not friable however, due to their location there is a risk that they could be easily disturbed. It is recommended that the debris is removed.</p>	
Management Actions	<p>The cement fragments should be removed via hand picking, including if practical, gently fine raking of wetted soil to 10 cm depth to expose ACM fragments as per Management of Small-Scale Low-Risk Soil Asbestos Contamination by a removalist with a Class B asbestos removal licence. Further investigation should be conducted to determine the extent of any soil contamination to establish appropriate remediation recommendations.</p> <p>Personal protective equipment – P2 facemask and coveralls required when working on material.</p> <p>Manage as per Asbestos Management Plan.</p> <p>Administrative – Follow safe work procedures during removal and maintenance.</p> <p>Personal protective equipment – P2 facemask and coveralls required when working on material.</p>

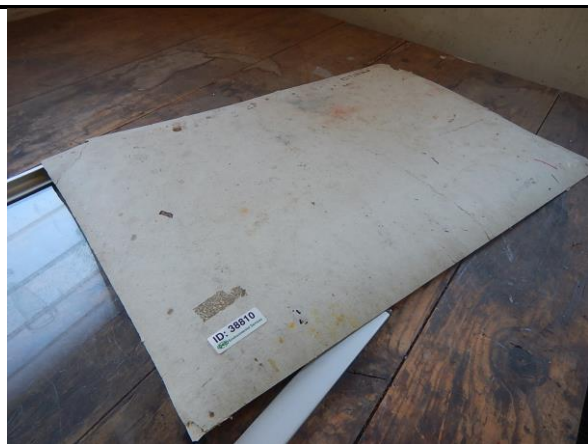
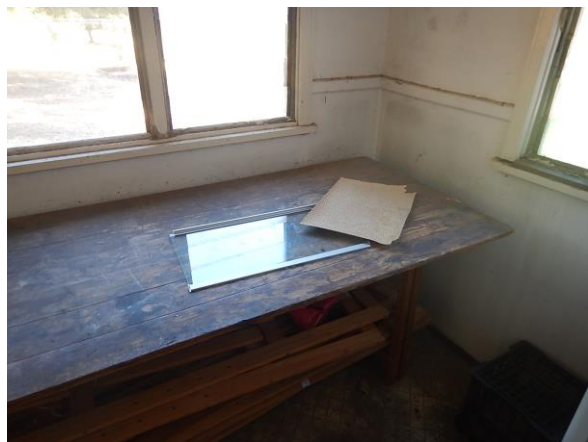
ID 7:- Mosaic Vinyl Flooring and Backing Layer (Suspected Asbestos Containing Material)	
Material	Suspected asbestos containing material.
Lab No.	N/A.
QED Sample No.	ID: Observed.
Locations	Internal – Kitchen storeroom, loose/stored.
Condition	Good, intact, Friable
Signage	None.
Potential for Disturbance	Medium.
Risk	<p>IMMEDIATE ACTION REQUIRED. The ACM are friable but are in a stable condition. The ACM are accessible. Serious consideration should be given to their removal. If removal is not immediately practicable, short-term control measures, such as sealing and enclosure, may be able to be used until removal is possible.</p>
Management Actions	Removal of material is recommended. May remain in-situ until replacement is required. May be disturbed only by a contractor holding a Class A Asbestos Removal License. Manage as per Asbestos Management Plan . Administrative – Follow safe work procedures during removal and maintenance. Personal protective equipment – P3 full face powered air respirator and coveralls required during removal of material.

7	Mosaic Vinyl Flooring and Backing Layer.	Internal – Kitchen storeroom, loose/stored.
<i>Recommendations:</i> Removal of material is recommended. Refer to Management Actions.

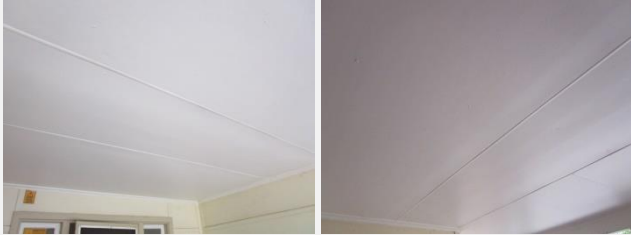
Item Description	Lab No.	Location	Photo	Comments
Front entry veranda ceiling lining.	ARL Lab No. 21-04932-C-5. QED ID: 32424.	Entrance ceiling.

No asbestos detected. Labels can be removed.
Panelling above the stove in the kitchen.	ARL Lab No. 21-04932-C-3. QED ID: 32420.	Above the stove in the kitchen.

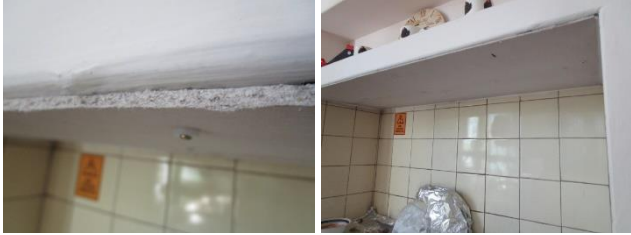
No asbestos detected. Labels can be removed.
Window Mastic.	ARL Lab No. 21-04932-C-6. QED ID: 32425.	Window frames throughout.

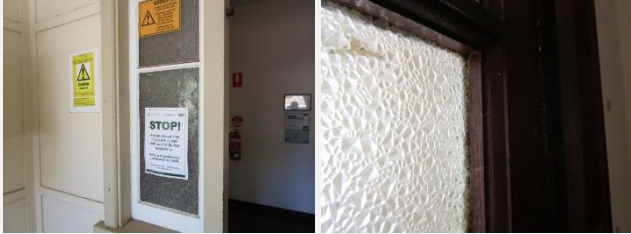
No asbestos detected.
Vinyl floor sheeting.	Greencap Report No. 41863. QED ID: 32421.	Kitchen and adjacent room.

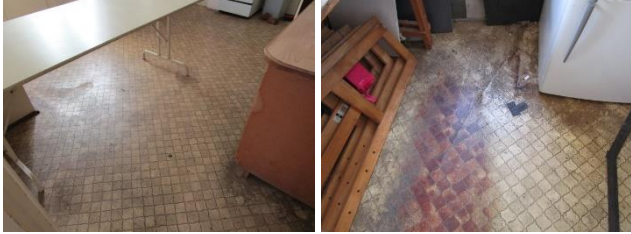
No asbestos detected.

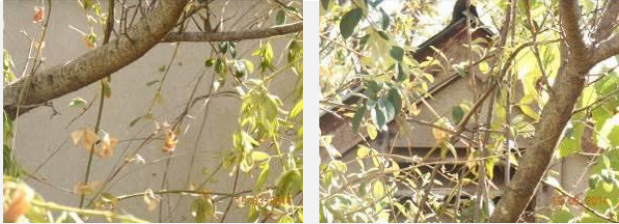
Item Description	Lab No.	Location	Photo	Comments
Panelling.	Removed.	Outside toilet rear left side of back yard.

Removed 22/09/2014. Information taken from the City of Kalamunda register: Building: Headingly Road house. Asset ID: BD_5032-00 to BD_5032-01. Date Inspected: 12-Dec-2019.
