ASBESTOS REGISTER

High Wycombe Library, 15 Markham Road, High Wycombe, WA

Report ID: **34740Br0**

Prepared for: **City of Kalamunda**

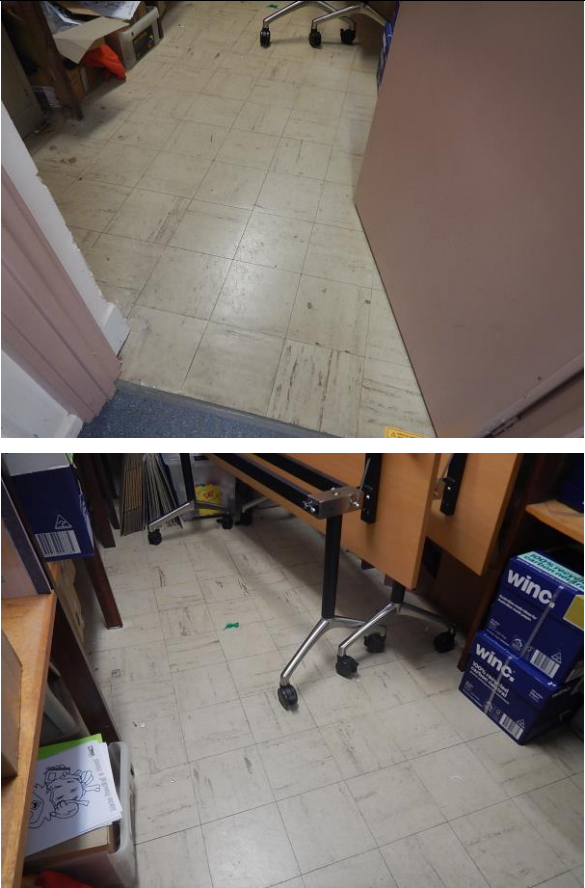
ID 1:- Beige Vinyl Floor Tiles (Asbestos Detected)

Material	Chrysotile asbestos detected.	
Lab No.	Greencap Report No. 41784.	
QED Sample No.	ID: 32387.	
Locations	Internal – Storeroom adjacent kitchen and below partition wall between kitchen/office.	
Condition	Good, intact, non-friable.	
Signage	None.	
Potential for Disturbance	Medium.	
Risk	<p>The ACM are not friable and are in stable condition. Ensure that they remain clearly labelled and regularly inspect to ensure they are not deteriorating or otherwise contributing to an unacceptable health risk.</p>	
Management Actions	<p>Label when practical. May remain in-situ until replacement is required. Manage as per Asbestos Management Plan. Administrative – Follow safe work procedures during removal and maintenance. Personal protective equipment – P2 facemask and coveralls required when working on material.</p>	
References (See Appendices)	<p>Safe Work Australia, Code of Practice: How to Manage and Control Asbestos in the Workplace. WHS Appendix F—Example of asbestos-related work WHS Appendix G—Recommended safe working practices Safe work practice 1—Drilling of ACM Safe Work Australia, Code of Practice: How to Safely Remove Asbestos Appendix E—Examples of asbestos removal work Removal of floor tiles</p>

Service Record	<p>Review– January 2028 Company: Date: Works: Clearance certificate:</p>

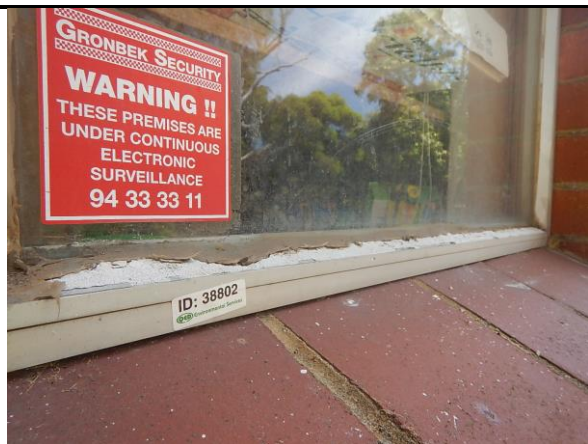
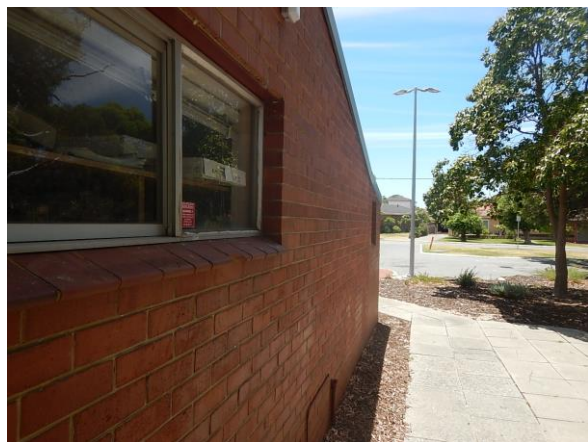
ID 2:- White/Grey Window Mastic (Suspected Asbestos Containing Material)	
Material	Suspected asbestos containing material.
Lab No.	N/A.
QED Sample No.	ID: Observed.
Locations	External – South-eastern elevation, window frames.
Condition	Good, intact, non-friable.
Signage	None.
Potential for Disturbance	Low.
Risk	<p>The ACM are not friable and are in stable condition. Ensure that they remain clearly labelled and regularly inspect to ensure they are not deteriorating or otherwise contributing to an unacceptable health risk.</p>
Management Actions	<p>Label when practical.</p> <p>Due to the potential variety of mastics used throughout the windows within the building, it is recommended that specific sampling be conducted prior to disturbance or removal of windows within the building or if the condition of the material deteriorates.</p> <p>Manage as per Asbestos Management Plan.</p> <p>Administrative – Follow safe work procedures during removal and maintenance.</p> <p>Personal protective equipment – P2 facemask and coveralls required when working on material.</p>

References (See Appendices)	<p>Safe Work Australia, Code of Practice: How to Manage and Control Asbestos in the Workplace. WHS Appendix G—Recommended safe working practices</p> <p>Safe work practice 2—Sealing, painting, coating and cleaning of asbestos cement products</p> <p>Safe Work Australia, Code of Practice: How to Safely Remove Asbestos Appendix E—Examples of asbestos removal work</p> <p>Removing bituminous (malthoid) products</p>
Service Record	<p>Review– January 2028</p> <p>Company:</p> <p>Date:</p> <p>Works:</p> <p>Clearance certificate:</p>

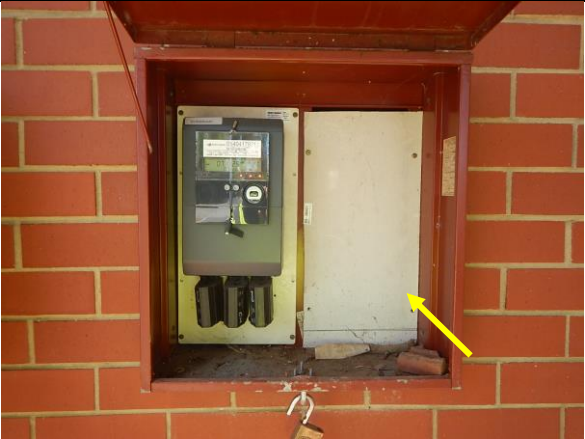
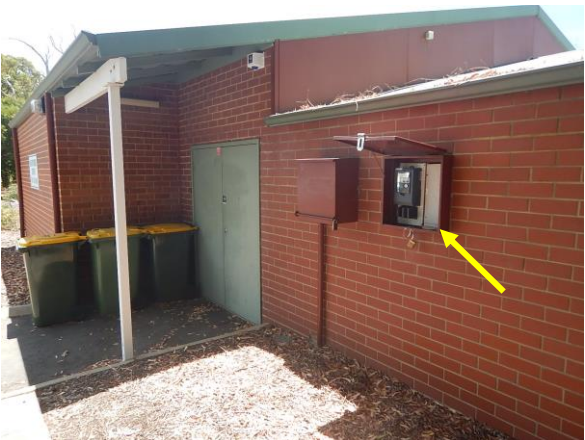
ID 3:- Fibre Cement Infill Panelling (Suspected Asbestos Containing Material)

Material	Suspected asbestos containing material.	
Lab No.	Unable to obtain suitable sample [sample restrictions].	
QED Sample No.	ID: Observed.	
Locations	External – South-western elevation, electrical cabinet, right hand side infill panel.	
Condition	Good, unsealed, non-friable.	
Signage	None.	
Potential for Disturbance	Low to medium.	
Risk	<p>The ACM are not friable and are in stable condition. Ensure that they remain clearly labelled and regularly inspect to ensure they are not deteriorating or otherwise contributing to an unacceptable health risk.</p>

Management Actions	<p>Label when practical. Material is unsealed, encapsulation is recommended. May remain in-situ until replacement is required. Manage as per Asbestos Management Plan. Administrative – Follow safe work procedures during removal and maintenance. Personal protective equipment – P2 facemask and coveralls required when working on material.</p>
