ASBESTOS REGISTER

Kalamunda Bowls Club, 18 Kalamunda Road, Kalamunda, WA

Report ID: **34751Br0**

Prepared for: **City of Kalamunda**

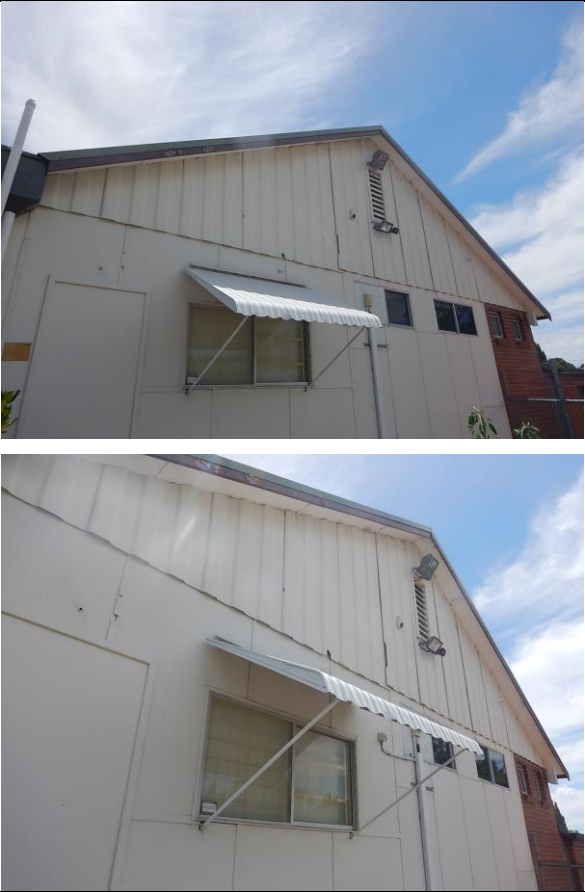
ID 1:- Fibre Cement Shadow-Line Panelling (Suspected Asbestos Containing Material)

Material	Suspected asbestos containing material.	
Lab No.	Unable to obtain suitable sample [height].	
QED Sample No.	ID: Observed.	
Locations	External – Eastern elevation, gable end of building.	
Condition	Good, sealed, non-friable.	
Signage	Labelled.	
Potential for Disturbance	Low.	
Risk	<p>The ACM are not friable and are in stable condition. Ensure that they remain clearly labelled and regularly inspect to ensure they are not deteriorating or otherwise contributing to an unacceptable health risk.</p>	
Management Actions	May remain in-situ until replacement is required. Manage as per Asbestos Management Plan . Administrative – Follow safe work procedures during removal and maintenance. Personal protective equipment – P2 facemask and coveralls required when working on material.	
References (See Appendices)	<p>Safe Work Australia, Code of Practice: How to Manage and Control Asbestos in the Workplace. WHS Appendix G—Recommended safe working practices Safe work practice 1—Drilling of ACM Safe work practice 2—Sealing, painting, coating and cleaning of asbestos cement products</p> <p>Safe Work Australia, Code of Practice: How to Safely Remove Asbestos Appendix E—Examples of asbestos removal work Asbestos cement products</p>

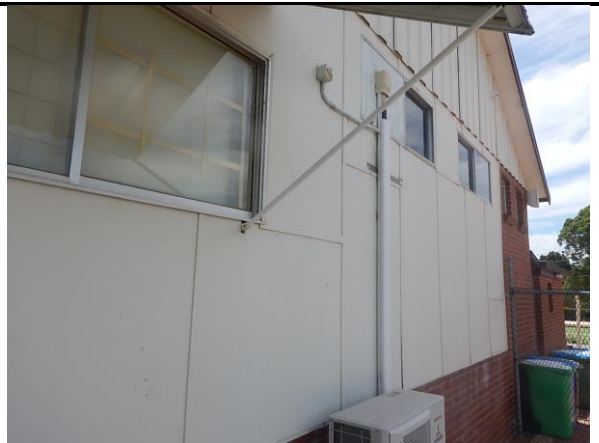
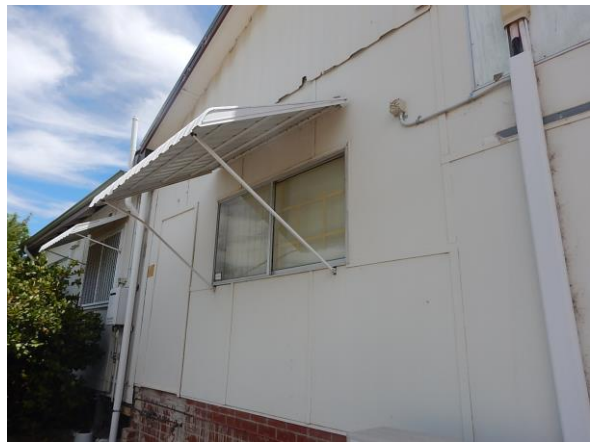
ID 2:- Fibre Cement Wall Panelling including Jointing Strips (Asbestos Detected)	
Material	Chrysotile and amosite asbestos detected.
Lab No.	Eurofins ALR Lab No. 21-10098-39.
QED Sample No.	ID: 32487.
Locations	External – Wall panelling of building.
Condition	Good to fair, small areas of damage.
Signage	Labelled.
Potential for Disturbance	Low.
Risk	<p>The ACM are not friable and are in stable condition. Ensure that they remain clearly labelled and regularly inspect to ensure they are not deteriorating or otherwise contributing to an unacceptable health risk.</p>
Management Actions	<p>A mixture of asbestos containing, and non-asbestos panels were identified. It should be presumed that all panels are asbestos containing unless specific sampling occurs. Exposed areas of the panels (broken edges, weathered areas etc.) should be encapsulated as soon as practical. May remain in-situ until replacement is required. Manage as per Asbestos Management Plan. Administrative – Follow safe work procedures during removal and maintenance. Personal protective equipment – P2 facemask and coveralls required when working on material.</p>

ID #	Product	Location
2	Fibre Cement Wall Panelling including Jointing Strips.	External – Wall panelling of building.
	Recommendations: Exposed areas of the panels (broken edges, weathered areas etc.) should be encapsulated as soon as practical.	
5	Fibre Cement Wall Panelling, Including Jointing Strips.	Internal – (Behind bar) Storeroom, wall panels.
	Recommendations: Exposed areas of the panels (broken edges, weathered areas etc.) should be encapsulated as soon as practical.	
6	Fibre Cement Ceiling Panelling Including Jointing Strips.	Internal – (Behind bar) Storeroom, ceiling panels.
	Recommendations: Exposed areas of the panels (broken edges, weathered areas etc.) should be encapsulated as soon as practical.	
8	Fibre Cement Panels – EMB Lining.	Internal - Small room off Bar storeroom, electrical cupboard lining.
	<i>Recommendations:</i> The fibre cement panels are unsealed; it is recommended the material is encapsulated as soon as possible.

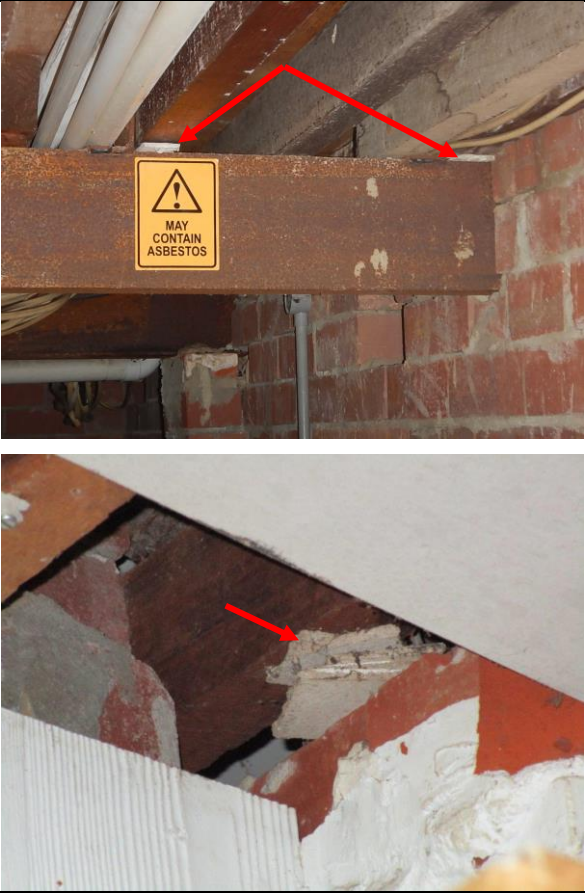
ID 3:- Fibre Cement Packers (Suspected Asbestos Containing Material)

Material	Suspected asbestos containing material.	
Lab No.	Unable to obtain suitable sample [inaccessible].	
QED Sample No.	ID: Observed.	
Locations	Internal – Throughout timber structure of building.	
Condition	Intact, non-friable.	
Signage	Labelled.	
Potential for Disturbance	Low.	
Risk	<p>The ACM are not friable and are in stable condition. Ensure that they remain clearly labelled and regularly inspect to ensure they are not deteriorating or otherwise contributing to an unacceptable health risk.</p>	
Management Actions	<p>May remain in-situ until replacement is required. Manage as per Asbestos Management Plan. Administrative – Follow safe work procedures during removal and maintenance. Personal protective equipment – P2 facemask and coveralls required when working on material.</p>	
References (See Appendices)	<p>Safe Work Australia, Code of Practice: How to Manage and Control Asbestos in the Workplace. WHS Appendix G—Recommended safe working practices Safe work practice 1—Drilling of ACM Safe work practice 2—Sealing, painting, coating and cleaning of asbestos cement products</p> <p>Safe Work Australia, Code of Practice: How to Safely Remove Asbestos Appendix E—Examples of asbestos removal work Asbestos cement products</p>

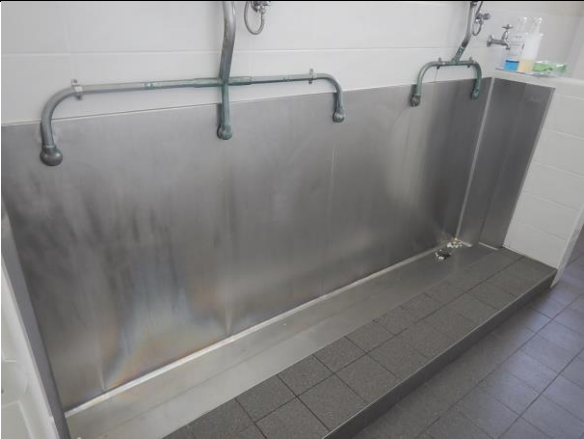
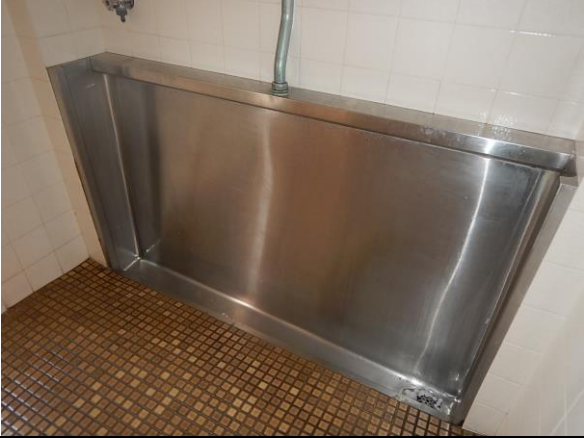
ID 4:- Urinal Backing Membrane (Bristile Units) (Suspected Asbestos Containing Material)

Material	Suspected asbestos containing material.		
Lab No.	Unable to sample (encapsulated)		
QED Sample No.	ID: N/A.		
Locations	Internal - Male toilets, urinals.		
Condition	Encased, non-friable.		
Signage	Unable to adequately label.		
Potential for Disturbance	Low.		
Risk	<p>The ACM are not friable and are in stable condition. Ensure that they are regularly inspected to ensure they are not deteriorating or otherwise contributing to an unacceptable health risk.</p>

Management Actions	May remain in-situ until replacement is required. Manage as per Asbestos Management Plan . Administrative – Follow safe work procedures during removal and maintenance. Personal protective equipment – P2 facemask and coveralls required when working on material.		
References (See Appendices)	Safe Work Australia, Code of Practice: How to Manage and Control Asbestos in the Workplace. Safe Work Australia, Code of Practice: How to Safely Remove Asbestos Appendix E—Examples of asbestos removal work Removing bituminous (malthoid) products

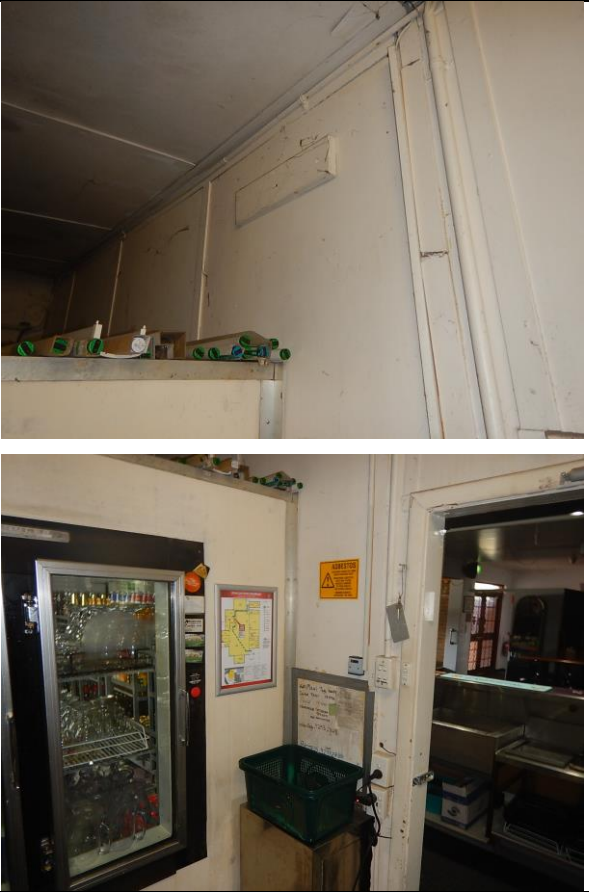
ID 5:- Fibre Cement Wall Panelling, Including Jointing Strips (Asbestos Detected)

Material	Chrysotile and amosite asbestos detected.	
Lab No.	Eurofins ARL Lab No. 21-10098-42 (panels). Eurofins ARL Lab No. 21-10098-44 (joints).	
QED Sample No.	ID: 32478. ID: 32480.	
Locations	Internal – (Behind bar) Storeroom, wall panels.	
Condition	Good to fair, sealed, non-friable.	
Signage	Labelled.	
Potential for Disturbance	Low.	
Risk	<p>The ACM are not friable and are in stable condition. Ensure that they remain clearly labelled and regularly inspect to ensure they are not deteriorating or otherwise contributing to an unacceptable health risk.</p>	
Management Actions	<p>Exposed areas of the panels (broken edges, weathered areas etc.) should be encapsulated as soon as practical. May remain in-situ until replacement is required.</p> <p>Manage as per Asbestos Management Plan.</p> <p>Administrative – Follow safe work procedures during removal and maintenance.</p> <p>Personal protective equipment – P2 facemask and coveralls required when working on material.</p>

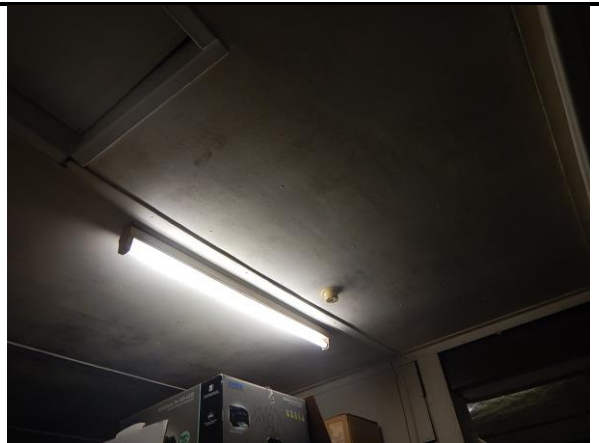
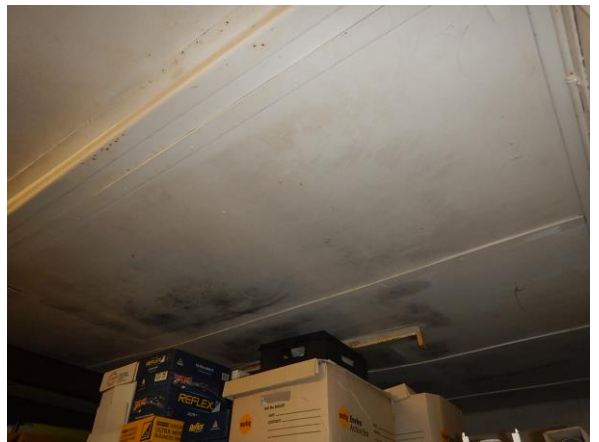
ID 6:- Fibre Cement Ceiling Panelling Including Jointing Strips (Asbestos Detected)	
Material	Chrysotile and amosite asbestos detected.
Lab No.	Eurofins ARL Lab No. 21-10098-43 (panels). Eurofins ARL Lab No. 21-10098-44 (joints).
QED Sample No.	ID: 32479. ID: 32480.
Locations	Internal – (Behind bar) Storeroom, ceiling panels.
Condition	Good to fair, sealed, non-friable.
Signage	Labelled.
Potential for Disturbance	Low.
Risk	<p>The ACM are not friable and are in stable condition. Ensure that they remain clearly labelled and regularly inspect to ensure they are not deteriorating or otherwise contributing to an unacceptable health risk.</p>
Management Actions	Exposed areas of the panels (broken edges, weathered areas etc.) should be encapsulated as soon as practical. May remain in-situ until replacement is required. Manage as per Asbestos Management Plan . Administrative – Follow safe work procedures during removal and maintenance. Personal protective equipment – P2 facemask and coveralls required when working on material.

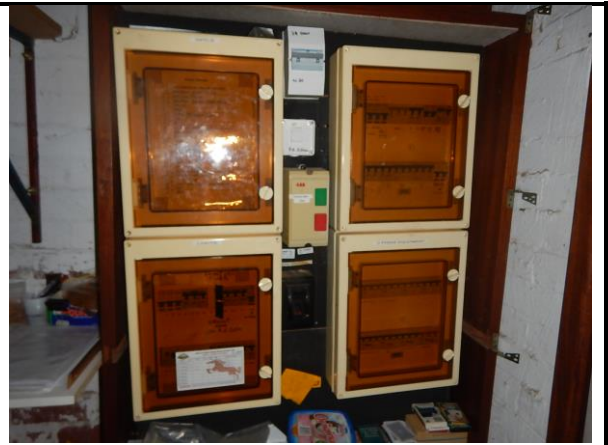
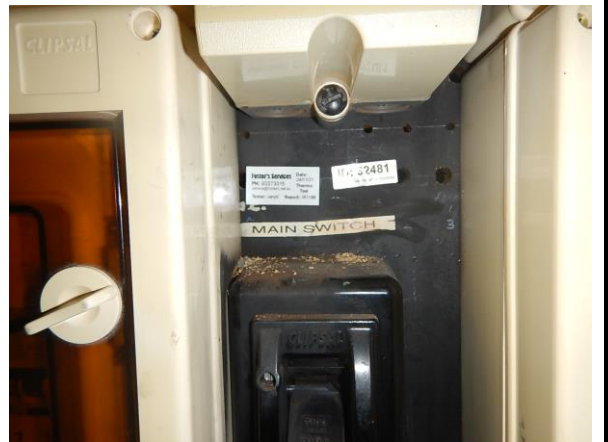
ID 7:- Electrical Mounting Board (Asbestos Detected)	
Material	Chrysotile asbestos detected.
Lab No.	Eurofins ARL Lab No. 21-10098-45.
QED Sample No.	ID: 32481.
Locations	Internal – Small room off Bar storeroom, to wall.
Condition	Good, non-friable.
Signage	Labelled.
Potential for Disturbance	Low.
Risk	<p>The ACM are not friable and are in stable condition. Ensure that they remain clearly labelled and regularly inspect to ensure they are not deteriorating or otherwise contributing to an unacceptable health risk.</p>
Management Actions	<p>May remain in-situ until replacement is required. Manage as per Asbestos Management Plan. Administrative – Follow safe work procedures during removal and maintenance. Personal protective equipment – P2 facemask and coveralls required when working on material.</p>
References (See Appendices)	<p>Safe Work Australia, Code of Practice: How to Manage and Control Asbestos in the Workplace. WHS Appendix G—Recommended safe working practices Safe work practice 5—Working on electrical mounting boards (switchboards) containing asbestos Safe Work Australia, Code of Practice: How to Safely Remove Asbestos Appendix E—Examples of asbestos removal work Asbestos cement products</p>

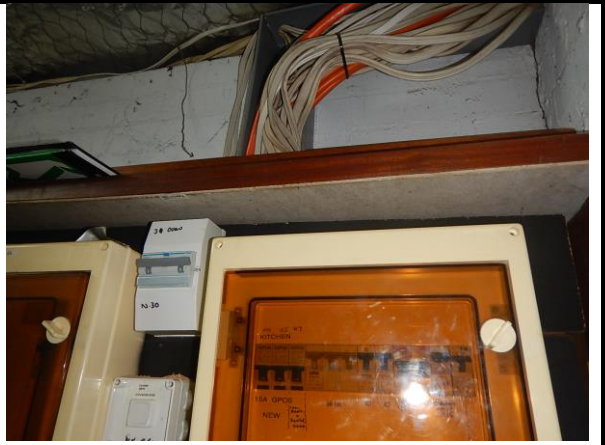
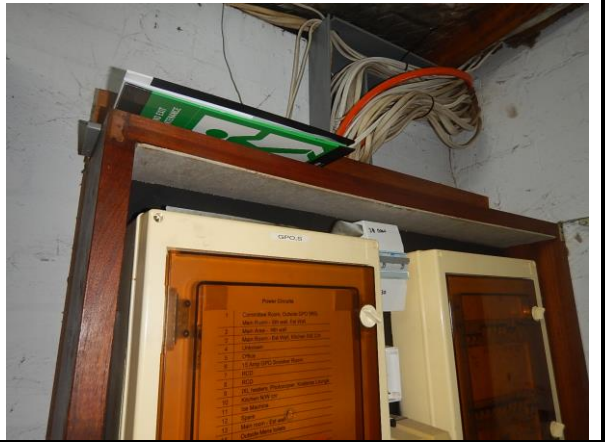
ID 8:- Fibre Cement Panels – EMB Lining (Asbestos Detected)	
Material	Chrysotile asbestos detected.
Lab No.	Eurofins ARL Lab No 21-10098-46.
QED Sample No.	ID: 32482.
Locations	Internal - Small room off Bar storeroom, electrical cupboard lining.
Condition	Good to fair, unsealed, non-friable.
Signage	None.
Potential for Disturbance	Low to medium.
Risk	<p>The ACM are not friable and are in stable condition. Ensure that they remain clearly labelled and regularly inspect to ensure they are not deteriorating or otherwise contributing to an unacceptable health risk.</p>
Management Actions	<p>Label when practical. The fibre cement panels are unsealed, it is recommended the material is encapsulated as soon as possible. May remain in-situ until replacement is required. Manage as per Asbestos Management Plan. Administrative – Follow safe work procedures during removal and maintenance. Personal protective equipment – P2 facemask and coveralls required when working on material.</p>

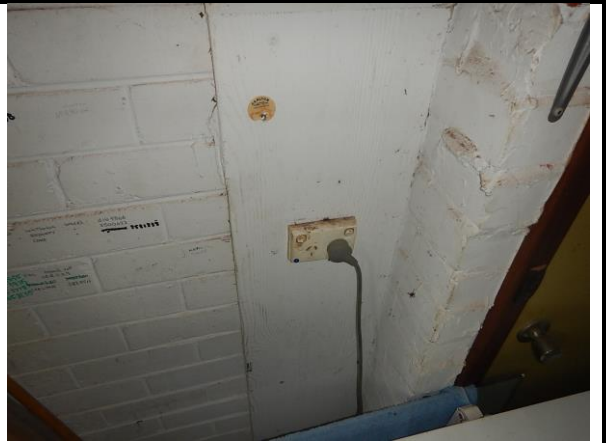
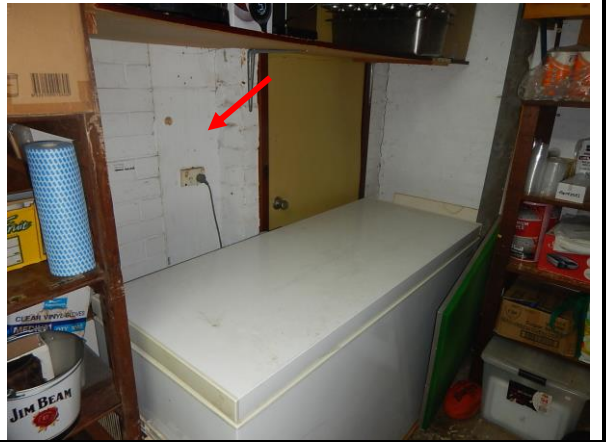
ID 9:- Fibre Cement Weatherboard Panelling (Asbestos Detected)	
Material	Chrysotile and amosite asbestos detected.
Lab No.	Eurofins ARL Lab No 21-10098-51.
QED Sample No.	ID: 32484.
Locations	Internal - Small room off Bar storeroom, wall panel.
Condition	Good, sealed, non-friable.
Signage	None.
Potential for Disturbance	Low.
Risk	<p>The ACM are not friable and are in stable condition. Ensure that they remain clearly labelled and regularly inspect to ensure they are not deteriorating or otherwise contributing to an unacceptable health risk.</p>
Management Actions	<p>Label when practical. May remain in-situ until replacement is required. Manage as per Asbestos Management Plan. Administrative – Follow safe work procedures during removal and maintenance. Personal protective equipment – P2 facemask and coveralls required when working on material.</p>
References (See Appendices)	<p>Safe Work Australia, Code of Practice: How to Manage and Control Asbestos in the Workplace. WHS Appendix G—Recommended safe working practices Safe work practice 1—Drilling of ACM Safe work practice 2—Sealing, painting, coating and cleaning of asbestos cement products Safe Work Australia, Code of Practice: How to Safely Remove Asbestos Appendix E—Examples of asbestos removal work Asbestos cement products</p>

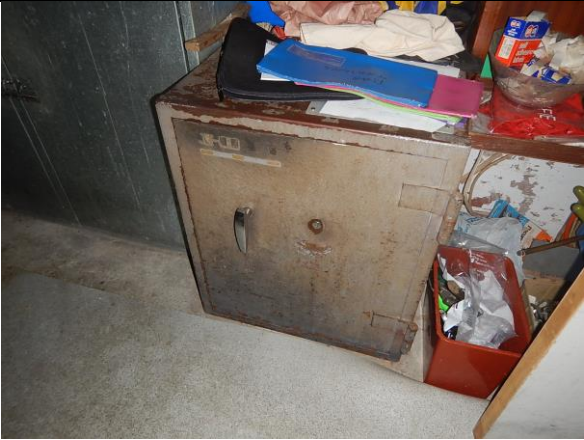
ID 10:- Safe Internal Insulation (Suspected Asbestos Containing Material)

Material	Suspected asbestos containing material.	
Lab No.	N/A.	
QED Sample No.	ID: Observed.	
Locations	Internal - Small room off Bar storeroom, loose/stored.	
Condition	Encased, sealed, friable.	
Signage	None.	
Potential for Disturbance	Low.	
Risk	<p>The ACM are friable but are encapsulated within the door skins. Ensure that they remain clearly labelled and regularly inspect to ensure they are not deteriorating or otherwise contributing to an unacceptable health risk.</p>	
Management Actions	<p>Label when practical. Asbestos thermal insulation may only be disturbed by a contractor holding a Class A Asbestos Removal License. May remain in-situ until replacement is required. Manage as per Asbestos Management Plan. Administrative – Follow safe work procedures during removal and maintenance. Personal protective equipment – P3 full face powered air respirator and coveralls required during removal of material.</p>

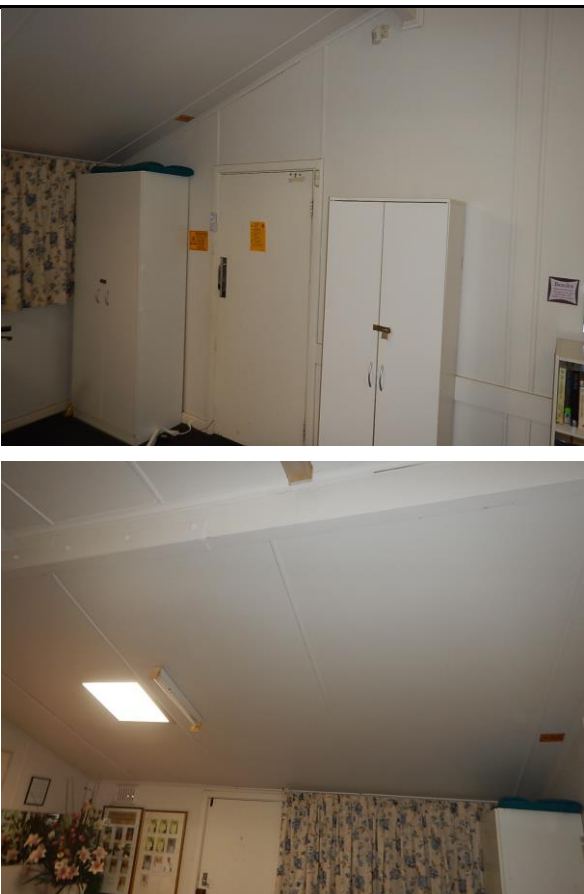
ID 11:- Fibre Cement Wall and Ceiling Panelling, Including Jointing Strips (Asbestos Detected)

Material	Chrysotile asbestos detected.	
Lab No.	Eurofins ARL Lab No 21-10098-52.	
QED Sample No.	ID: 32485.	
Locations	Internal – Female toilet sitting room, walls and ceiling.	
Condition	Good, sealed, non-friable.	
Signage	Labelled.	
Potential for Disturbance	Low.	
Risk	<p>The ACM are not friable and are in stable condition. Ensure that they remain clearly labelled and regularly inspect to ensure they are not deteriorating or otherwise contributing to an unacceptable health risk.</p>	
Management Actions	<p>May remain in-situ until replacement is required. Manage as per Asbestos Management Plan. Administrative – Follow safe work procedures during removal and maintenance. Personal protective equipment – P2 facemask and coveralls required when working on material.</p>	
References (See Appendices)	<p>Safe Work Australia, Code of Practice: How to Manage and Control Asbestos in the Workplace. WHS Appendix G—Recommended safe working practices Safe work practice 1—Drilling of ACM Safe work practice 2—Sealing, painting, coating and cleaning of asbestos cement products Safe Work Australia, Code of Practice: How to Safely Remove Asbestos Appendix E—Examples of asbestos removal work Asbestos cement products</p>

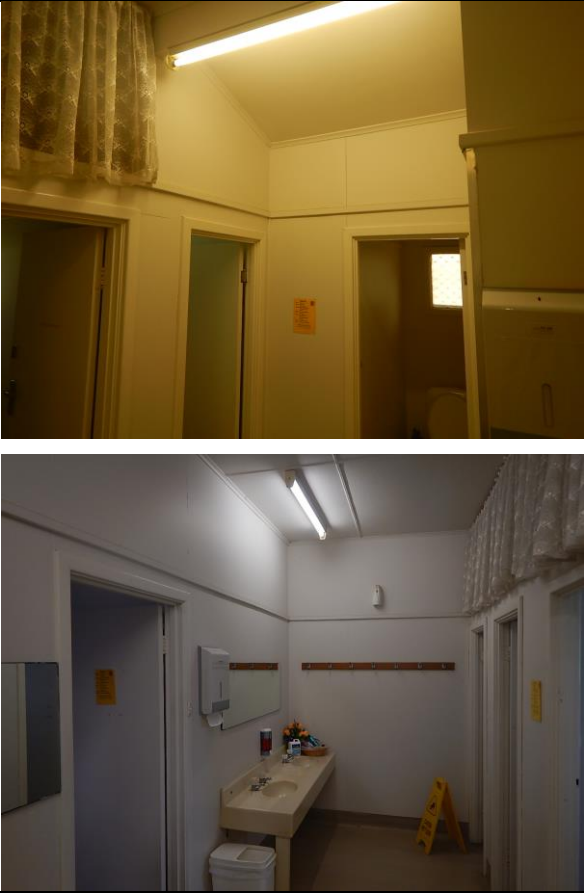
ID 12:- Fibre Cement Wall and Ceiling Panelling, Including Jointing Strips (Suspected Asbestos Containing Material)

Material	Suspected asbestos containing material.	
Lab No.	N/A.	
QED Sample No.	ID: Observed.	
Locations	Internal – Female toilet walls and ceiling (walls and ceiling possibly double lined).	
Condition	Good, sealed, non-friable.	
Signage	Wall labelled.	
Potential for Disturbance	Low.	
Risk	<p>The ACM are not friable and are in stable condition. Ensure that they remain clearly labelled and regularly inspect to ensure they are not deteriorating or otherwise contributing to an unacceptable health risk.</p>	
Management Actions	<p>May remain in-situ until replacement is required. Manage as per Asbestos Management Plan. Administrative – Follow safe work procedures during removal and maintenance. Personal protective equipment – P2 facemask and coveralls required when working on material.</p>

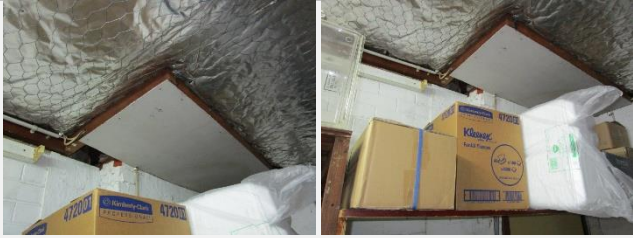
No asbestos detected
Fibre Cement Panels.	Eurofins ARL Lab No. 21-10098-47 QED ID: 32483	Ceiling panels to the bar

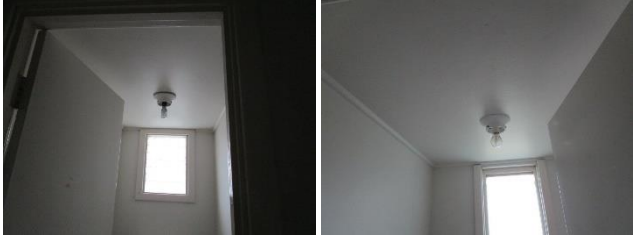
No asbestos detected. Organic fibres detected.
Fibre Cement Panels.	Eurofins ARL Lab No. 21-10098-38 QED ID: 32486	Ceiling panels to female toilets

No asbestos detected. Organic fibres detected.
