# ASBESTOS REGISTER

KPAC (Performing Arts Centre & Ag Hall), 48 Canning Road, Kalamunda, WA

Report ID: **34754Br0**

**January 2023**

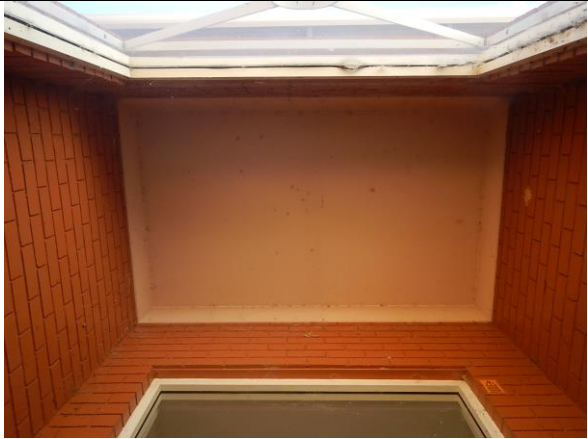
<b>ID 1:- Fibre Cement Ceiling Panelling (Suspected Asbestos Containing Material)</b>

Material	Suspected asbestos containing material.	
Lab No.	Unable to obtain suitable sample [height].	
QED Sample No.	ID: Observed.	
Locations	External – Rear main entry ceiling (near downstairs external toilets).	
Condition	Good, sealed, non-friable.	
Signage	Labelled.	
Potential for Disturbance	Low.	
<b>Risk</b>	<p><b>The ACM are not friable and are in stable condition. Ensure that they remain clearly labelled and regularly inspect to ensure they are not deteriorating or otherwise contributing to an unacceptable health risk.</b></p>	
Management Actions	<p>May remain in-situ until replacement is required.                  Manage as per <b>Asbestos Management Plan</b>.                  Administrative – Follow safe work procedures during removal and maintenance.                  Personal protective equipment – P2 facemask and coveralls required when working on material.</p>

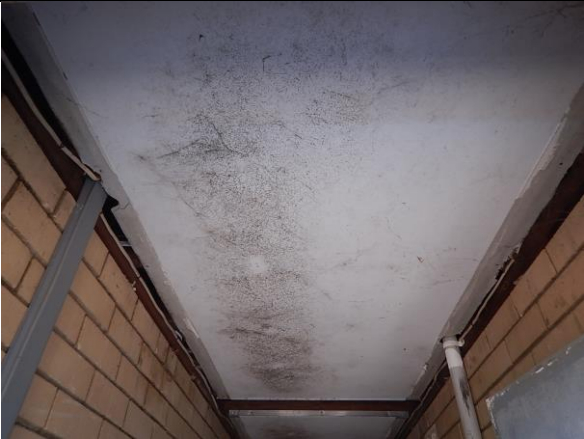
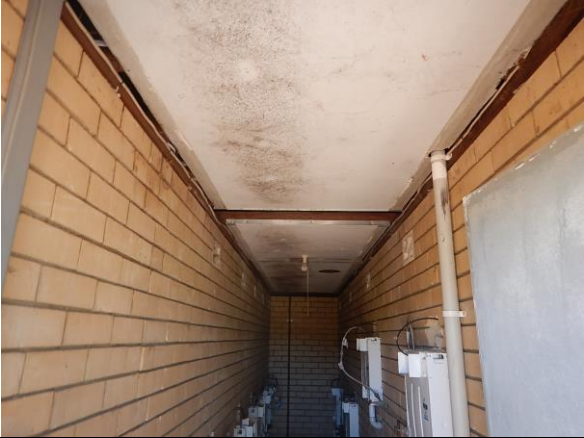
<b>ID 2:- Fibre Cement Ceiling Panelling (Asbestos Detected)</b>

Material	Chrysotile and amosite asbestos detected.	
Lab No.	Eurofins ARL Lab no. 21-10098-96.	
QED Sample No.	ID: 28187.	
Locations	Internal – Rear external toilets, plumbing duct ceiling.	
Condition	Good to fair, some areas with minor damage, non-friable.	
Signage	Labelled.	
Potential for Disturbance	Low.	
<b>Risk</b>	<p>The ACM are not friable and are in stable condition. Ensure that they remain clearly labelled and regularly inspect to ensure they are not deteriorating or otherwise contributing to an unacceptable health risk.</p>	
Management Actions	<p>Material is becoming unsealed (possibly due to moisture), encapsulation of material would extend the serviceable lifespan of material. Removal of material would be preferable.                  May remain in-situ until replacement is required.                  Manage as per <b>Asbestos Management Plan</b>.                  Administrative – Follow safe work procedures during removal and maintenance.                  Personal protective equipment – P2 facemask and coveralls required when working on material.</p>

ID #	Product	Location
2	Fibre Cement Ceiling Panelling.	Internal – Rear external toilets, plumbing duct ceiling.
	<i>Recommendations:</i> Material is becoming unsealed (possibly due to moisture), encapsulation of material would extend the serviceable lifespan of material. Removal of material would be preferable.	
3	Asbestos Cement Fragments.	External – Rear external toilets, plumbing duct, to ground.
	<i>Recommendations:</i> Material was not sighted during 2023 inspection. QED have not been provided information as to the removal of this material, however if this information can be provided this item can be removed from this register. If item has not been removed, then plan for removal and provide information to QED.

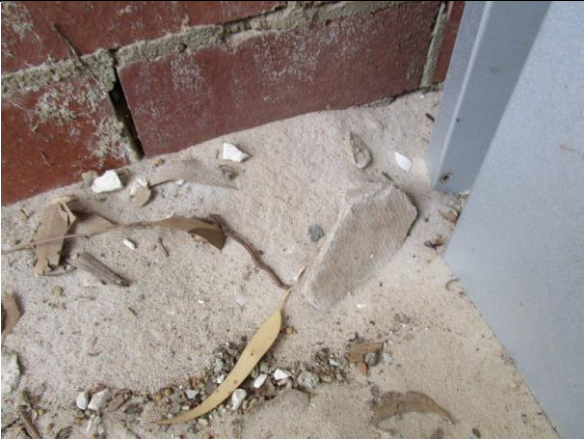
<b>ID 3:- Asbestos Cement Fragments (Presumed Asbestos Containing Material)</b>

<p>2021 Photograph.</p>
Material	Presumed asbestos containing material.	
Lab No.	N/A.	
QED Sample No.	ID: Observed.	
Location	External – Rear external toilets, plumbing duct, to ground.	
Condition	Fair, intact, non-friable.	
Signage	None.	
Potential for Disturbance	Low.	
<b>Risk</b>	<p><b>IMMEDIATE ACTION REQUIRED.</b>  <b>The ACM are not friable however, due to their location there is a risk that they could be easily disturbed. It is recommended that the debris is removed.</b></p>	
Management Actions	<p>Material was not sighted during 2023 inspection. QED have not been provided information as to the removal of this material, however if this information can be provided this item can be removed from this register.</p> <p>The cement fragments should be removed via hand picking, including if practical, gently fine raking of wetted soil to 10 cm depth to expose ACM fragments as per Management of Small-Scale Low-Risk Soil Asbestos Contamination by a removalist with a Class B asbestos removal licence.</p> <p>Further investigation should be conducted to determine the extent of any soil contamination to establish appropriate remediation recommendations.</p> <p>Personal protective equipment – P2 facemask and coveralls required when working on material.</p> <p>Manage as per <b>Asbestos Management Plan</b>.</p> <p>Administrative – Follow safe work procedures during removal and maintenance.</p> <p>Personal protective equipment – P2 facemask and coveralls required when working on material.</p>

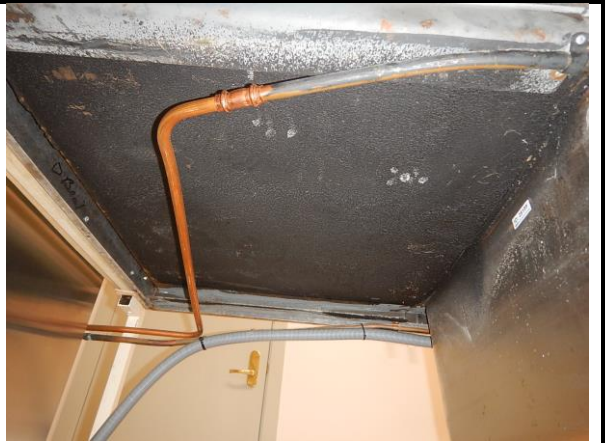
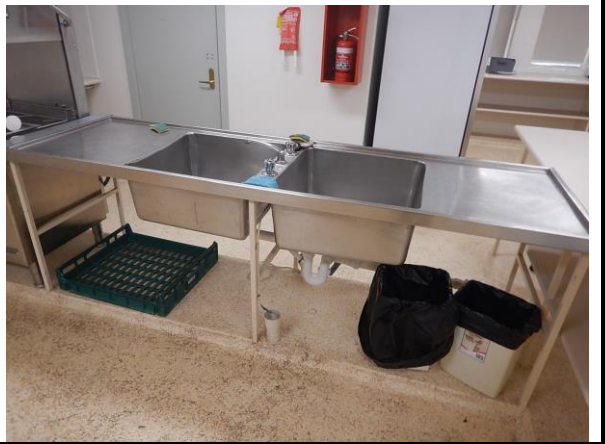
<b>ID 4:- Under Sink Membrane (Asbestos Detected)</b>	
Material	Chrysotile asbestos detected.
Lab No.	Eurofins ARL Lab No. 21-10098-99.
QED Sample No.	ID: 28189.
Locations	Internal – Main kitchen, sink unit
Condition	Good, intact, non-friable.
Signage	None.
Potential for Disturbance	Medium.
<b>Risk</b>	<p>The ACM are not friable and are in stable condition. Ensure that they remain clearly labelled and regularly inspect to ensure they are not deteriorating or otherwise contributing to an unacceptable health risk.</p>
Management Actions	<p>Label when practical.                  May remain in-situ until replacement is required.                  Manage as per <b>Asbestos Management Plan</b>.                  Administrative – Follow safe work procedures during removal and maintenance.                  Personal protective equipment – P2 facemask and coveralls required when working on material.</p>
References (See Appendices)	<p><b>Safe Work Australia, Code of Practice: How to Manage and Control Asbestos in the Workplace.</b>  <b>Safe Work Australia, Code of Practice: How to Safely Remove Asbestos</b>  <b>Appendix E—Examples of asbestos removal work</b>                  Removing bituminous (malthoid) products</p>

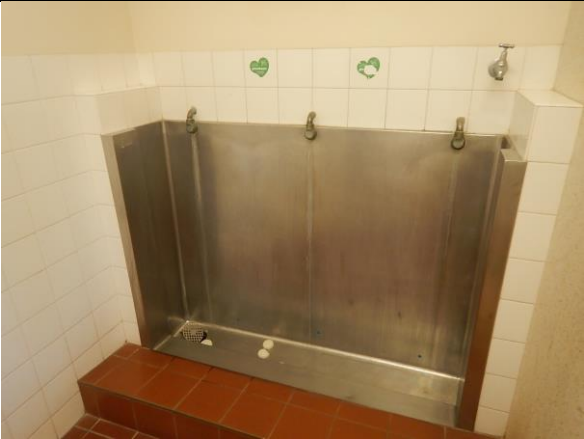
<p style="text-align: center;">Ag Hall.</p>

<b>ID 5:- Urinal Backing Membrane (Suspected Asbestos Containing Material)</b>

<p style="text-align: center;">Theatre Foyer.</p>
Material	Suspected asbestos containing material.	
Lab No.	Unable to sample (encapsulated)	
QED Sample No.	ID: N/A.	
Locations	Internal – Ag Hall and Theatre Foyer, Male toilets, urinals.	
Condition	Encased, intact, non-friable.	
Signage	Unable to adequately label.	
Potential for Disturbance	Low.	
<b>Risk</b>	<p><b>The ACM are not friable and are in stable condition. Ensure that they are regularly inspected to ensure they are not deteriorating or otherwise contributing to an unacceptable health risk.</b></p>	
Management Actions	May remain in-situ until replacement is required. Manage as per <b>Asbestos Management Plan</b> . Administrative – Follow safe work procedures during removal and maintenance. Personal protective equipment – P2 facemask and coveralls required when working on material.

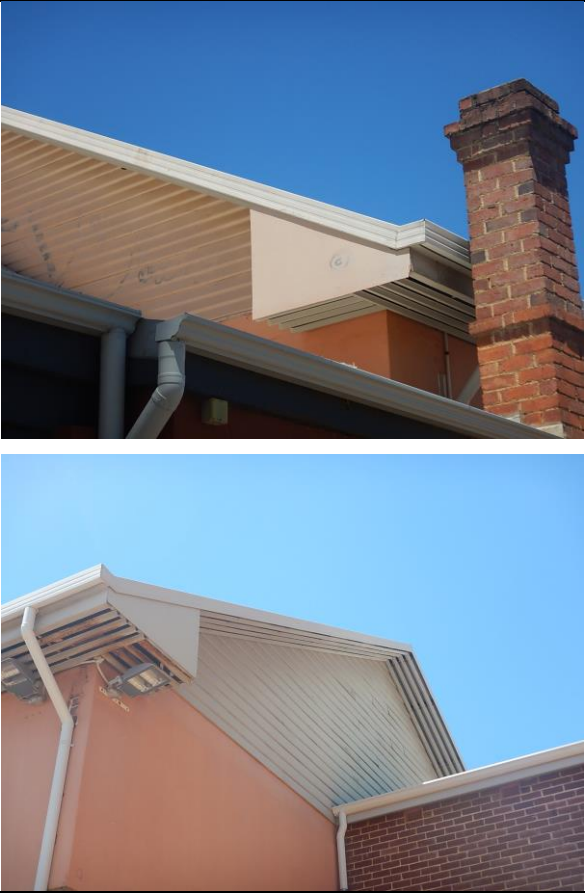
<b>ID 6:- Fibre Cement Panelling (Suspected Asbestos Containing Material)</b>

Material	Suspected asbestos containing material.	
Lab No.	Unable to obtain suitable sample [height].	
QED Sample No.	ID: Observed.	
Locations	External – Agricultural Hall, high level gable ends.	
Condition	Good, sealed, non-friable.	
Signage	None.	
Potential for Disturbance	Low.	
<b>Risk</b>	<p><b>The ACM are not friable and are in stable condition. Ensure that they remain clearly labelled and regularly inspect to ensure they are not deteriorating or otherwise contributing to an unacceptable health risk.</b></p>	
Management Actions	<p>May remain in-situ until replacement is required.                  Manage as per <b>Asbestos Management Plan</b>.                  Administrative – Follow safe work procedures during removal and maintenance.                  Personal protective equipment – P2 facemask and coveralls required when working on material.</p>

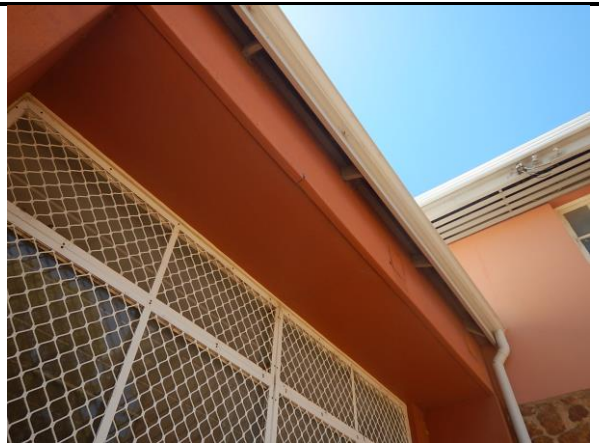
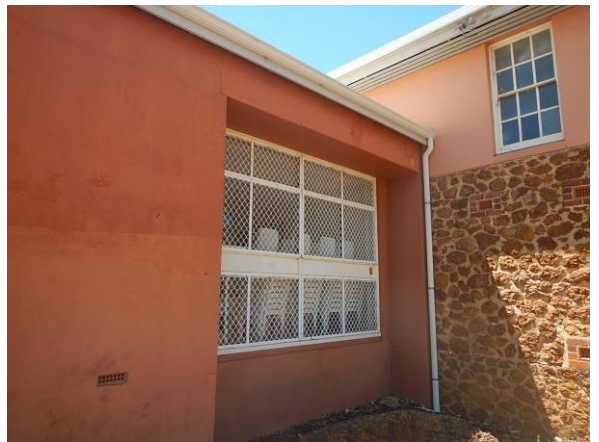
<b>ID 7:- Fibre Cement Infill Panelling (Suspected Asbestos Containing Material)</b>	
Material	Suspected asbestos containing material.
Lab No.	Unable to obtain suitable sample [height].
QED Sample No.	ID: Observed.
Locations	External – Northwest elevation, infill (high wall)/eave panelling.
Condition	Good, sealed, non-friable.
Signage	Labelled.
Potential for Disturbance	Low to medium.
<b>Risk</b>	<p><b>The ACM are not friable and are in stable condition. Ensure that they remain clearly labelled and regularly inspect to ensure they are not deteriorating or otherwise contributing to an unacceptable health risk.</b></p>
Management Actions	<p>May remain in-situ until replacement is required.                  Manage as per <b>Asbestos Management Plan</b>.                  Administrative – Follow safe work procedures during removal and maintenance.                  Personal protective equipment – P2 facemask and coveralls required when working on material.</p>

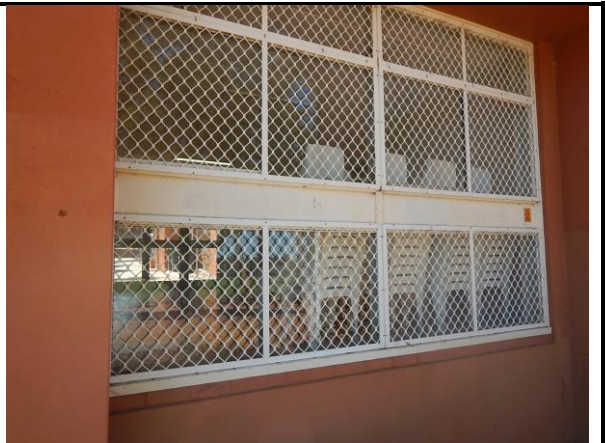
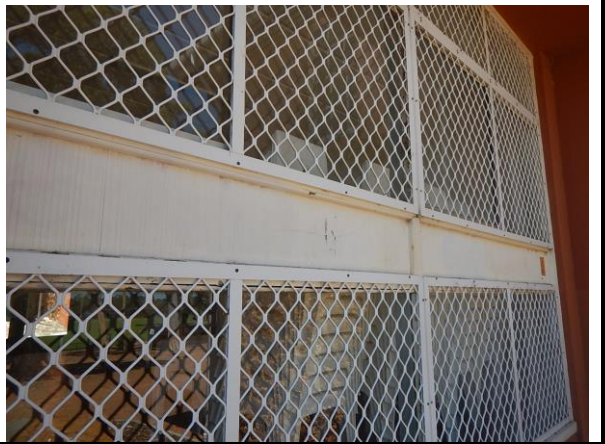
<b>ID 8:- Textured Fibre Cement Panelling (Asbestos Detected)</b>	
Material	Chrysotile, amosite and crocidolite asbestos detected.
Lab No.	Eurofins ARL Lab No. 21-10098-101.
QED Sample No.	ID: 28191.
Locations	External – Northwest elevation, infill panel between windows (white textured surface).
Condition	Good to fair, intact, non-friable.
Signage	Labelled.
Potential for Disturbance	Low to medium.
<b>Risk</b>	<p><b>The ACM are not friable and are in stable condition. Ensure that they remain clearly labelled and regularly inspect to ensure they are not deteriorating or otherwise contributing to an unacceptable health risk.</b></p>
Management Actions	<p>Encapsulation of material will extend the serviceable life of the material. This should occur prior to the next inspection.                      May remain in-situ until replacement is required.                      Manage as per <b>Asbestos Management Plan</b>.                      Administrative – Follow safe work procedures during removal and maintenance.                      Personal protective equipment – P2 facemask and coveralls required when working on material.</p>

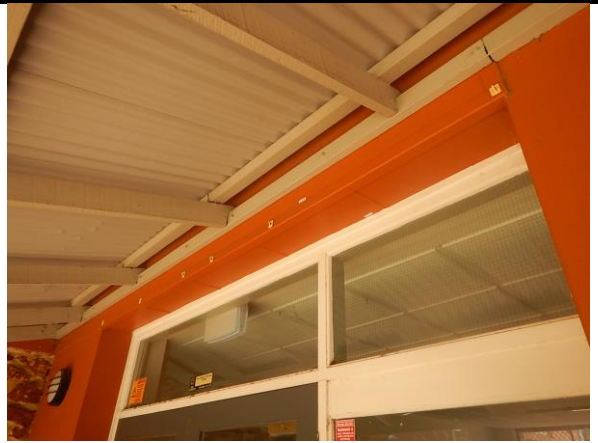
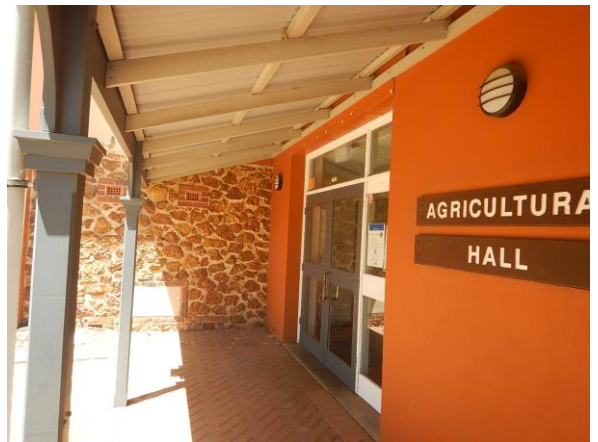
<b>ID 9:- Fibre Cement Eave Panelling (Asbestos Detected)</b>	
Material	Chrysotile and crocidolite asbestos detected.
Lab No.	Eurofins ARL Lab No. 21-10098-104.
QED Sample No.	ID: 28194.
Locations	External – North-eastern elevation/entrance to Hall foyer, eaves lining.
Condition	Good, sealed, non-friable.
Signage	Labelled.
Potential for Disturbance	Low.
<b>Risk</b>	<p><b>The ACM are not friable and are in stable condition. Ensure that they remain clearly labelled and regularly inspect to ensure they are not deteriorating or otherwise contributing to an unacceptable health risk.</b></p>
Management Actions	<p>May remain in-situ until replacement is required.            Manage as per <b>Asbestos Management Plan</b>.            Administrative – Follow safe work procedures during removal and maintenance.            Personal protective equipment – P2 facemask and coveralls required when working on material.</p>

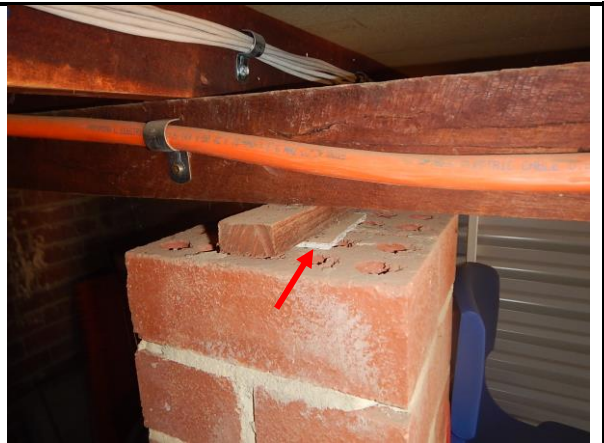
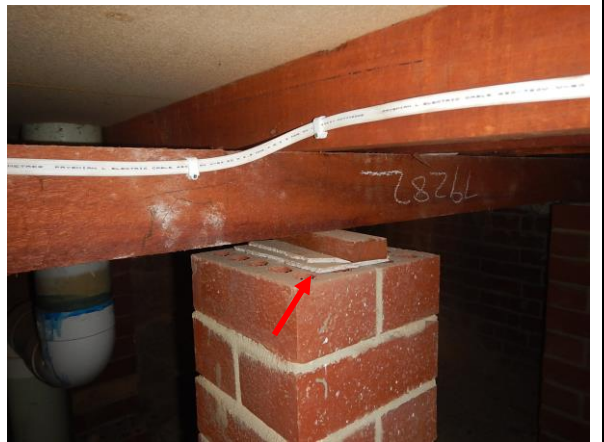
<b>ID 10:- Fibre Cement Building Packers (Asbestos Detected)</b>	
Material	Chrysotile and amosite asbestos detected.
Lab No.	Eurofins ARL Lab No. 21-10098-102.
QED Sample No.	ID: 28187.
Locations	Internal – Observed in rear external toilets, toilet duct. Likely to be present throughout building.
Condition	Good to fair, intact, non-friable.
Signage	None.
Potential for Disturbance	Low.
<b>Risk</b>	<p>The ACM are not friable and are in stable condition. Ensure that they remain clearly labelled and regularly inspect to ensure they are not deteriorating or otherwise contributing to an unacceptable health risk.</p>
Management Actions	<p>May remain in-situ until replacement is required.            Manage as per <b>Asbestos Management Plan</b>.            Administrative – Follow safe work procedures during removal and maintenance.            Personal protective equipment – P2 facemask and coveralls required when working on material.</p>

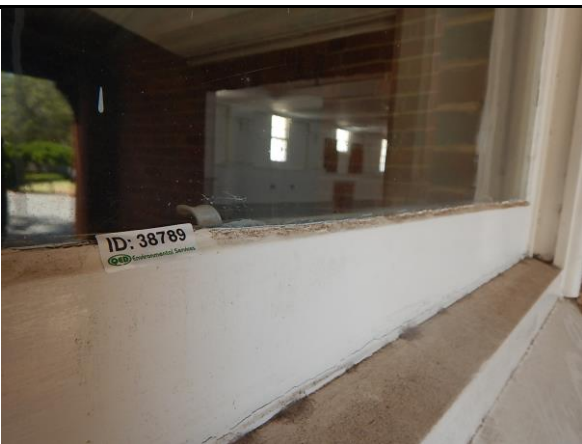
<b>ID 12:- Window Mastic (Assumed Asbestos Containing Material)</b>

Material	Assumed asbestos containing materials.	
Lab No.	N/A.	
QED Sample No.	ID: Observed.	
Locations	Throughout – Window frames throughout.	
Condition	Good, sealed, non-friable.	
Signage	None.	
Potential for Disturbance	Low.	
<b>Risk</b>	<p><b>The ACM are not friable and are in stable condition. Ensure that they remain clearly labelled and regularly inspect to ensure they are not deteriorating or otherwise contributing to an unacceptable health risk.</b></p>	
Management Actions	<p>Label when practical.                  Due to the potential variety of mastics used throughout the windows within the building, it is recommended that specific sampling be conducted prior to disturbance or removal of windows within the building or if the condition of the material deteriorates.                  Manage as per <b>Asbestos Management Plan</b>.                  Administrative – Follow safe work procedures during removal and maintenance.                  Personal protective equipment – P2 facemask and coveralls required when working on material.</p>

Window mastics were observed within the window frames of the building. A sample from one window frame was taken and assumed to contain asbestos. However, due to the potential variety of mastics used throughout the building and the potential for variation in the installation dates, it is recommended that specific sampling be conducted prior to disturbance or removal of windows or if the condition of the material deteriorates.

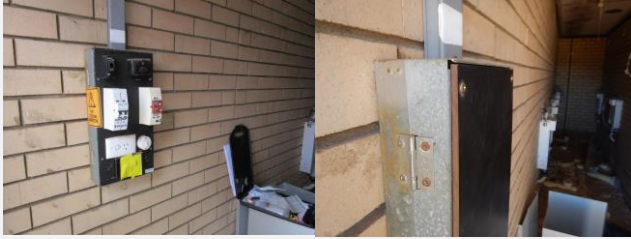
Item Description	Lab No.	Location	Photo	Comments
<b>Electrical Mounting Board.</b>	Lab # Eurofins ARL Lab No. 21-10098-97.  QED ID: 28186.

<p style="text-align: center;">2021                      2023</p>	Removed and replaced. Previous report ID# 2.
<b>KPAC - Electrical Mounting Board</b>	N/A.	Front entry Left side near teaching entry

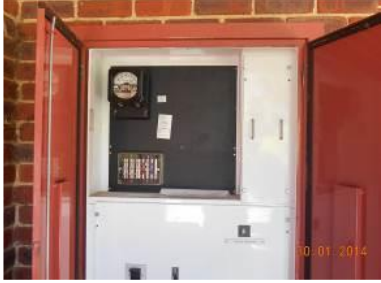
Removed. Information taken from City of Kalamunda Asbestos Register: Building: Kalamunda Performing Arts Centre & Agricultural Hall (KPAC) Asset ID: BD_5053-00 Date Inspected: 12-Dec-2019
<b>KPAC - Downpipe Infill Panel</b>	Presumed replaced	Front Theatre entry right hand corner near kitchen door

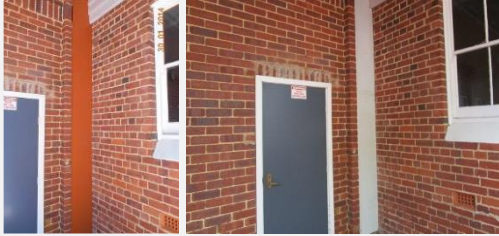
<p style="text-align: center;">2019                      2021</p>	Presumed removed. New material unpainted.

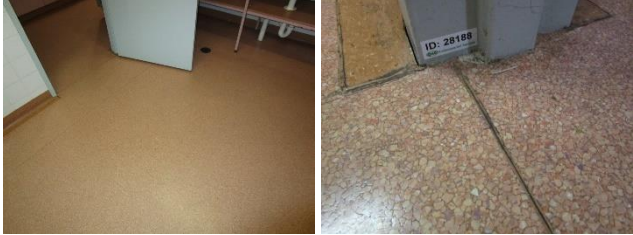
Item Description	Lab No.	Location	Photo	Comments
<b>KPAC - Kitchen Vinyl Floor backing material</b>	Eurofins ARL Lab No. 21-10098-98  QED ID: 28188	Throughout the kitchen and bar area.

No asbestos detected.  Synthetic Mineral Fibres Detected.
<b>Ag Hall - Facia flashing</b>	Eurofins ARL Lab No. 21-10098-105  QED ID: 28193	Facia flashing left side of entry near chimney

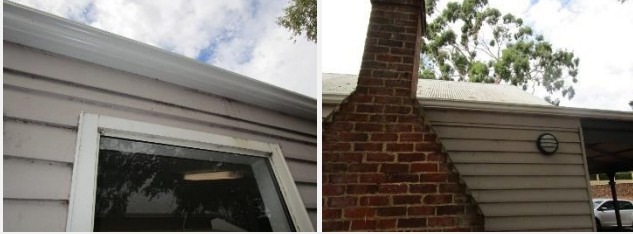
No asbestos detected.
<b>Ag Hall – Front Entrance Fascia</b>	Eurofins ARL Lab No. 21-10098-103  QED ID: 28195	Above the front entrance to the foyer
