ASBESTOS REGISTER

Pickering Brook Sports Club, 36 Weston Road, WA

Report ID: **34771Br0**

Prepared for: **City of Kalamunda**

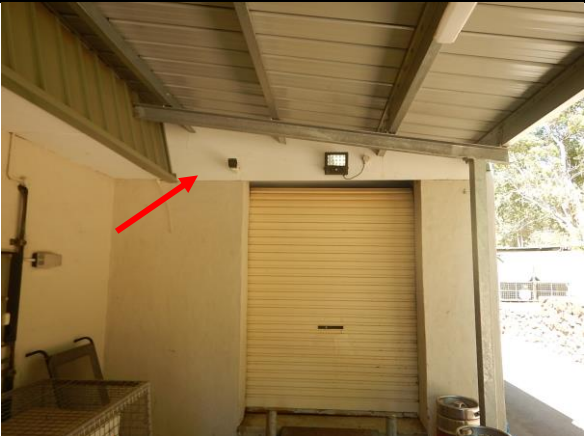
ID 1:- Fibre Cement Panelling - Loading Bay (Suspected Asbestos Containing Material)

Material	Suspected asbestos containing material.	
Lab No.	Unable to obtain suitable sample [sample restrictions].	
QED Sample No.	ID: Observed.	
Locations	External/internal – Loading Bay gable cladding front and rear.	
Condition	Good, sealed, non-friable.	
Signage	Labelled.	
Potential for Disturbance	Low.	
Risk	The ACM are not friable and are in stable condition. Ensure that they remain clearly labelled and regularly inspect to ensure they are not deteriorating or otherwise contributing to an unacceptable health risk.	
Management Actions	Material entry submitted by City of Kalamunda. May remain in-situ until replacement is required. Manage as per Asbestos Management Plan . Administrative – Follow safe work procedures during removal and maintenance. Personal protective equipment – P2 facemask and coveralls required when working on material.

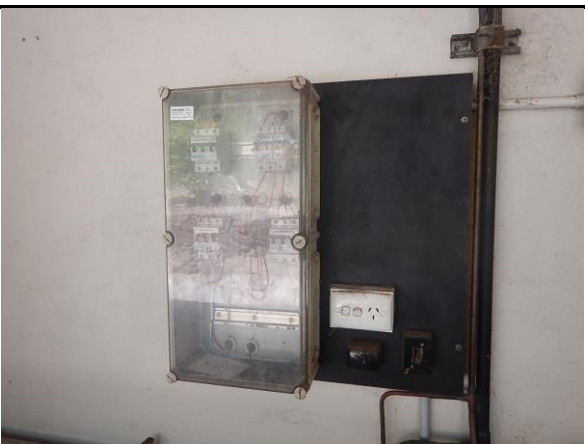
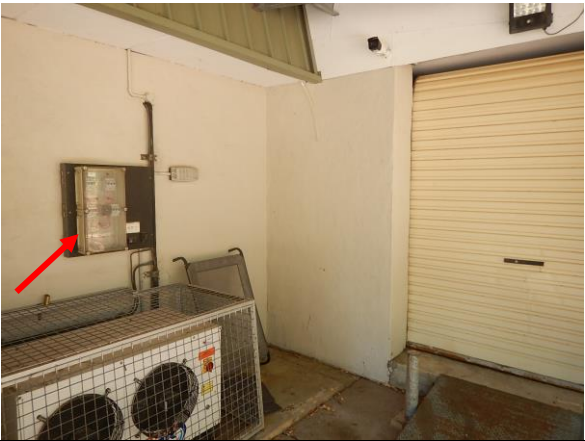
ID 2:- Electrical Mounting Board (Suspect Asbestos Containing)

Material	Suspected asbestos containing material.	
Lab No.	N/A.	
QED Sample No.	ID: Observed.	
Locations	External – Northern elevation, to wall.	
Condition	Good, intact.	
Signage	None.	
Potential for Disturbance	Low.	
Risk	<p>The ACM are not friable and are in stable condition. Ensure that they remain clearly labelled and regularly inspect to ensure they are not deteriorating or otherwise contributing to an unacceptable health risk.</p>

Management Actions	<p>Label when practical. May remain in-situ until replacement is required. Manage as per Asbestos Management Plan. Administrative – Follow safe work procedures during removal and maintenance. Personal protective equipment – P2 facemask and coveralls required when working on material.</p>	
References (See Appendices)	<p>Safe Work Australia, Code of Practice: How to Manage and Control Asbestos in the Workplace. WHS Appendix G—Recommended safe working practices Safe work practice 5—Working on electrical mounting boards (switchboards) containing asbestos Safe Work Australia, Code of Practice: How to Safely Remove Asbestos Appendix E—Examples of asbestos removal work Asbestos cement products</p>

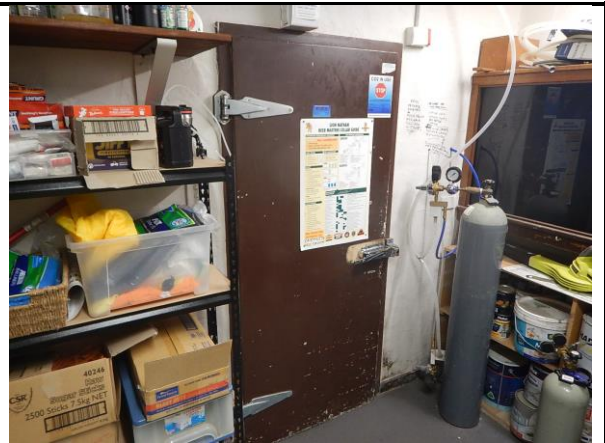
ID 3:- Cool Room Door Core & Cool Room Door Seal (Suspected Asbestos Containing Material)	
Material	Suspected asbestos containing material.
Lab No.	Manufacturer details (Unknown).
QED Sample No.	ID: Observed.
Locations	Internal – Cool room entry door.
Condition	Fair, encased, friable.
Signage	None.
Potential for Disturbance	Medium.
Risk	The ACM are friable but are encapsulated within the door skins. Ensure that they remain clearly labelled and regularly inspect to ensure they are not deteriorating or otherwise contributing to an unacceptable health risk.
Management Actions	<p>Unlabelled doors require labelling immediately. Sampling of material is recommended to determine asbestos content. May remain in-situ until replacement is required. Manage as per Asbestos Management Plan. Administrative – Follow safe work procedures during removal and maintenance. Personal protective equipment – P2 facemask and coveralls required when working on material.</p>

ID #	Product	Location
3	Cool Room Door Core & Cool Room Door Seal.	Internal – Cool room entry door.
	<i>Recommendations:</i> Unlabeled doors require labelling immediately. Sampling of material is recommended to determine asbestos content.	
4	Pizza Oven Seal.	Internal – Kitchen, pizza oven, oven seal.
	<i>Recommendations:</i> Restrict use of oven until asbestos presence/non-presence is determined.

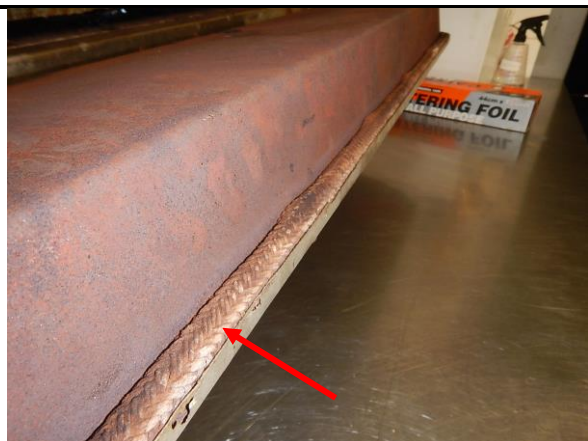
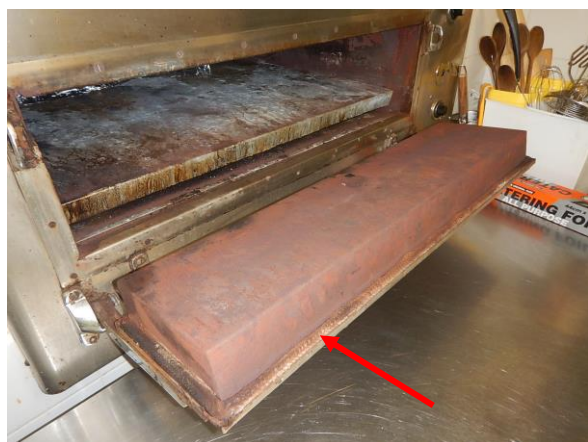
ID 4:- Pizza Oven Seal (Suspected Asbestos Containing Material)	
Material	Suspected asbestos containing material.
Lab No.	Unable to obtain suitable sample (Live).
QED Sample No.	ID: Observed.
Locations	Internal – Kitchen, pizza oven, oven seal.
Condition	Good, intact, friable.
Signage	None.
Potential for Disturbance	Medium.
Risk	<p>The ACM are not friable and are in stable condition. Ensure that they remain clearly labelled and regularly inspect to ensure they are not deteriorating or otherwise contributing to an unacceptable health risk.</p>
Management Actions	<p>Label immediately. Restrict use of oven until asbestos presence/non-presence is determined. Manage as per Asbestos Management Plan. Administrative – Follow safe work procedures during removal and maintenance. Personal protective equipment – P2 facemask and coveralls required when working on material.</p>
References (See Appendices)	<p>Safe Work Australia, Code of Practice: How to Manage and Control Asbestos in the Workplace. Safe Work Australia, Code of Practice: How to Safely Remove Asbestos Appendix E—Examples of asbestos removal work Removal of gaskets and rope seals</p>

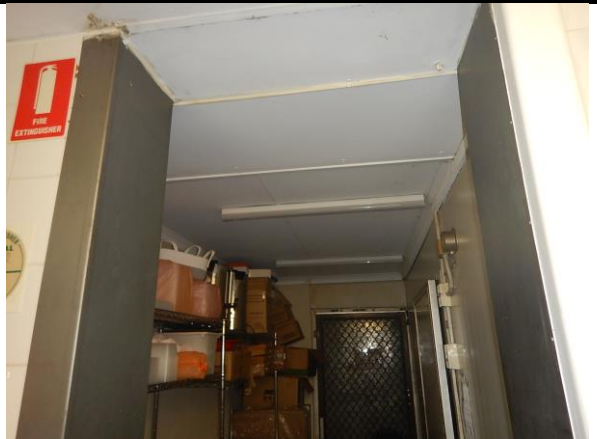
ID 5:- Fibre Cement Ceiling Panelling (Suspected Asbestos Containing Material)

Material	Suspected asbestos containing material.	
Lab No.	Unable to obtain suitable sample [sample restrictions].	
QED Sample No.	ID: Observed.	
Locations	Internal – Rear storeroom off kitchen, ceiling.	
Condition	Good, sealed, non-friable.	
Signage	Labelled.	
Potential for Disturbance	Low.	
Risk	<p>The ACM are not friable and are in stable condition. Ensure that they remain clearly labelled and regularly inspect to ensure they are not deteriorating or otherwise contributing to an unacceptable health risk.</p>	
Management Actions	<p>Material entry submitted by City of Kalamunda. May remain in-situ until replacement is required. Manage as per Asbestos Management Plan. Administrative – Follow safe work procedures during removal and maintenance. Personal protective equipment – P2 facemask and coveralls required when working on material.</p>

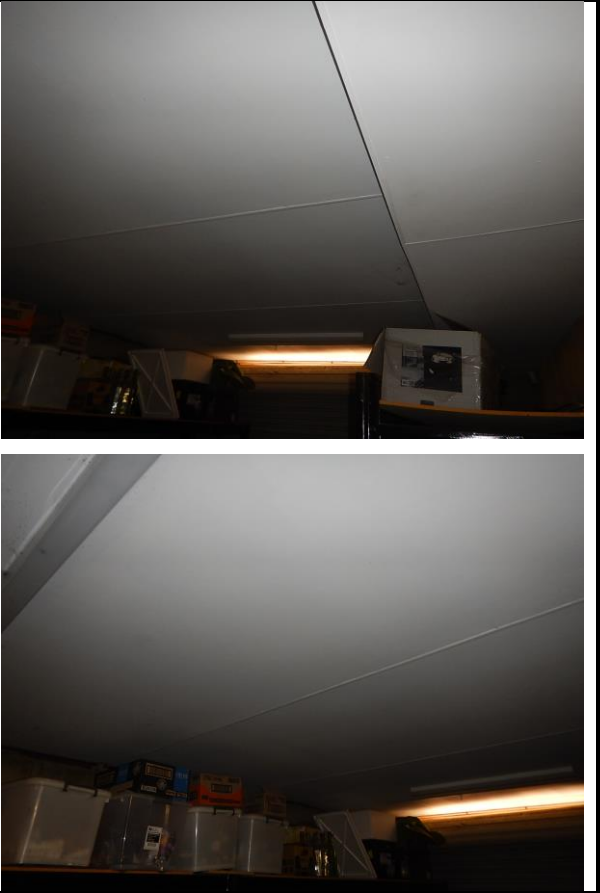
ID 6:- Fibre Cement Ceiling Panelling (Suspected Asbestos Containing Material)

Material	Suspected asbestos containing material.	
Lab No.	Unable to obtain suitable sample [sample restrictions].	
QED Sample No.	ID: Observed.	
Locations	Internal – Loading Bay and Loading Bay Storeroom, ceilings.	
Condition	Good, sealed, non-friable.	
Signage	Labelled.	
Potential for Disturbance	Low.	
Risk	<p>The ACM are not friable and are in stable condition. Ensure that they remain clearly labelled and regularly inspect to ensure they are not deteriorating or otherwise contributing to an unacceptable health risk.</p>	
Management Actions	<p>Material entry submitted by City of Kalamunda. May remain in-situ until replacement is required. Manage as per Asbestos Management Plan. Administrative – Follow safe work procedures during removal and maintenance. Personal protective equipment – P2 facemask and coveralls required when working on material.</p>

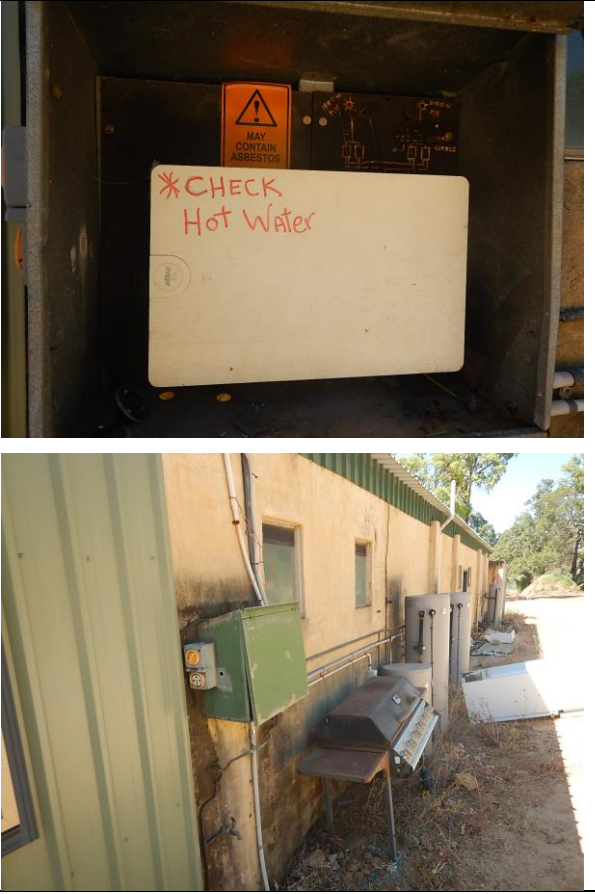
ID 7:- Electrical Mounting Board (Suspected Asbestos Containing Material)

Material	Suspected asbestos containing material.	
Lab No.	N/A.	
QED Sample No.	ID: Observed.	
Locations	External – Sub board at rear of building.	
Condition	Good, intact, non-friable.	
Signage	Labelled.	
Potential for Disturbance	Low.	
Risk	<p>The ACM are not friable and are in stable condition. Ensure that they remain clearly labelled and regularly inspect to ensure they are not deteriorating or otherwise contributing to an unacceptable health risk.</p>	
Management Actions	<p>May remain in-situ until replacement is required. Manage as per Asbestos Management Plan. Administrative – Follow safe work procedures during removal and maintenance. Personal protective equipment – P2 facemask and coveralls required when working on material.</p>	
References (See Appendices)	<p>Safe Work Australia, Code of Practice: How to Manage and Control Asbestos in the Workplace. WHS Appendix G—Recommended safe working practices Safe work practice 5—Working on electrical mounting boards (switchboards) containing asbestos Safe Work Australia, Code of Practice: How to Safely Remove Asbestos Appendix E—Examples of asbestos removal work Asbestos cement products</p>

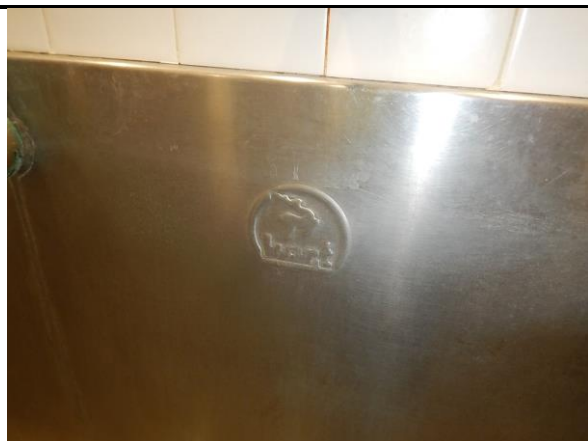
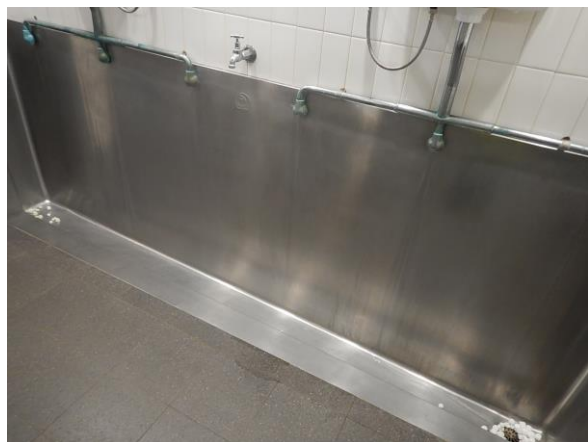
ID 9:- Urinal Backing Membrane (Hart unit) (Suspected Asbestos Containing Material)	
Material	Suspected asbestos containing material.
Lab No.	Unable to sample (encapsulated)
QED Sample No.	ID: N/A.
Locations	Internal - Male toilets, urinal.
Condition	Encased, non-friable.
Signage	Unable to adequately label.
Potential for Disturbance	Low.
Risk	<p>The ACM are not friable and are in stable condition. Ensure that they are regularly inspected to ensure they are not deteriorating or otherwise contributing to an unacceptable health risk.</p>
Management Actions	<p>May remain in-situ until replacement is required. Manage as per Asbestos Management Plan. Administrative – Follow safe work procedures during removal and maintenance. Personal protective equipment – P2 facemask and coveralls required when working on material.</p>
References (See Appendices)	<p>Safe Work Australia, Code of Practice: How to Manage and Control Asbestos in the Workplace. Safe Work Australia, Code of Practice: How to Safely Remove Asbestos Appendix E—Examples of asbestos removal work Removing bituminous (malthoid) products</p>

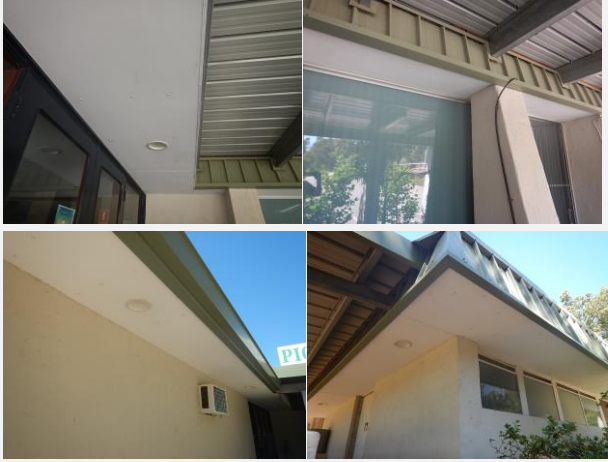
Item Description	Lab No.	Location	Photo	Comments
Fibre Cement Eave Sheets.	Lab # N/A. QED ID: N/A.	Front Entry Eave Sheets. Front left side eave sheets. Left side eave sheets (Oval side). Right side eave sheets.
