ASBESTOS REGISTER

Town Square Hall, 5 Barber Street, Kalamunda, WA

Report ID: **34756Br0**

Prepared for: **City of Kalamunda**

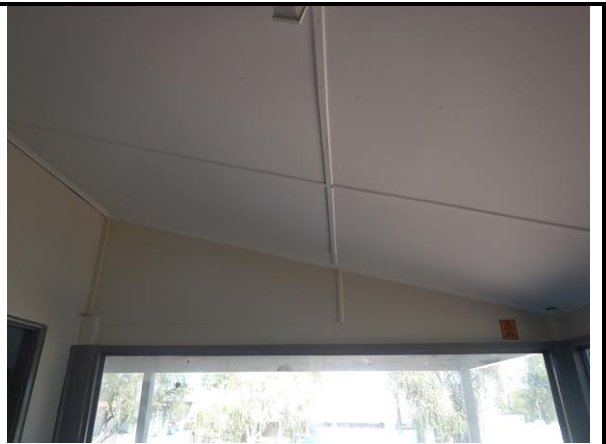
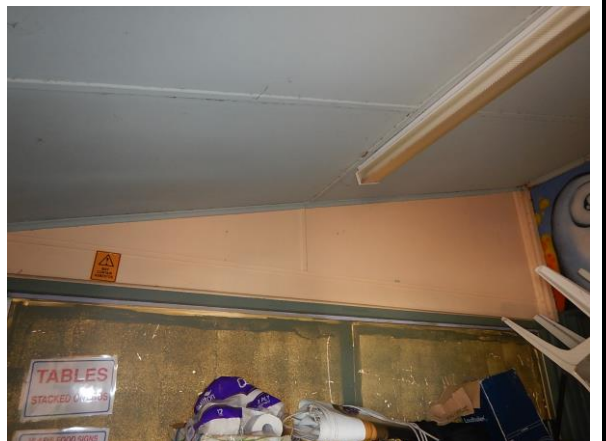
ID 1:- Fibre Cement Infill Panelling (Asbestos Detected)	
Material	Chrysotile and crocidolite asbestos detected.
Lab No.	Eurofins ARL Lab No. 21-10098-58.
QED Sample No.	ID: 32431.
Locations	Internal – External storeroom, eastern wall; and veranda room, western wall.
Condition	Good, sealed, non-friable.
Signage	Labelled.
Potential for Disturbance	Low.
Risk	<p>The ACM are not friable and are in stable condition. Ensure that they remain clearly labelled and regularly inspect to ensure they are not deteriorating or otherwise contributing to an unacceptable health risk.</p>
Management Actions	<p>May remain in-situ until replacement is required. Manage as per Asbestos Management Plan. Administrative – Follow safe work procedures during removal and maintenance. Personal protective equipment – P2 facemask and coveralls required when working on material.</p>
References (See Appendices)	<p>Safe Work Australia, Code of Practice: How to Manage and Control Asbestos in the Workplace. WHS Appendix G—Recommended safe working practices Safe work practice 1—Drilling of ACM Safe work practice 2—Sealing, painting, coating and cleaning of asbestos cement products</p> <p>Safe Work Australia, Code of Practice: How to Safely Remove Asbestos Appendix E—Examples of asbestos removal work Asbestos cement products</p>

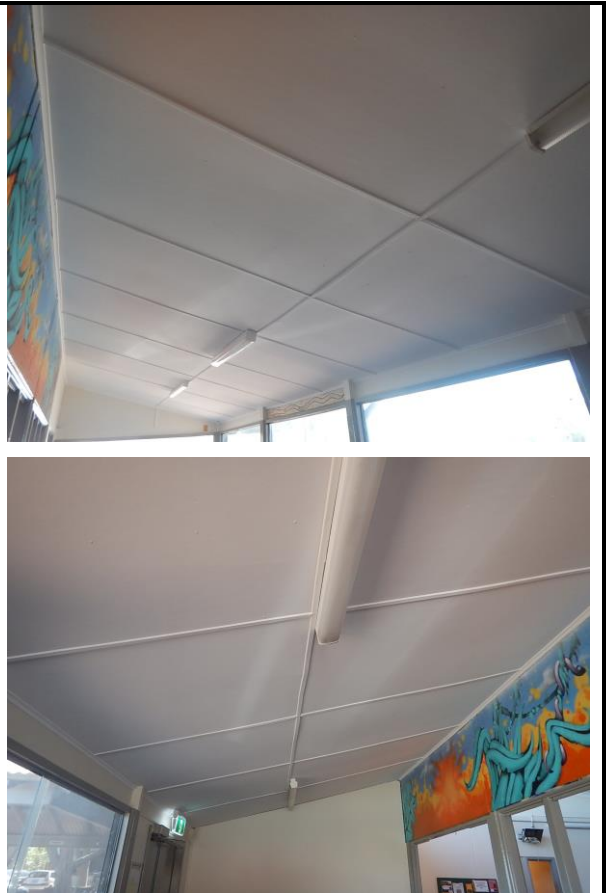
ID 2:- Fibre Cement Ceiling Panelling (Asbestos Detected)	
Material	Chrysotile and crocidolite asbestos detected.
Lab No.	Eurofins ARL Lab No. 21-10098-59.
QED Sample No.	ID: 32432.
Locations	Internal – External storeroom and veranda room, ceiling.
Condition	Good, sealed, non-friable.
Signage	Labelled.
Potential for Disturbance	Low.
Risk	<p>The ACM are not friable and are in stable condition. Ensure that they remain clearly labelled and regularly inspect to ensure they are not deteriorating or otherwise contributing to an unacceptable health risk.</p>
Management Actions	<p>May remain in-situ until replacement is required. Manage as per Asbestos Management Plan. Administrative – Follow safe work procedures during removal and maintenance. Personal protective equipment – P2 facemask and coveralls required when working on material.</p>
References (See Appendices)	<p>Safe Work Australia, Code of Practice: How to Manage and Control Asbestos in the Workplace. WHS Appendix G—Recommended safe working practices Safe work practice 1—Drilling of ACM Safe work practice 2—Sealing, painting, coating and cleaning of asbestos cement products</p> <p>Safe Work Australia, Code of Practice: How to Safely Remove Asbestos Appendix E—Examples of asbestos removal work Asbestos cement products</p>

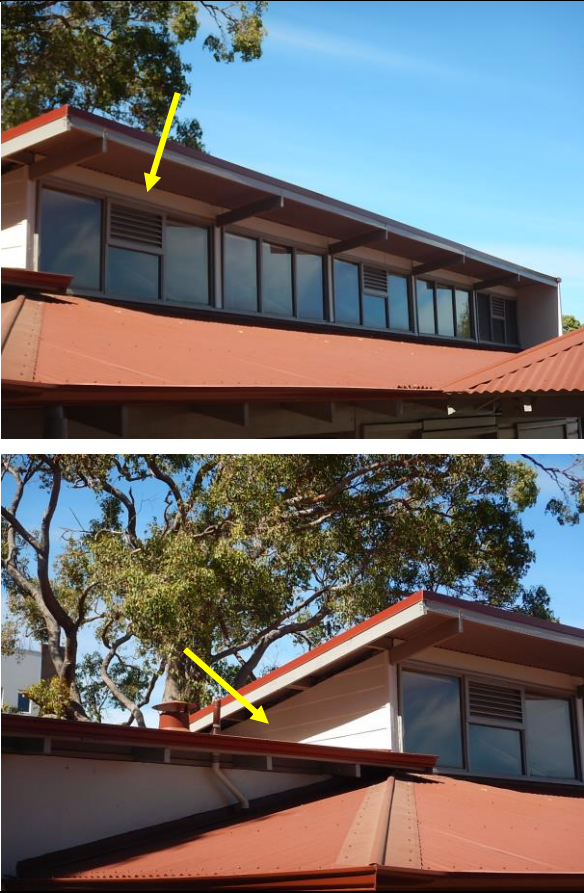
ID 3:- Fibre Cement Roof/Weather-Board Panelling (Suspected Asbestos Containing Material)

Material	Suspected asbestos containing material.	
Lab No.	Unable to obtain suitable sample [height].	
QED Sample No.	ID: Observed.	
Locations	External – Infill/gable panels for high level section of roof.	
Condition	Good, sealed, non-friable.	
Signage	Labelled.	
Potential for Disturbance	Low.	
Risk	<p>The ACM are not friable and are in stable condition. Ensure that they remain clearly labelled and regularly inspect to ensure they are not deteriorating or otherwise contributing to an unacceptable health risk.</p>	
Management Actions	<p>May remain in-situ until replacement is required. Manage as per Asbestos Management Plan. Administrative – Follow safe work procedures during removal and maintenance. Personal protective equipment – P2 facemask and coveralls required when working on material.</p>	
References (See Appendices)	<p>Safe Work Australia, Code of Practice: How to Manage and Control Asbestos in the Workplace. WHS Appendix G—Recommended safe working practices Safe work practice 1—Drilling of ACM Safe work practice 2—Sealing, painting, coating and cleaning of asbestos cement products</p> <p>Safe Work Australia, Code of Practice: How to Safely Remove Asbestos Appendix E—Examples of asbestos removal work Asbestos cement products</p>

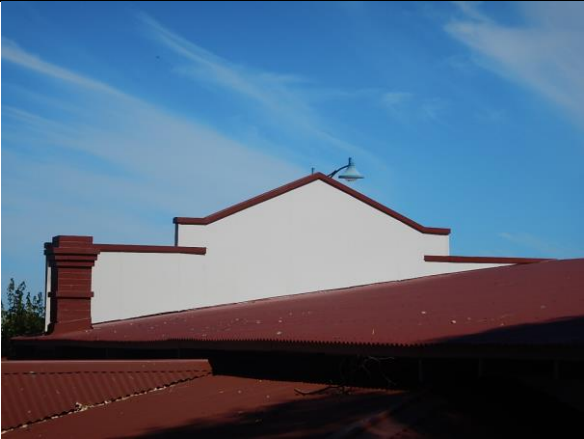
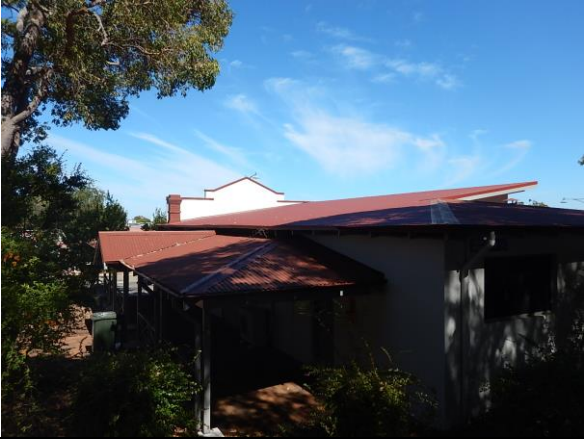
ID 4:- Fibre Cement Panelling (Suspected Asbestos Containing Material)

Material	Suspected asbestos containing material.	
Lab No.	Unable to obtain suitable sample [height].	
QED Sample No.	ID: Observed.	
Locations	External – Eastern elevation of west facing roof structure (parapet wall).	
Condition	Good, sealed, non-friable.	
Signage	Labelled.	
Potential for Disturbance	Low.	
Risk	<p>The ACM are not friable and are in stable condition. Ensure that they remain clearly labelled and regularly inspect to ensure they are not deteriorating or otherwise contributing to an unacceptable health risk.</p>	
Management Actions	<p>May remain in-situ until replacement is required. Manage as per Asbestos Management Plan. Administrative – Follow safe work procedures during removal and maintenance. Personal protective equipment – P2 facemask and coveralls required when working on material.</p>	
References (See Appendices)	<p>Safe Work Australia, Code of Practice: How to Manage and Control Asbestos in the Workplace. WHS Appendix G—Recommended safe working practices Safe work practice 1—Drilling of ACM Safe work practice 2—Sealing, painting, coating and cleaning of asbestos cement products</p> <p>Safe Work Australia, Code of Practice: How to Safely Remove Asbestos Appendix E—Examples of asbestos removal work Asbestos cement products</p>

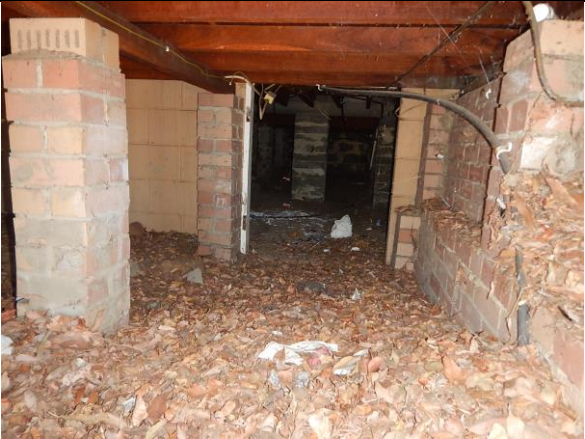
ID 5:- Fibre Cement Debris/Fragments (Suspected Asbestos Containing Material)

Material	Suspected asbestos containing material.	
Lab No.	Unable to obtain suitable sample [confined space].	
QED Sample No.	ID: Observed.	
Locations	External – Below building (under building crawl space)	
Condition	Fair, debris, non-friable.	
Signage	Unable to adequately label.	
Potential for Disturbance	Low.	
Risk	<p>The ACM are not friable and are in stable condition. Ensure that they remain clearly labelled/access is restricted and regularly inspect to ensure they are not deteriorating or otherwise contributing to an unacceptable health risk.</p>	
Management Actions	<p>May remain in-situ until replacement is required. Manage as per Asbestos Management Plan. Administrative – Follow safe work procedures during removal and maintenance. Personal protective equipment – P2 facemask and coveralls required when working on material.</p>

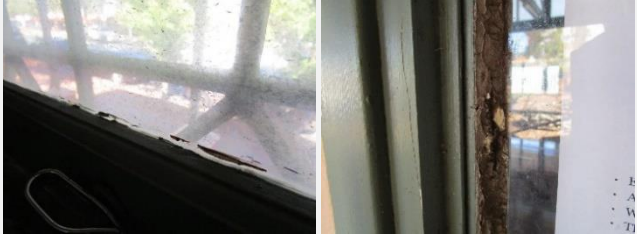
Item Description	Lab No.	Location	Photo	Comments
Window Putty	Eurofins ARL Lab No. 21-10098-55 QED ID: 32437	Windows under veranda on south side.

No asbestos detected. Organic Fibres Detected.
Infill Panel	Eurofins ARL Lab No. 21-10098-56 QED ID: 32434	Infill panel on bottom section of roof truss.

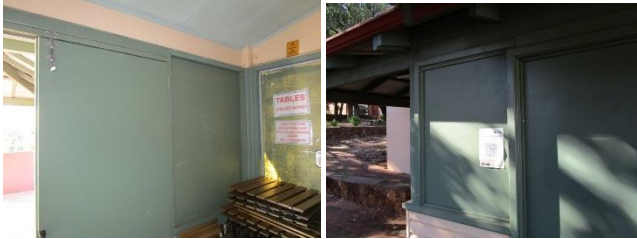
No asbestos detected. Organic Fibres Detected. Synthetic Mineral Fibres Detected.
Window Infill Panel	Eurofins ARL Lab No. 21-10098-60 QED ID: 32433	External Storeroom.

No asbestos detected. Organic Fibres Detected.
Red Vinyl Layer	Greencap Report No. 41948 QED ID: 32438	Kitchen.
