Lot 192 Hale Road

Wattle Grove

Preliminary Arborist Report

September 2023

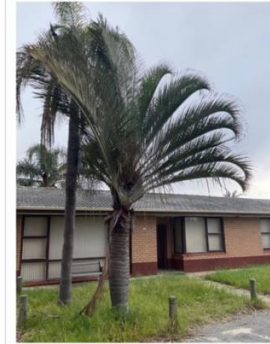
Cocos Palm Tree ID 15**Tree Details**

Botanical Name:	<i>Syagrus romanzoffiana</i>
Common Name:	Cocos Palm
Height (m):	8
Spread (m):	4
Health:	Good
Structure:	Poor
Age:	Mature
SULE:	21-40 yrs
Retention Value:	Low
Comments (assessment):	Non-native palm species
DBH (mm):	270
Tree Protection Zone (TPZ)(m):	3.24
Structural Root Zone (SRZ)(m):	1.91
