## **WATER and STORMWATER MANAGEMENT PLAN**

**CHALET RIGI RESTAURANT, PIESSE BROOK, KALAMUNDA, WA 6076**

**DECEMBER 2019**

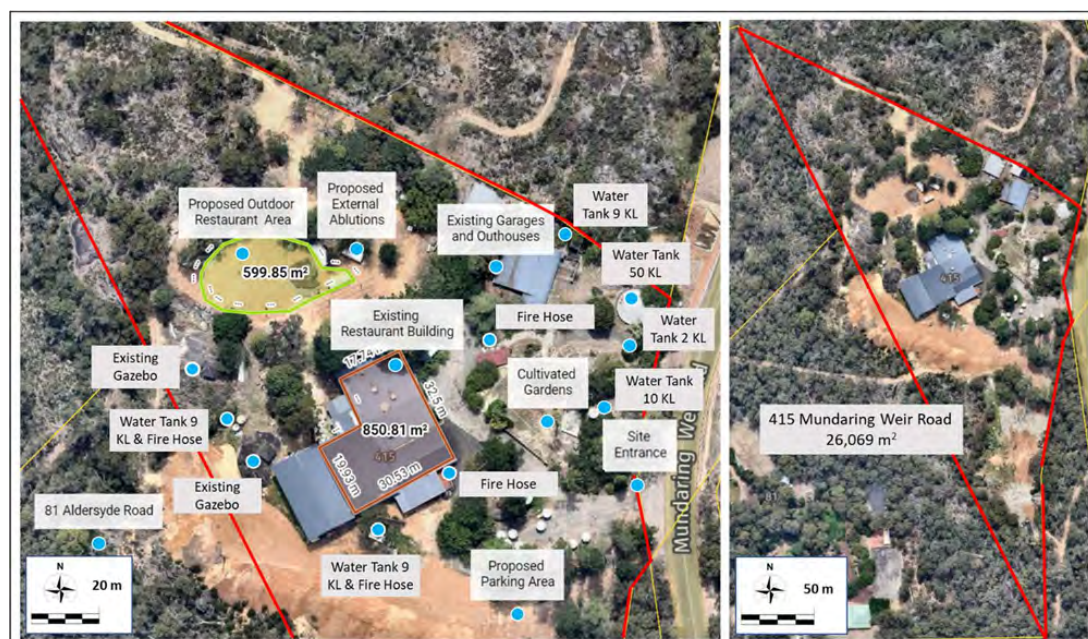
Figure 2 Site Layout and Infrastructure

Chalet Rigi (the site) is located at 415 Mundaring Weir, Piesse Brook, within the Local Government Authority of the City of Kalamunda. The total site area is 7 acres (approx. 26,069 m<sup>2</sup>). The central portion of the site contains the existing restaurant building, garages, outhouses, and landscaped gardens, whilst the northern and southern portions of the site comprise bushland (refer **Figure 2**).

Sealed ground surfaces on the site are limited to a bituminised/hardstand driveway connecting the restaurant with Mundaring Weir Road (refer **Figure 2**). The sealed driveway forms an area of less than 1,000 m<sup>2</sup> and was in place when Fallright purchased the property.

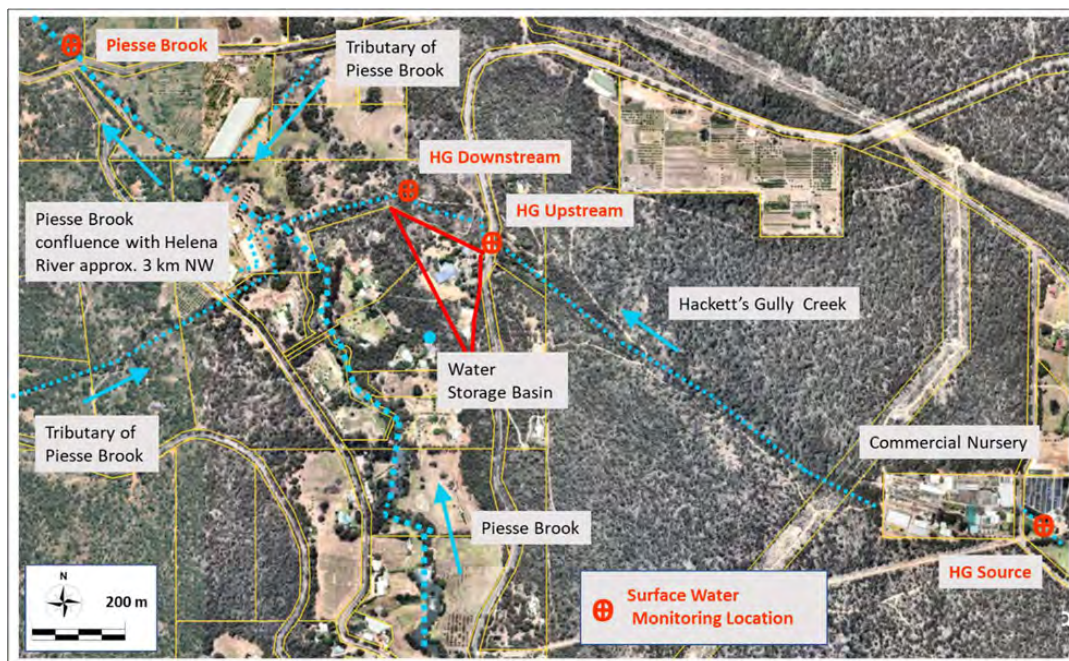
Figure 6 Local Surface Waters

The nearest surface water course to Chalet Rigi is Hackett's Gully Creek, a small tributary of Piesse Brook. It originates at the top of Mount Gungin in the Greenmount State Forest, almost 4 km southeast of Chalet Rigi. The creek flows in a north-westerly direction, passing within 23 m of the northern site corner at its closest point (refer **Figure 6**). It flows into Piesse Brook approximately 250 m downstream of Chalet Rigi.

In September 2019, Evergreen collected surface water samples from three locations along Hackett's Gulley Creek and one location on Piesse Brook to assess local surface water quality. Sample locations were chosen to be reflective of baseline conditions prior to the ATU being installed at Chalet Rigi. The location of the samples is shown on **Figure 6** in **Section 4.5** and on **Plates 1 – 8** below.

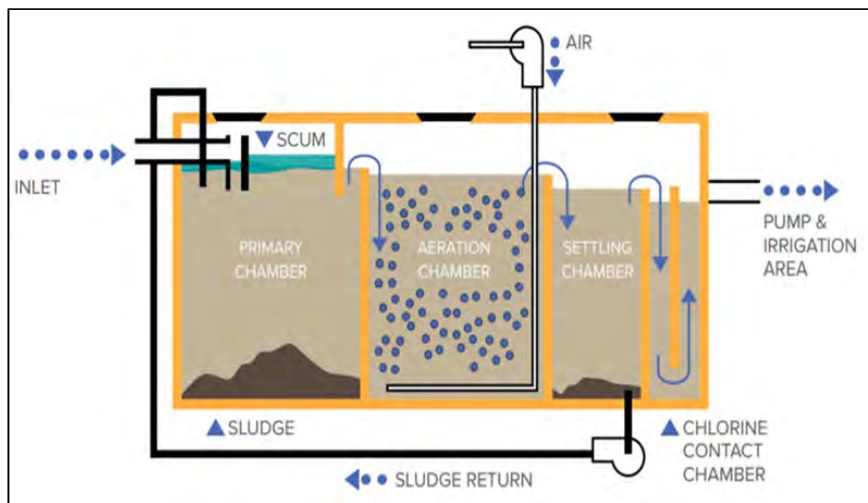
Figure 8 Simplified Schematic of BioMAX Treatment Technology

A simplified schematic of the treatment process is presented in **Figure 8**.

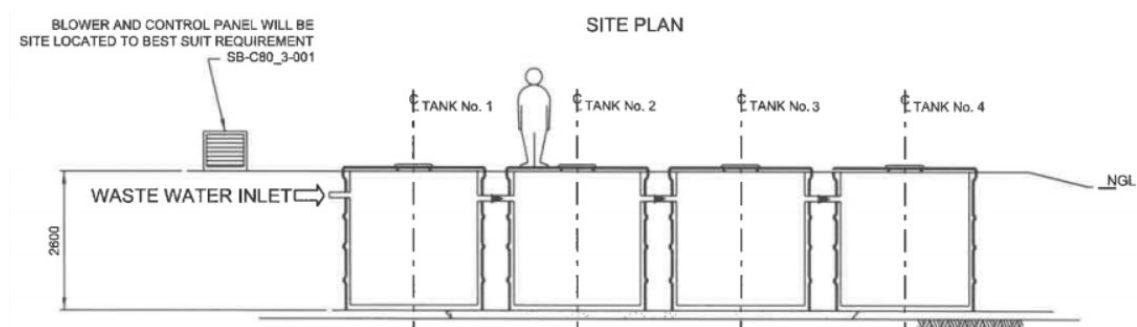
Figure 10 Schematic Section of BioMAX C80 ATU installation

The ATU will be installed onto a flat concrete pad with a footprint of 6m x 12m. Geotechnical investigations have confirmed that the site is underlain by a sandy clay loam which is suitably stable to support the installation of the ATU as per the manufacturer's instructions. A schematic cross section provided by BioMAX is presented in **Figure 10** and a typical BioMAX installation is shown in **Figure 11**.

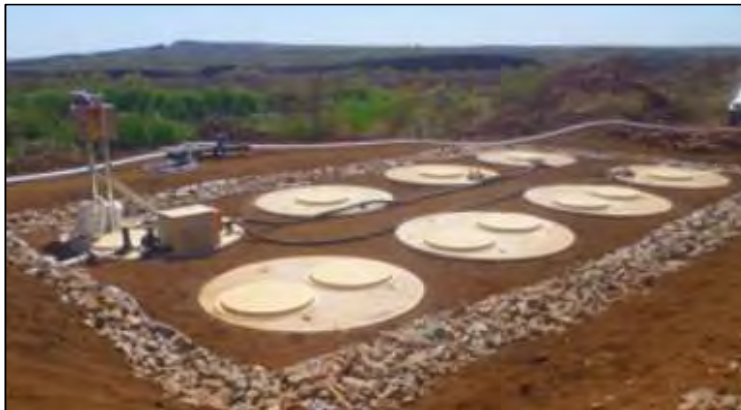
Figure 11 Typical BioMAX C80 Installation

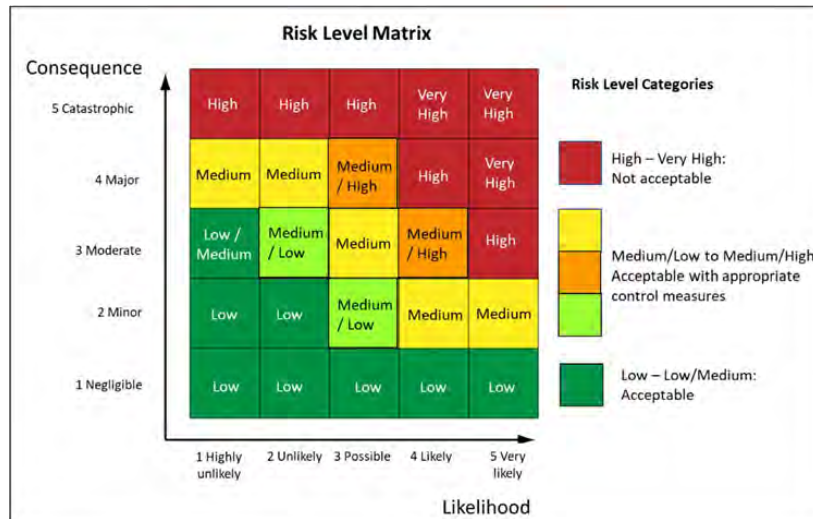
Figure 15 Risk Assessment: Risk Level Matrix

A Risk Level Matrix was used to analyse the potential risks posed by operation of the ATU system at Chalet Rigi, including likelihood of a hazardous event occurring in a specified time frame and the severity of the consequences should the hazard occur and cause harm to public health or the environment (refer **Figure 15**).

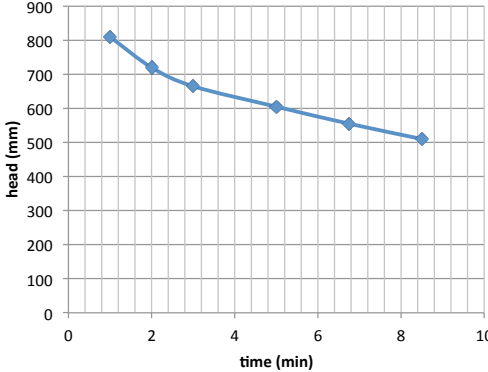
**Water Level**

Environmental							
Client:	SAFERIGHT Pty Ltd	Job No:	S936784	Project No:	S936784-A				
Project:	Chalet Rigi Proposed Extensions & Alterations - #415 Mundaring Weir Rd, Piesse Brook			GPS:	E413976				
Percolation No:	PERC 3	Operator:	BEW	Test Date:	10/10/19				
<table border="1"> <tr> <td>Diameter (mm)</td> <td>50</td> </tr> <tr> <td>Depth (mm)</td> <td>1000</td> </tr> </table>		Diameter (mm)	50	Depth (mm)	1000	<b>Inverted Auger Hole</b> (Porchet Method) $K = 1.15r \frac{\log\left(h_0 + \frac{r}{2}\right) - \log\left(h_1 + \frac{r}{2}\right)}{t}$			
Diameter (mm)	50								
Depth (mm)	1000								
Time (min)	Depth (mm)	Head (mm)	k (mm/min)	k (m/s)	k (m/day)				
1	190	810							
2	280	720	1.44693798	2.4116E-05	2.08359069				
3	335	665	0.97457697	1.6243E-05	1.40339084				
5	395	605	0.57891485	9.6486E-06	0.83363739				
6.75	445	555	0.60245372	1.0041E-05	0.86753336				
8.5	490	510	0.5894501	9.8242E-06	0.84880814				
		Average	0.83846672	1.3974E-05	1.20739208				
		Entire Interval	0.75535685	1.2589E-05	1.08771386

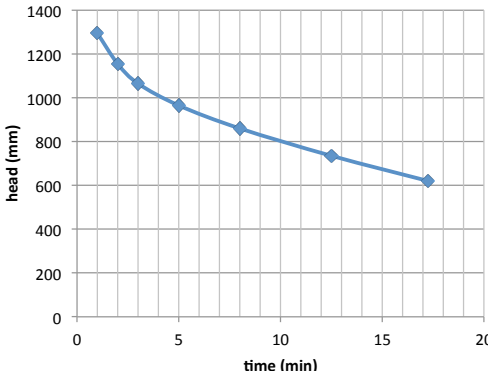
**Water Level**

8	640	860	0.47295025	7.8825E-06	0.68104836
12.5	765	735	0.42904097	7.1507E-06	0.617819
17.25	880	620	0.43912246	7.3187E-06	0.63233634
		Average	0.72748093	1.2125E-05	1.04757254
		Entire Interval	0.55798207	9.2997E-06	0.80349417

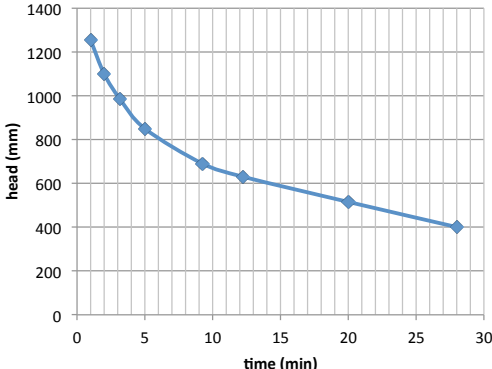
### Water Level

Time (min)	Head (mm)
1	1255
2	1100
3.17	985
5	850
9.25	690
12.25	630
20	515
28	400

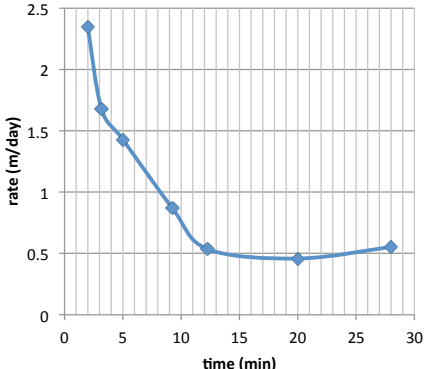
### Permeability Rate

Time (min)	Rate (m/day)
2	2.345
3.17	1.677
5	1.429
9.25	0.868
12.25	0.535
20	0.458
28	0.553

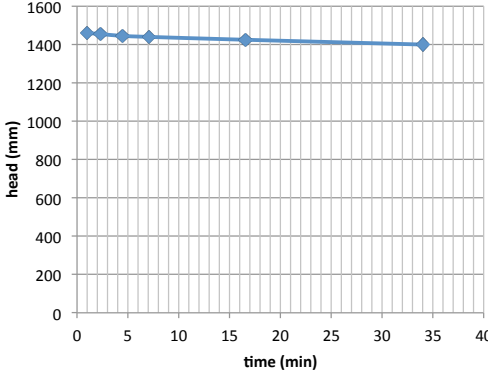
**Water Level**

Diameter (mm) 50 Depth (mm) 1500		<b>Inverted Auger Hole</b> (Porchet Method) $K = 1.15r \frac{\log\left(h_0 + \frac{r}{2}\right) - \log\left(h_1 + \frac{r}{2}\right)}{t}$			
Time (min)	Depth (mm)	Head (mm)	k (mm/min)	k (m/s)	k (m/day)
1	40	1460			
2.3	45	1455	0.0326687	5.4448E-07	0.04704293
4.47	55	1445	0.03934307	6.5572E-07	0.05665402
7.08	60	1440	0.01643952	2.7399E-07	0.02367291
16.55	75	1425	0.01368672	2.2811E-07	0.01970888
34	100	1400	0.01255345	2.0922E-07	0.01807696
Average			0.02293829	3.8230E-07	0.03303114
Entire Interval			0.01574006	2.6233E-07	0.02266568

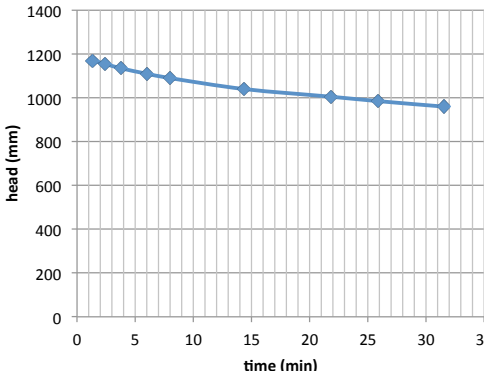
### Water Level

Time (min)	Head (mm)
1.33	1170
2.42	1155
3.75	1135
6	1110
8	1090
14.37	1040
21.83	1005
25.83	985
31.5	960

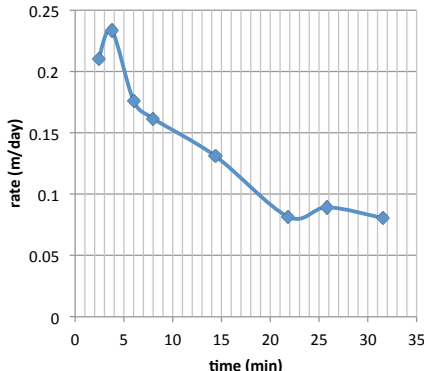
### Permeability Rate

Time (min)	Rate (m/day)
1.33	0.21058016
2.42	0.23358923
3.75	0.17602074
6	0.16162046
8	0.13100139
14.37	0.08151075
21.83	0.08923267
25.83	0.08048755
31.5	0.08048755

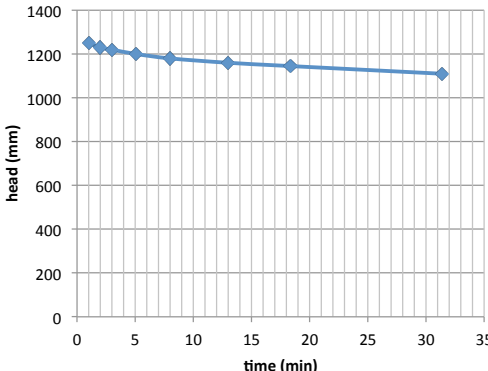
### Water Level

Time (min)	Head (mm)
1	1250
2	1230
3	1220
5.08	1200
8	1180
13	1160
18.33	1145
31.33	1110

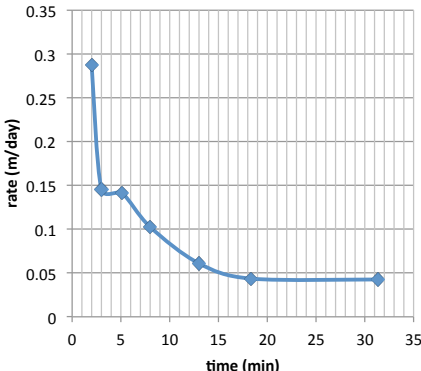
### Permeability Rate

Time (min)	Rate (m/day)
1	0.29
2	0.15
3	0.14
5.08	0.10
8	0.07
13	0.05
18.33	0.04
31.33	0.04

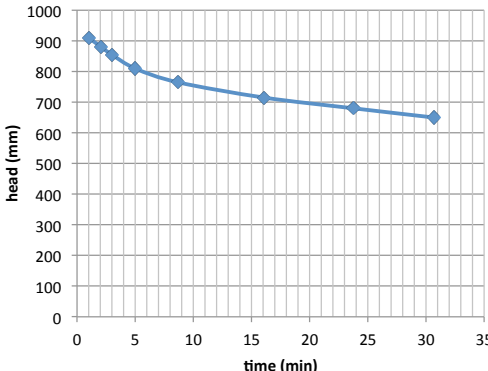
### Water Level

Time (min)	Head (mm)
1	910
2.08	880
3	855
5	810
8.66	765
16.08	715
23.75	680
30.66	650

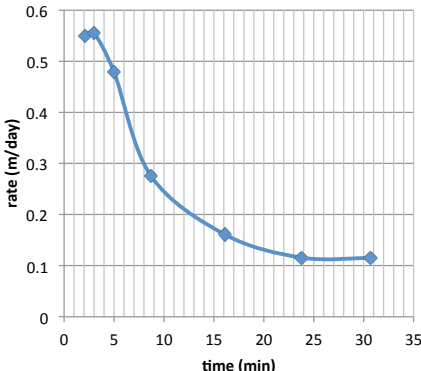
### Permeability Rate

Time (min)	Rate (m/day)
1	0.5504
2.08	0.5504
3	0.5552
5	0.4789
8.66	0.2764
16.08	0.1611
23.75	0.1156
30.66	0.1152
