# ASBESTOS REGISTER

Cyril Road Hall, 58 Cyril Road, High Wycombe, WA

Report ID: **34737Br1**

Prepared for: **City of Kalamunda**

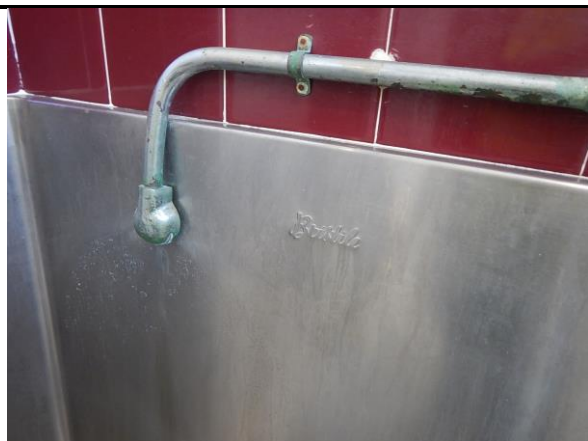
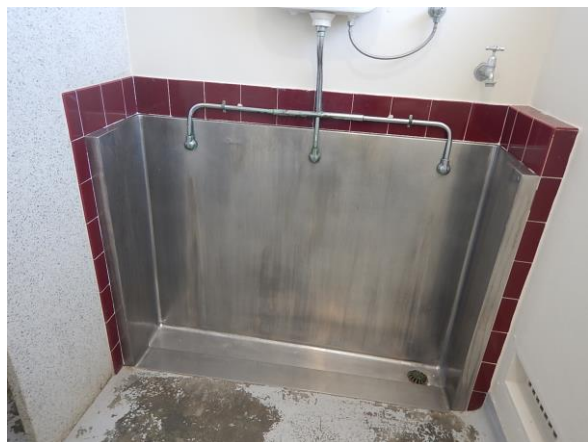
<b>ID 2:- Urinal Backing Membrane (Bristile) (Suspected Asbestos Containing Material)</b>	
Material	Suspected asbestos containing material.
Lab No.	Unable to sample (encapsulated)
QED Sample No.	ID: N/A.
Locations	Internal - Male toilets, urinal.
Condition	Encased, intact, non-friable.
Signage	Unable to adequately label.
Potential for Disturbance	Low.
<b>Risk</b>	<p><b>The ACM are not friable and are in stable condition. Ensure that they are regularly inspected to ensure they are not deteriorating or otherwise contributing to an unacceptable health risk.</b></p>
Management Actions	<p>May remain in-situ until replacement is required.                  Manage as per <b>Asbestos Management Plan</b>.                  Administrative – Follow safe work procedures during removal and maintenance.                  Personal protective equipment – P2 facemask and coveralls required when working on material.</p>

References (See Appendices)	<p><b>Safe Work Australia, Code of Practice: How to Manage and Control Asbestos in the Workplace.</b>  <b>Safe Work Australia, Code of Practice: How to Safely Remove Asbestos</b>  <b>Appendix E—Examples of asbestos removal work</b>                  Removing bituminous (malthoid) products</p>
Service Record	<p>Review– January 2028                  Company:                  Date:                  Works:                  Clearance certificate:</p>

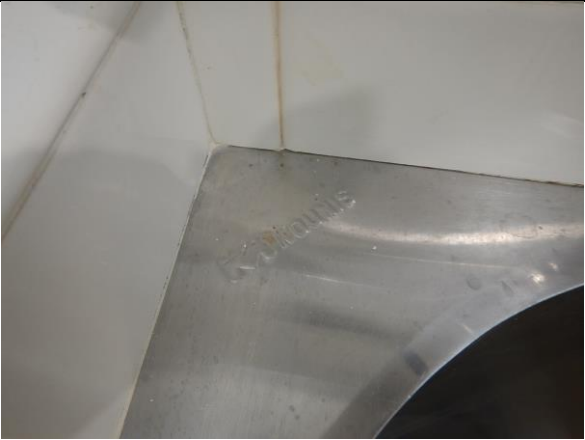
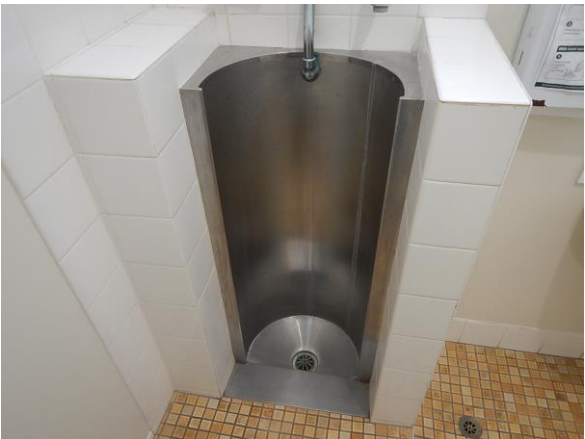
<b>ID 3:- Urinal Backing Membrane (Kounis) (Suspected Asbestos Containing Material)</b>

Material	Suspected asbestos containing material.		
Lab No.	Unable to sample (encapsulated)		
QED Sample No.	ID: N/A.		
Locations	Internal - Male toilets, urinal.		
Condition	Encased, intact, non-friable.		
Signage	Unable to adequately label.		
Potential for Disturbance	Low.		
<b>Risk</b>	<p><b>The ACM are not friable and are in stable condition. Ensure that they are regularly inspected to ensure they are not deteriorating or otherwise contributing to an unacceptable health risk.</b></p>

Management Actions	<p>May remain in-situ until replacement is required.                  Manage as per <b>Asbestos Management Plan</b>.                  Administrative – Follow safe work procedures during removal and maintenance.                  Personal protective equipment – P2 facemask and coveralls required when working on material.</p>
