ASBESTOS REGISTER

Edinburgh Road Centre, 35 Edinburgh Road, Forrestfield, WA

Report ID: **34727Br0**

Prepared for: **City of Kalamunda**

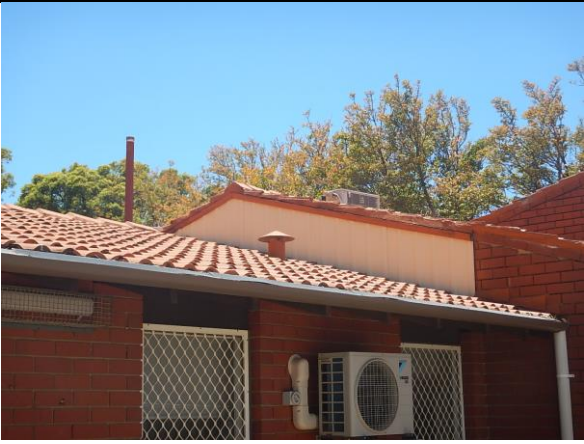
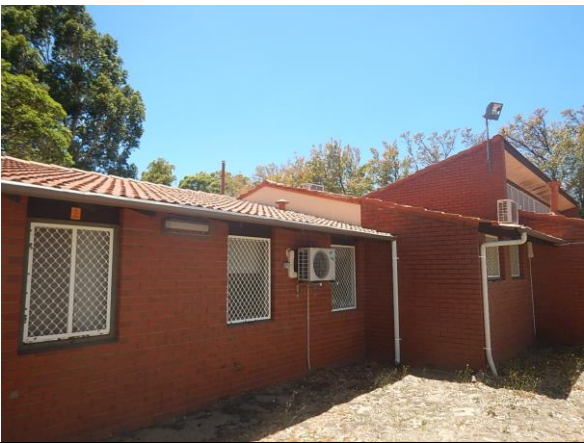
ID 1:- Shadow-Line Fibre Cement Gable End Panelling (Suspected Asbestos Containing Material)

Material	Suspected asbestos containing material.	
Lab No.	Unable to obtain suitable sample [height].	
QED Sample No.	ID: Observed.	
Locations	External – Western elevation, gable end.	
Condition	Good, sealed, non-friable.	
Signage	None.	
Potential for Disturbance	Low.	
Risk	<p>The ACM are not friable and are in stable condition. Ensure that they remain clearly labelled and regularly inspect to ensure they are not deteriorating or otherwise contributing to an unacceptable health risk.</p>

Management Actions	<p>Label when practical. May remain in-situ until replacement is required. Manage as per Asbestos Management Plan. Administrative – Follow safe work procedures during removal and maintenance. Personal protective equipment – P2 facemask and coveralls required when working on material.</p>	
References (See Appendices)	<p>Safe Work Australia, Code of Practice: How to Manage and Control Asbestos in the Workplace. WHS Appendix G—Recommended safe working practices Safe work practice 1—Drilling of ACM Safe work practice 2—Sealing, painting, coating and cleaning of asbestos cement products Safe Work Australia, Code of Practice: How to Safely Remove Asbestos Appendix E—Examples of asbestos removal work Asbestos cement products</p>

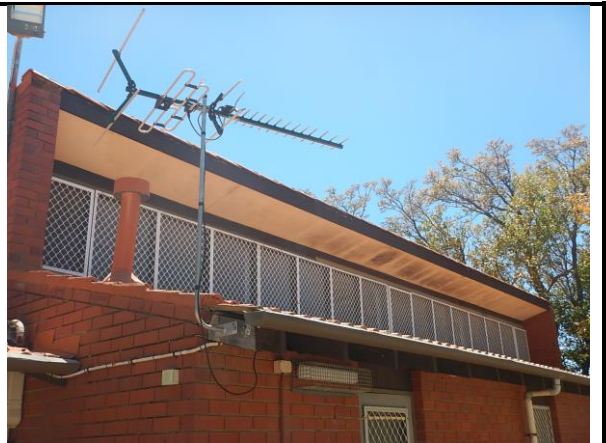
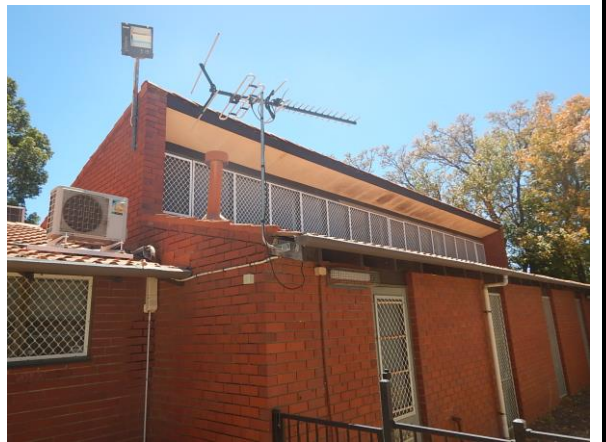
ID 2:- Fibre Cement Eave Panelling (Suspected Asbestos Containing Material)	
Material	Suspected asbestos containing material.
Lab No.	Unable to obtain suitable sample [height].
QED Sample No.	ID: Observed.
Locations	External – Southern elevation, high level eaves lining.
Condition	Good, sealed, non-friable.
Signage	None.
Potential for Disturbance	Low.
Risk	<p>The ACM are not friable and are in stable condition. Ensure that they remain clearly labelled and regularly inspect to ensure they are not deteriorating or otherwise contributing to an unacceptable health risk.</p>
Management Actions	<p>Label when practical. May remain in-situ until replacement is required. Manage as per Asbestos Management Plan. Administrative – Follow safe work procedures during removal and maintenance. Personal protective equipment – P2 facemask and coveralls required when working on material.</p>
References (See Appendices)	<p>Safe Work Australia, Code of Practice: How to Manage and Control Asbestos in the Workplace. WHS Appendix G—Recommended safe working practices Safe work practice 1—Drilling of ACM Safe work practice 2—Sealing, painting, coating and cleaning of asbestos cement products Safe Work Australia, Code of Practice: How to Safely Remove Asbestos Appendix E—Examples of asbestos removal work Asbestos cement products</p>

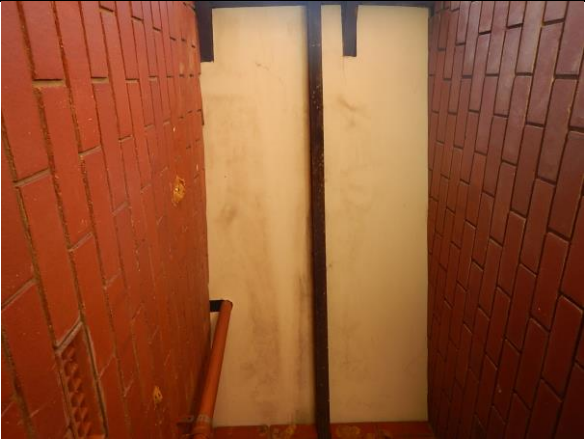
ID 3:- Fibre Cement Ceiling/Infill Panelling (Asbestos Detected)

Material	Chrysotile and amosite asbestos detected.	
Lab No.	Eurofins ARL Lab No. 21-08932-47.	
QED Sample No.	ID: 28243.	
Locations	External – Ceiling above plumbing duct (between toilets and main entrance).	
Condition	Good, sealed, non-friable.	
Signage	Labelled.	
Potential for Disturbance	Low.	
Risk	<p>The ACM are not friable and are in stable condition. Ensure that they remain clearly labelled and regularly inspect to ensure they are not deteriorating or otherwise contributing to an unacceptable health risk.</p>	
Management Actions	<p>May remain in-situ until replacement is required. Manage as per Asbestos Management Plan. Administrative – Follow safe work procedures during removal and maintenance. Personal protective equipment – P2 facemask and coveralls required when working on material.</p>	
References (See Appendices)	<p>Safe Work Australia, Code of Practice: How to Manage and Control Asbestos in the Workplace. WHS Appendix G—Recommended safe working practices Safe work practice 1—Drilling of ACM Safe work practice 2—Sealing, painting, coating and cleaning of asbestos cement products Safe Work Australia, Code of Practice: How to Safely Remove Asbestos Appendix E—Examples of asbestos removal work Asbestos cement products</p>

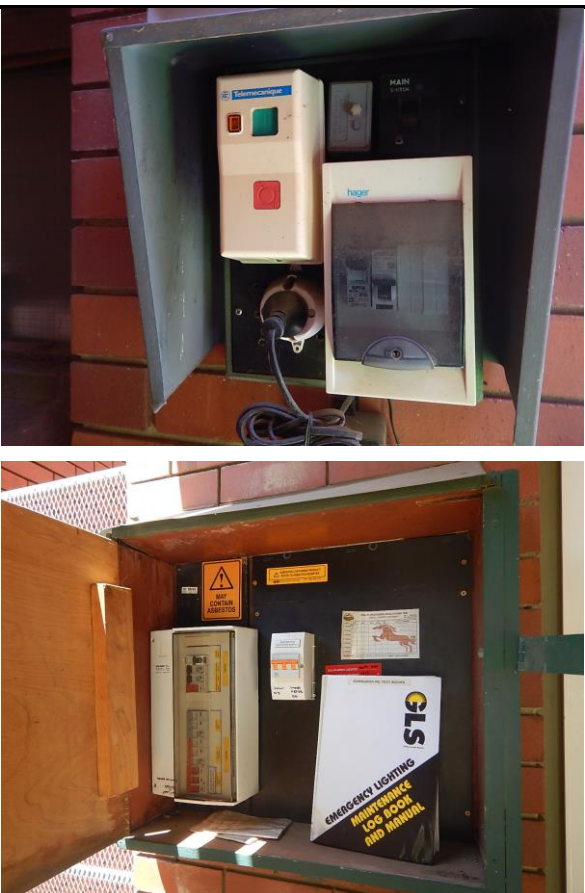
ID 4:- Electrical Mounting Board (Asbestos Detected)

Material	Chrysotile asbestos detected.	
Lab No.	Eurofins ARL Lab No. 21-08932-46.	
QED Sample No.	ID: 28242.	
Locations	External – Electrical cabinet adjacent entry and plumbing duct.	
Condition	Good, intact, non-friable.	
Signage	Main Board Labelled.	
Potential for Disturbance	Low to medium.	
Risk	<p>The ACM are not friable and are in stable condition. Ensure that they remain clearly labelled and regularly inspect to ensure they are not deteriorating or otherwise contributing to an unacceptable health risk.</p>	
Management Actions	<p>Label plumbing duct electrical mounting board when practical. May remain in-situ until replacement is required. Manage as per Asbestos Management Plan. Administrative – Follow safe work procedures during removal and maintenance. Personal protective equipment – P2 facemask and coveralls required when working on material.</p>

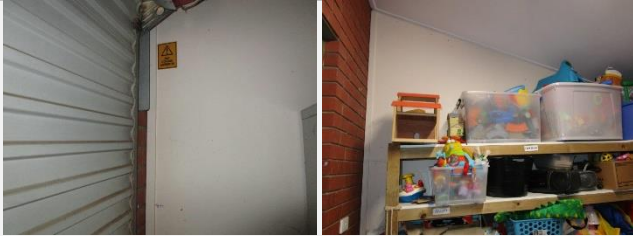
No asbestos detected.
