ASBESTOS REGISTER

Grove Road Centre, 12 Grove Road, Walliston, WA

Report ID: **34775Br0**

Prepared for: **City of Kalamunda**

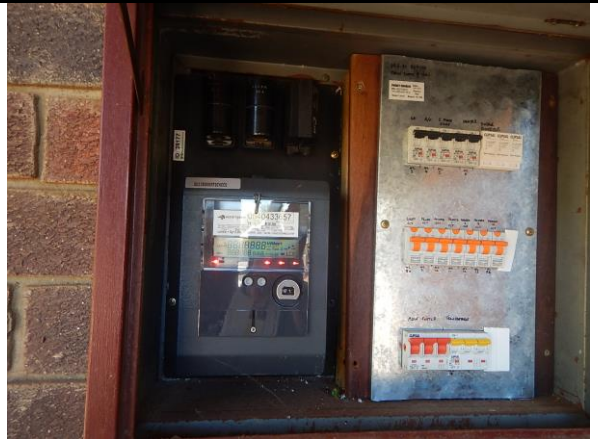
ID 1:- Electrical Mounting Board (Asbestos Detected)	
Material	Chrysotile and amosite asbestos detected.
Lab No.	Eurofins ARL Lab No. 21-08932-8.
QED Sample No.	ID: 28177.
Locations	External – Electrical cabinet adjacent main entry door.
Condition	Good to fair, non-friable.
Signage	None.
Potential for Disturbance	Low to medium.
Risk	The ACM are not friable and are in stable condition. Ensure that they remain clearly labelled and regularly inspect to ensure they are not deteriorating or otherwise contributing to an unacceptable health risk.
Management Actions	Label when practical. May remain in-situ until replacement is required. Manage as per Asbestos Management Plan . Administrative – Follow safe work procedures during removal and maintenance. Personal protective equipment – P2 facemask and coveralls required when working on material.
References (See Appendices)	Safe Work Australia, Code of Practice: How to Manage and Control Asbestos in the Workplace. WHS Appendix G—Recommended safe working practices Safe work practice 5—Working on electrical mounting boards (switchboards) containing asbestos Safe Work Australia, Code of Practice: How to Safely Remove Asbestos Appendix E—Examples of asbestos removal work Asbestos cement products

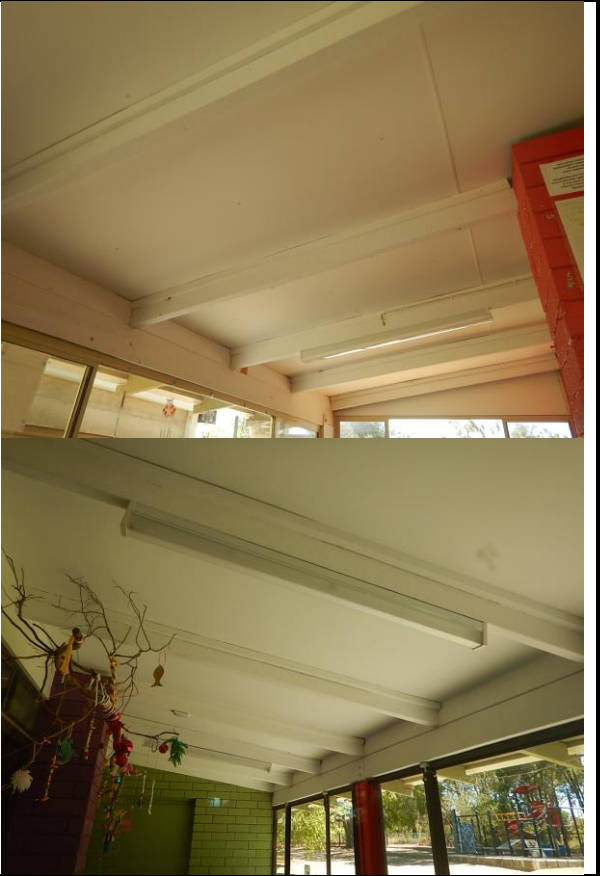
ID 2:- Fibre Cement Panelling – Ceiling and Fascia Panels (Asbestos Detected)

Material	Chrysotile asbestos detected.	
Lab No.	Eurofins ARL Lab No. 21-08932-11.	
QED Sample No.	ID: 28180.	
Locations	Internal – Activity Room ceiling/fascia panels.	
Condition	Good, sealed, non-friable.	
Signage	Labelled.	
Potential for Disturbance	Low.	
Risk	<p>The ACM are not friable and are in stable condition. Ensure that they remain clearly labelled and regularly inspect to ensure they are not deteriorating or otherwise contributing to an unacceptable health risk.</p>	
Management Actions	<p>May remain in-situ until replacement is required. Manage as per Asbestos Management Plan. Administrative – Follow safe work procedures during removal and maintenance. Personal protective equipment – P2 facemask and coveralls required when working on material.</p>	
References (See Appendices)	<p>Safe Work Australia, Code of Practice: How to Manage and Control Asbestos in the Workplace. WHS Appendix G—Recommended safe working practices Safe work practice 1—Drilling of ACM Safe work practice 2—Sealing, painting, coating and cleaning of asbestos cement products Safe Work Australia, Code of Practice: How to Safely Remove Asbestos Appendix E—Examples of asbestos removal work Asbestos cement products</p>

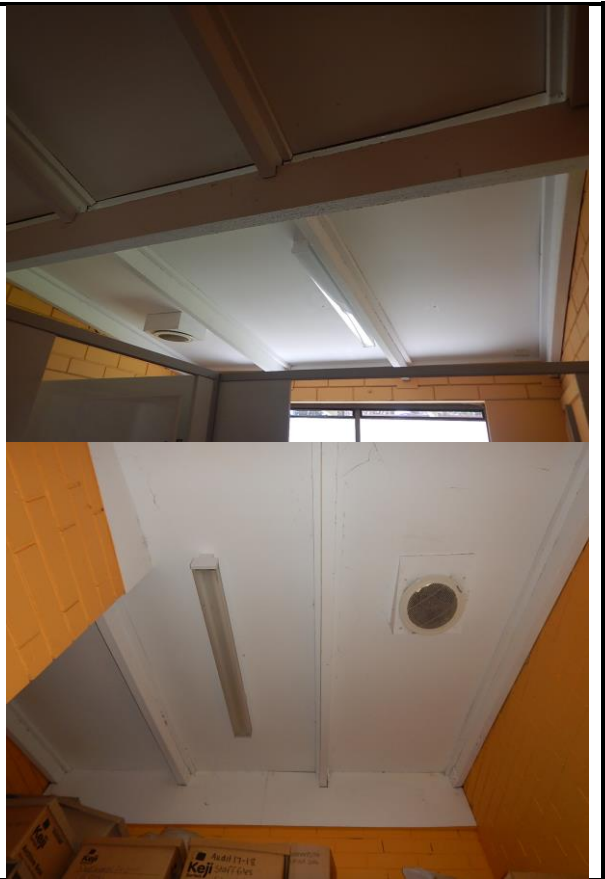
ID 3:- Fibre Cement Panelling – Ceiling Panels (Asbestos Detected)	
Material	Chrysotile asbestos detected.
Lab No.	Eurofins ARL Lab No. 21-08932-12.
QED Sample No.	ID: 28181.
Locations	Internal – Kids bathroom/toilet, ceiling panels.
Condition	Good, sealed, non-friable.
Signage	Labelled.
Potential for Disturbance	Low.
Risk	<p>The ACM are not friable and are in stable condition. Ensure that they remain clearly labelled and regularly inspect to ensure they are not deteriorating or otherwise contributing to an unacceptable health risk.</p>
Management Actions	<p>May remain in-situ until replacement is required. Manage as per Asbestos Management Plan. Administrative – Follow safe work procedures during removal and maintenance. Personal protective equipment – P2 facemask and coveralls required when working on material.</p>
References (See Appendices)	<p>Safe Work Australia, Code of Practice: How to Manage and Control Asbestos in the Workplace. WHS Appendix G—Recommended safe working practices Safe work practice 1—Drilling of ACM Safe work practice 2—Sealing, painting, coating and cleaning of asbestos cement products Safe Work Australia, Code of Practice: How to Safely Remove Asbestos Appendix E—Examples of asbestos removal work Asbestos cement products</p>
