# ASBESTOS REGISTER

Kalamunda Water Park, Collins Road, Kalamunda, WA

Report ID: **34742Br0**

Prepared for: **City of Kalamunda**

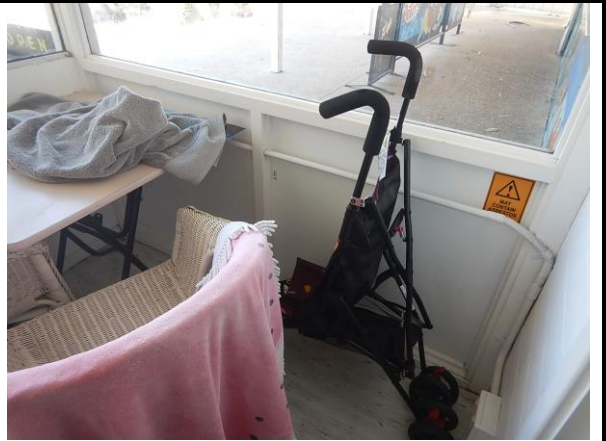
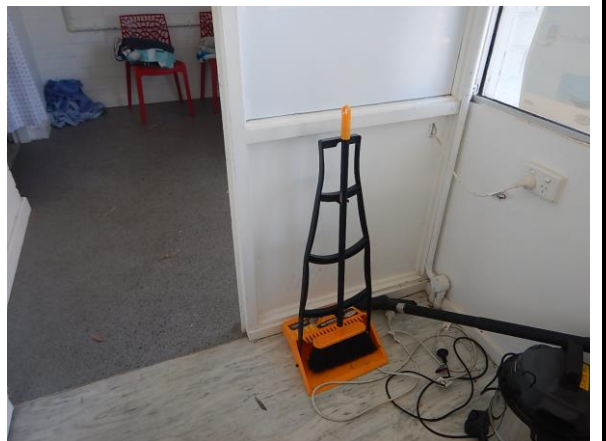
<b>ID 1:- Fibre Cement Panelling and Window Infill Panels (Asbestos Detected)</b>	
Material	Chrysotile asbestos detected.
Lab No.	Eurofins ARL Lab No. 21-10098-110.
QED Sample No.	ID: 28099.
Locations	Internal – First aid and lifeguard room, wall panelling, and infill panels above windows.
Condition	Good, sealed, non-friable.
Signage	Labelled.
Potential for Disturbance	Low to medium.
<b>Risk</b>	<p><b>The ACM are not friable and are in stable condition. Ensure that they remain clearly labelled and regularly inspect to ensure they are not deteriorating or otherwise contributing to an unacceptable health risk.</b></p>
Management Actions	<p>May remain in-situ until replacement is required.                  Manage as per <b>Asbestos Management Plan</b>.                  Administrative – Follow safe work procedures during removal and maintenance.                  Personal protective equipment – P2 facemask and coveralls required when working on material.</p>

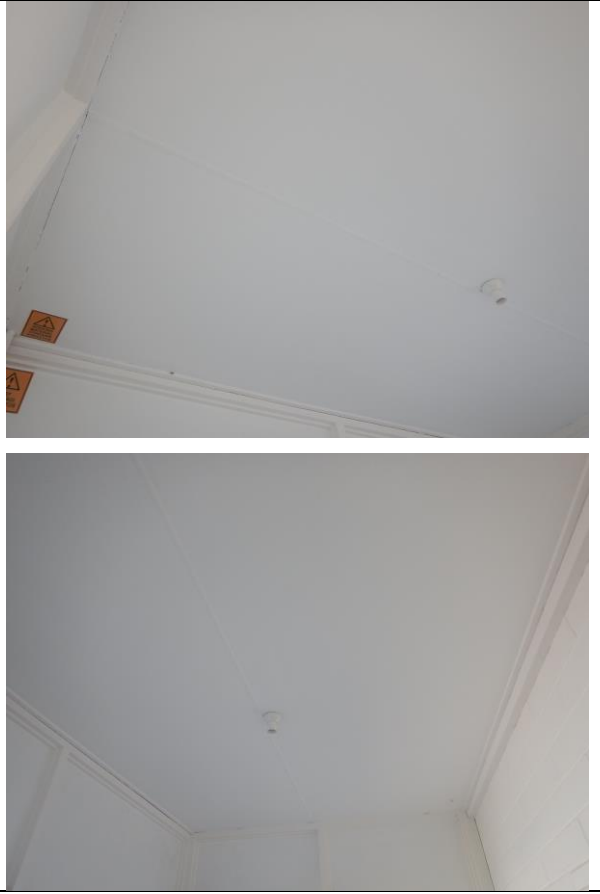
<b>ID 2:- Fibre Cement Ceiling Panelling (Asbestos Detected)</b>

Material	Chrysotile asbestos detected.	
Lab No.	Eurofins ARL Lab No. 21-10098-109.	
QED Sample No.	ID: 28100.	
Locations	Internal – Lifeguard room, ceiling.	
Condition	Good, sealed, non-friable.	
Signage	Labelled.	
Potential for Disturbance	Low to medium.	
<b>Risk</b>	<p>The ACM are not friable and are in stable condition. Ensure that they remain clearly labelled and regularly inspect to ensure they are not deteriorating or otherwise contributing to an unacceptable health risk.</p>	
Management Actions	<p>May remain in-situ until replacement is required.                  Manage as per <b>Asbestos Management Plan</b>.                  Administrative – Follow safe work procedures during removal and maintenance.                  Personal protective equipment – P2 facemask and coveralls required when working on material.</p>	
References (See Appendices)	<p><b>Safe Work Australia, Code of Practice: How to Manage and Control Asbestos in the Workplace.</b>  <b>WHS Appendix G—Recommended safe working practices</b>                  Safe work practice 1—Drilling of ACM                  Safe work practice 2—Sealing, painting, coating and cleaning of asbestos cement products  <b>Safe Work Australia, Code of Practice: How to Safely Remove Asbestos</b>  <b>Appendix E—Examples of asbestos removal work</b>                  Asbestos cement products</p>

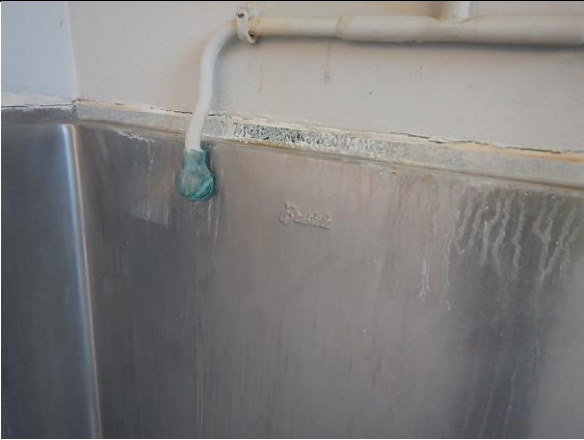
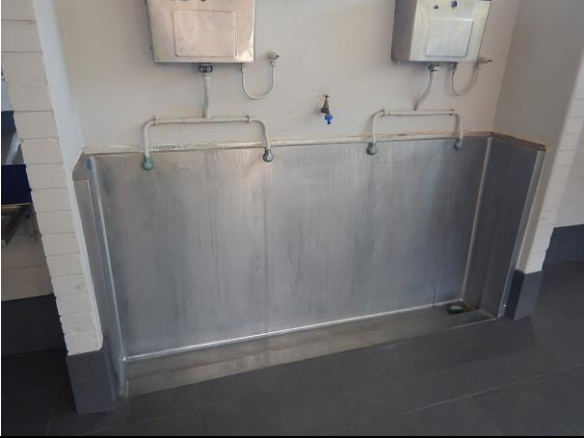
<b>ID 3:- Urinal Backing Membrane (Bristile) (Suspected Asbestos Containing Material)</b>

Material	Suspected asbestos containing material.		
Lab No.	Unable to sample (encapsulated)		
QED Sample No.	ID: N/A.		
Locations	Internal – Male changeroom, male toilet, urinal.		
Condition	Encased, intact, non-friable.		
Signage	Unable to adequately label.		
Potential for Disturbance	Low.		
<b>Risk</b>	<p><b>The ACM are not friable and are in stable condition. Ensure that they are regularly inspected to ensure they are not deteriorating or otherwise contributing to an unacceptable health risk.</b></p>

Management Actions	<p>May remain in-situ until replacement is required.                  Manage as per <b>Asbestos Management Plan</b>.                  Administrative – Follow safe work procedures during removal and maintenance.                  Personal protective equipment – P2 facemask and coveralls required when working on material.</p>

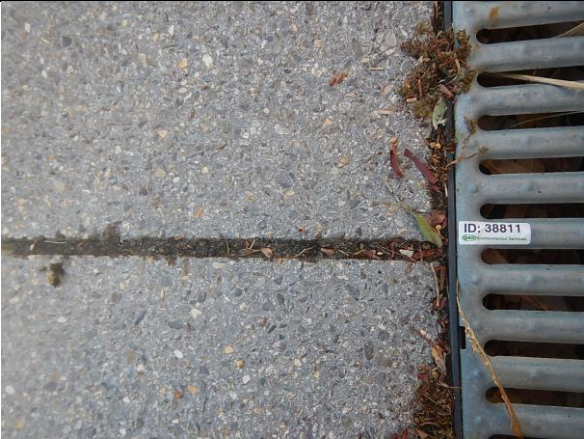
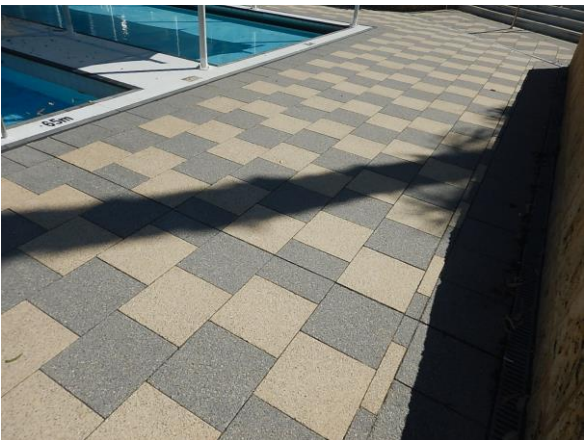
<b>ID 4:- Mastic (Suspected Asbestos Containing Material)</b>

Material	Suspected asbestos containing material.		
Lab No.	N/A.		
QED Sample No.	ID: Observed.		
Locations	External – Adjacent large/main pool, floor expansion joints.		
Condition	Intact, non-friable.		
Signage	None.		
Potential for Disturbance	Low.		
<b>Risk</b>	<p>The ACM are not friable and are in stable condition. Ensure that they remain clearly labelled and regularly inspect to ensure they are not deteriorating or otherwise contributing to an unacceptable health risk.</p>

Management Actions	<p>Label when practical.                  May remain in-situ until replacement is required.                  Manage as per <b>Asbestos Management Plan</b>.                  Administrative – Follow safe work procedures during removal and maintenance.                  Personal protective equipment – P2 facemask and coveralls required when working on material.</p>

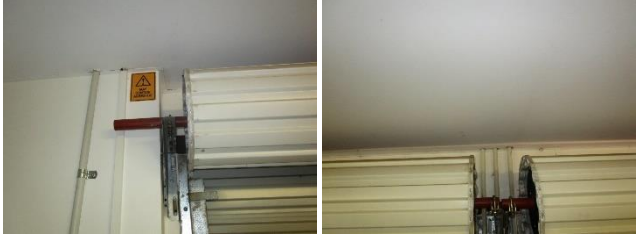
No asbestos detected.
<b>Kiosk cladding on roller door.</b>	Eurofins ARL Lab No. 21-10098-108.  QED ID: 28101.	Internal panelling behind the roller door in the kiosk.

No asbestos detected.
