ASBESTOS REGISTER

Norm Sadler Pavilion, Acacia Road, Maida Vale, WA

Report ID: **34768Br0**

Prepared for: **City of Kalamunda**

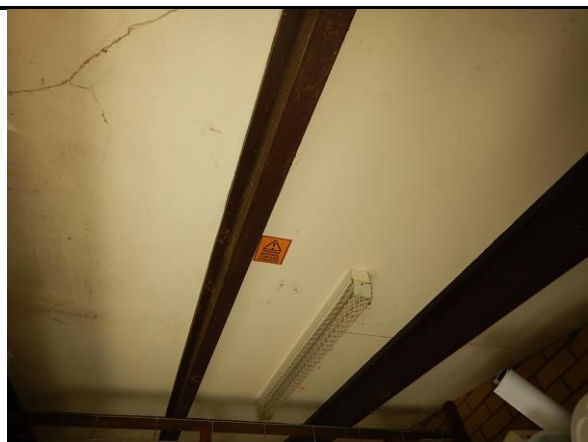
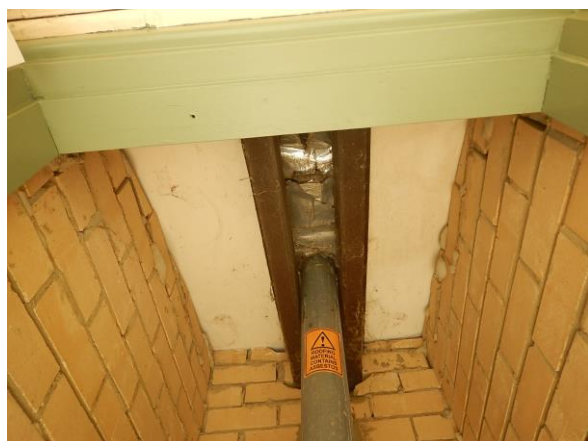
ID 2:- Fibre Cement Ceiling Panelling (Asbestos Detected)	
Material	Chrysotile asbestos detected.
Lab No.	ARL Lab No. 16-08123-1/2 (samples taken by City of Kalamunda).
QED Sample No.	ID: N/A.
Locations	Internal – Storeroom, toilets, changerooms, plumbing ducts and boiler room – ceilings.
Condition	Typically good, sealed, non-friable.
Signage	Labelled.
Potential for Disturbance	Low.
Risk	<p>The ACM are not friable and are in stable condition. Ensure that they remain clearly labelled and regularly inspect to ensure they are not deteriorating or otherwise contributing to an unacceptable health risk.</p>
Management Actions	<p>May remain in-situ until replacement is required. Manage as per Asbestos Management Plan. Administrative – Follow safe work procedures during removal and maintenance. Personal protective equipment – P2 facemask and coveralls required when working on material.</p>
References (See Appendices)	<p>Safe Work Australia, Code of Practice: How to Manage and Control Asbestos in the Workplace. WHS Appendix G—Recommended safe working practices Safe work practice 1—Drilling of ACM Safe work practice 2—Sealing, painting, coating and cleaning of asbestos cement products</p> <p>Safe Work Australia, Code of Practice: How to Safely Remove Asbestos Appendix E—Examples of asbestos removal work Asbestos cement products</p>

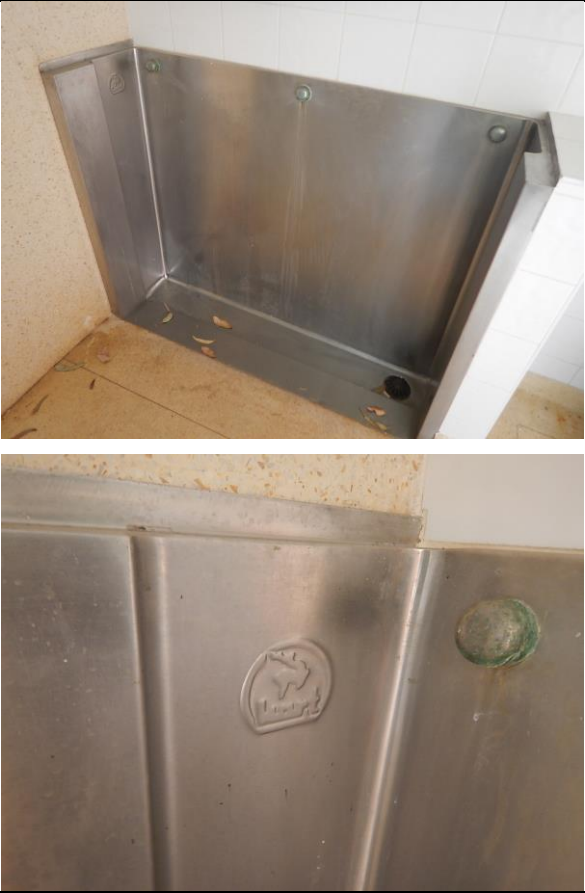
ID 3:- Urinal Backing Membrane (Hart) (Suspected Asbestos Containing Material)

Material	Suspected asbestos containing material.	
Lab No.	Unable to sample (encapsulated)	
QED Sample No.	ID: N/A.	
Locations	Internal - Male toilets	
Condition	Encased, intact, non-friable.	
Signage	Unable to adequately label.	
Potential for Disturbance	Low.	
Risk	<p>The ACM are not friable and are in stable condition. Ensure that they are regularly inspected to ensure they are not deteriorating or otherwise contributing to an unacceptable health risk.</p>	
Management Actions	<p>May remain in-situ until replacement is required. Manage as per Asbestos Management Plan. Administrative – Follow safe work procedures during removal and maintenance. Personal protective equipment – P2 facemask and coveralls required when working on material.</p>	
References (See Appendices)	<p>Safe Work Australia, Code of Practice: How to Manage and Control Asbestos in the Workplace. Safe Work Australia, Code of Practice: How to Safely Remove Asbestos Appendix E—Examples of asbestos removal work Removing bituminous (malthoid) products</p>

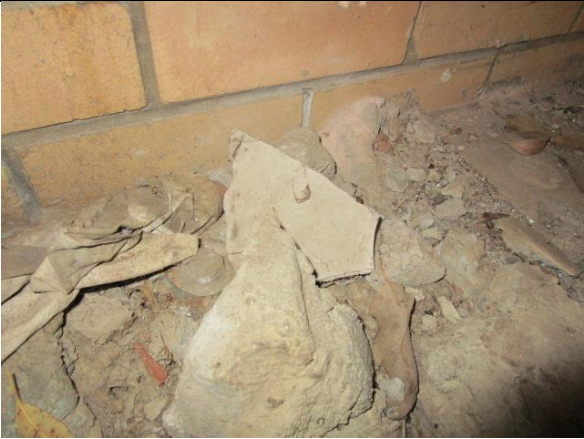
ID 4:- Fibre Cement Debris (Asbestos Detected)

Material	Chrysotile asbestos detected.	
Lab No.	ARL Lab No. 16-08123-1/2 (samples taken by City of Kalamunda).	
QED Sample No.	ID: N/A.	
Location	Internal – Boiler room, to floor and boiler.	
Condition	Debris, intact, non-friable.	
Signage	Labelling not practicable.	
Potential for Disturbance	Low to medium.	
Risk	<p>IMMEDIATE ACTION REQUIRED. The ACM are not friable however, due to their location there is a risk that they could be easily disturbed. It is recommended that the debris is removed.</p>	
Management Actions	<p>Unable to access boiler room in 2023. Assume material is still present. The cement fragments should be removed via hand picking by a removalist with a Class B asbestos removal licence. Further investigation should be conducted to determine the extent of any soil contamination to establish appropriate remediation recommendations. Personal protective equipment – P2 facemask and coveralls required when working on material. Manage as per Asbestos Management Plan. Administrative – Follow safe work procedures during removal and maintenance. Personal protective equipment – P2 facemask and coveralls required when working on material.</p>

ID #	Product	Location
4	Fibre Cement Debris.	Internal – Boiler room, to floor and boiler.
<i>Recommendations: Material is non-friable and in the main inaccessible; however, material should be removed as soon as practical.</i>

1. ID#4 requires removal as soon as practical. Refer to Management Actions for further information.
2. All other materials identified may remain in situ until requiring replacement although, where practicable, asbestos containing materials should be removed, consistent with the Federal Government’s stated ultimate goal of the prohibition of asbestos, which is for “all workplaces to be free of asbestos”.

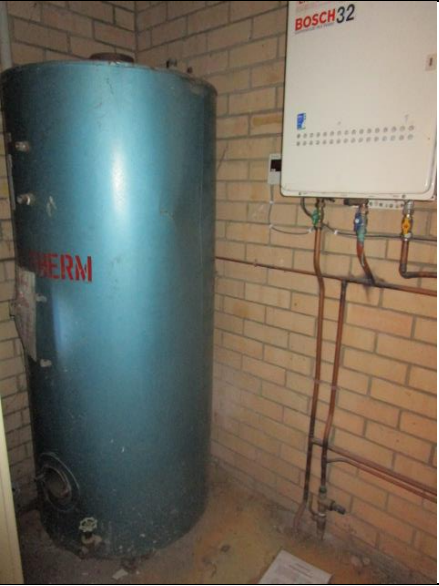
ID 5:- Boiler Unit Components (Asbestos Detected)

Material	Suspected asbestos containing material.	
Lab No.	Unable to access, locked/encased.	
QED Sample No.	ID: Observed.	
Locations	Internal – Boiler room, boiler unit.	
Condition	Unable to access.	
Signage	None.	
Potential for Disturbance	Low.	
Risk	<p>The ACM are not friable and are in stable condition. Ensure that they remain clearly labelled and regularly inspect to ensure they are not deteriorating or otherwise contributing to an unacceptable health risk.</p>	
Management Actions	<p>Due to the age of the boiler unit it is possible to have various asbestos containing materials (e.g. gaskets, seals, insulation). Caution should be used when performing works on or adjacent boiler unit. May remain in-situ until replacement is required. Manage as per Asbestos Management Plan. Administrative – Follow safe work procedures during removal and maintenance. Personal protective equipment – P2 facemask and coveralls required when working on material.</p>
