ASBESTOS REGISTER

Overflow Cottage, 8 Lindsay Street, Kalamunda, WA

Report ID: **34758Br0**

Prepared for: **City of Kalamunda**

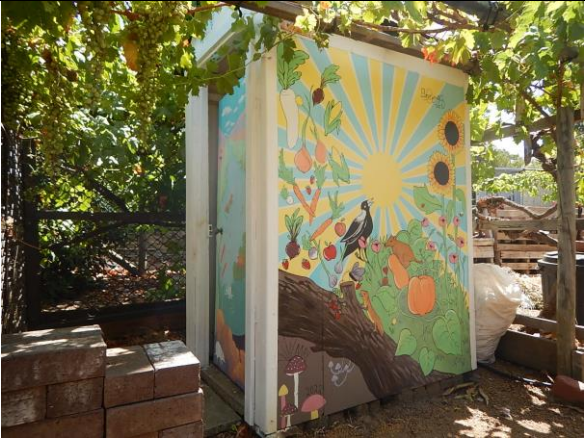
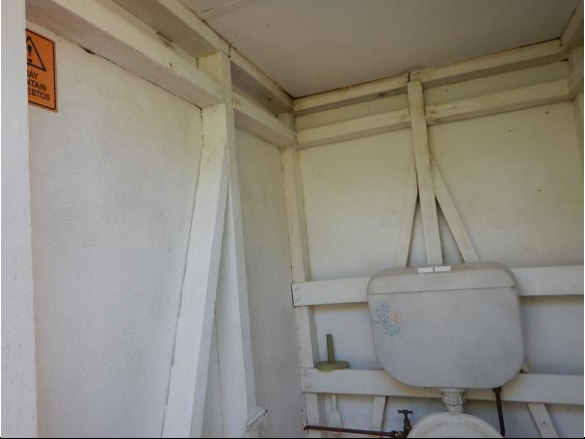
ID 1:- Fibre Cement Wall Panelling (Asbestos Detected)

Material	Chrysotile and amosite asbestos detected.		
Lab No.	Eurofins ARL Lab No. 19-10098-191.		
QED Sample No.	ID: 32428.		
Locations	External – External toilet, internal and external walls.		
Condition	Good, sealed, non-friable.		
Signage	Labelled.		
Potential for Disturbance	Low to medium.		
Risk	<p>The ACM are not friable and are in stable condition. Ensure that they remain clearly labelled and regularly inspect to ensure they are not deteriorating or otherwise contributing to an unacceptable health risk.</p>

Management Actions	<p>May remain in-situ until replacement is required. Manage as per Asbestos Management Plan. Administrative – Follow safe work procedures during removal and maintenance. Personal protective equipment – P2 facemask and coveralls required when working on material.</p>		
References (See Appendices)	<p>Safe Work Australia, Code of Practice: How to Manage and Control Asbestos in the Workplace. WHS Appendix G—Recommended safe working practices Safe work practice 1—Drilling of ACM Safe work practice 2—Sealing, painting, coating and cleaning of asbestos cement products Safe Work Australia, Code of Practice: How to Safely Remove Asbestos Appendix E—Examples of asbestos removal work Asbestos cement products</p>

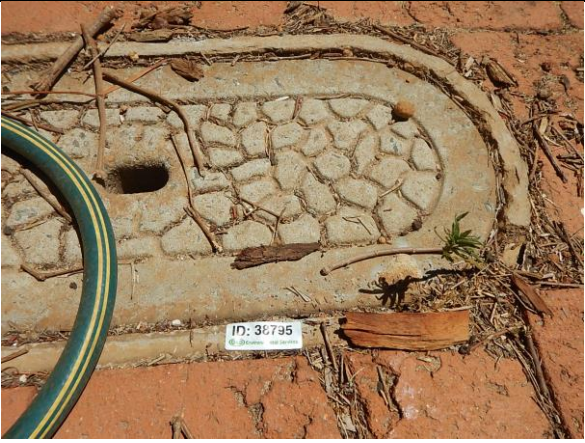
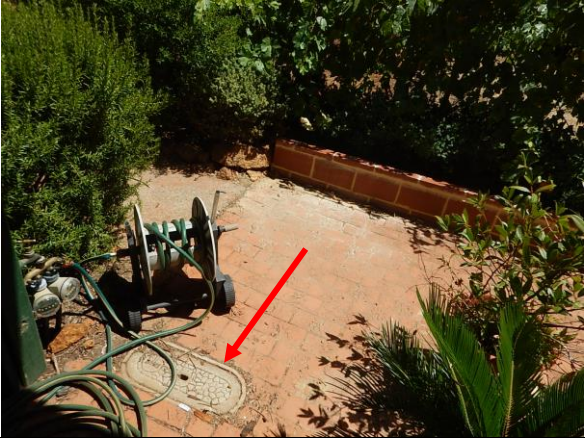
ID 2:- Cable Pit Surrounds (Suspected Asbestos Containing Material)

Material	Suspected asbestos containing material.		
Lab No.	Unable to obtain suitable sample [sample restrictions].		
QED Sample No.	ID: Observed.		
Locations	External – North-western elevation, in walkway/footpath.		
Condition	Fair, unsealed, non-friable.		
Signage	None.		
Potential for Disturbance	Low to medium.		
Risk	<p>The ACM are not friable and are in stable condition. Ensure that they remain clearly labelled and regularly inspect to ensure they are not deteriorating or otherwise contributing to an unacceptable health risk.</p>

Management Actions	<p>Label when practical. May remain in-situ until replacement is required. Manage as per Asbestos Management Plan. Administrative – Follow safe work procedures during removal and maintenance. Personal protective equipment – P2 facemask and coveralls required when working on material.</p>

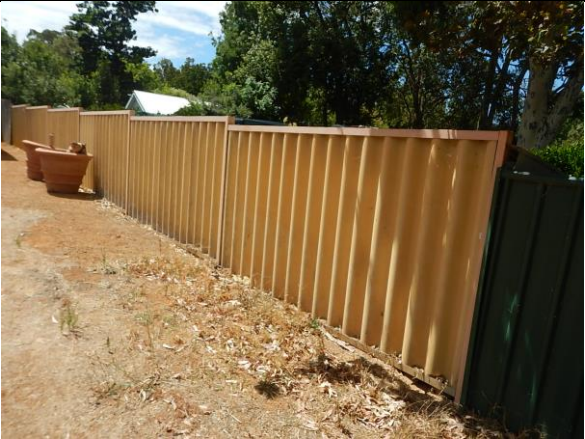
ID 3:- Corrugated Fibre Cement Fence Panelling (Suspected Asbestos Containing Material)

Material	Suspected asbestos containing material.	
Lab No.	Unable to obtain suitable sample [sample restrictions].	
QED Sample No.	ID: Observed.	
Locations	External – (Pictured) Section of Southern perimeter fencing.	
Condition	Good, sealed, non-friable.	
Signage	None.	
Potential for Disturbance	Low.	
Risk	<p>The ACM are not friable and are in stable condition. Ensure that they remain clearly labelled and regularly inspect to ensure they are not deteriorating or otherwise contributing to an unacceptable health risk.</p>	
Management Actions	<p>Label when practical. May remain in-situ until replacement is required. Manage as per Asbestos Management Plan. Administrative – Follow safe work procedures during removal and maintenance. Personal protective equipment – P2 facemask and coveralls required when working on material.</p>

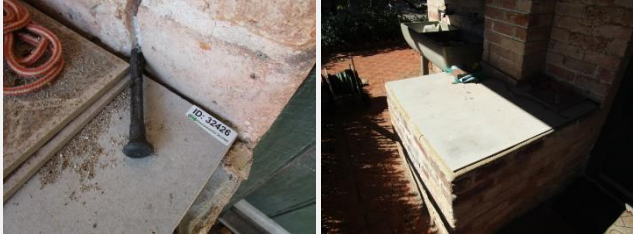
Item Description	Lab No.	Location	Photo	Comments
Cover panel.	Eurofins ARL Lab No. 21-10098-189. QED ID: 32426.	Covering the outside water trough at the front entry.

No asbestos detected.
Window Mastic.	Eurofins ARL Lab No. 21-10098-190. QED ID: 32427.	Windows throughout the house.

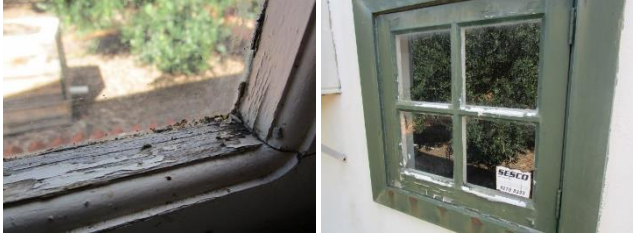
No asbestos detected.
External toilet ceiling panelling.	Eurofins ARL Lab No. 21-10098-192. QED ID: 32429.	Ceiling of the external toilet at the rear of the house.

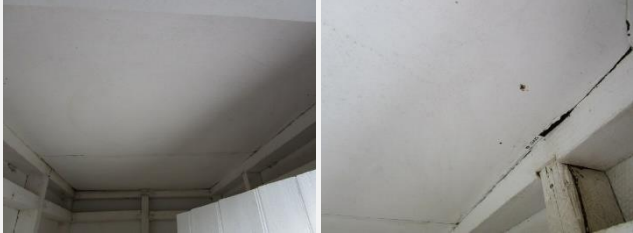
No asbestos detected. Note: the external walls of the toilet contain asbestos.
Chimney infill panel.	Eurofins ARL Lab No. 21-10098-193. QED ID: 32477.	Kitchen Chimney.

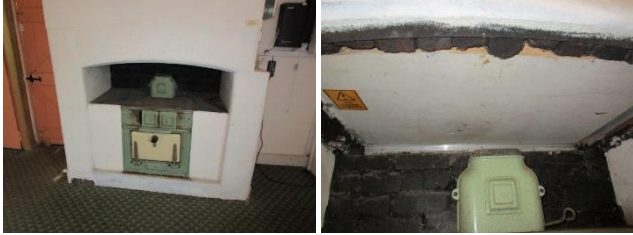
No asbestos detected.
