ASBESTOS REGISTER

Veteran Car Club - House, 263 Hale Road, Wattle Grove, WA

Report ID: **35152Br0**

Prepared for: **City of Kalamunda**

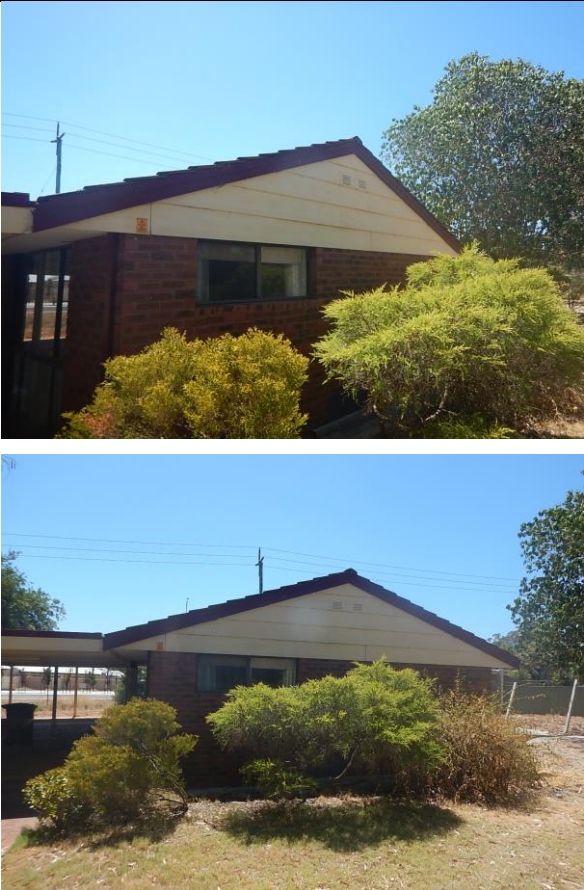
ID 1:- Fibre Cement Gable End Panelling (Suspected Asbestos Containing Material)

Material	Suspected asbestos containing material.	
Lab No.	Unable to obtain suitable sample [sample restrictions].	
QED Sample No.	ID: Observed.	
Locations	External – Property Gabel ends.	
Condition	Good, sealed, non-friable.	
Signage	Labelled.	
Potential for Disturbance	Low.	
Risk	<p>The ACM are not friable and are in stable condition. Ensure that they remain clearly labelled and regularly inspect to ensure they are not deteriorating or otherwise contributing to an unacceptable health risk.</p>	
Management Actions	May remain in-situ until replacement is required. Manage as per Asbestos Management Plan . Administrative – Follow safe work procedures during removal and maintenance. Personal protective equipment – P2 facemask and coveralls required when working on material.	
References (See Appendices)	<p>Safe Work Australia, Code of Practice: How to Manage and Control Asbestos in the Workplace. WHS Appendix G—Recommended safe working practices Safe work practice 1—Drilling of ACM Safe work practice 2—Sealing, painting, coating and cleaning of asbestos cement products</p> <p>Safe Work Australia, Code of Practice: How to Safely Remove Asbestos Appendix E—Examples of asbestos removal work Asbestos cement products</p>

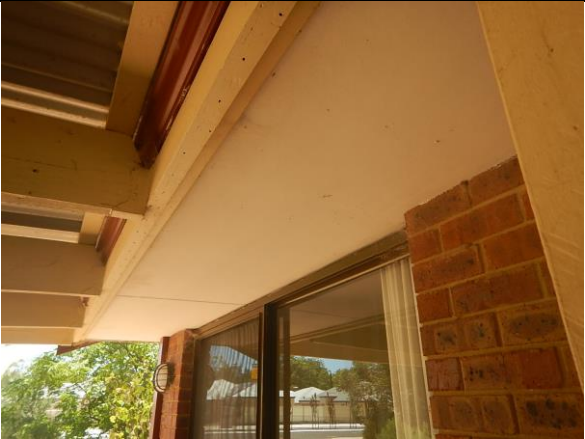
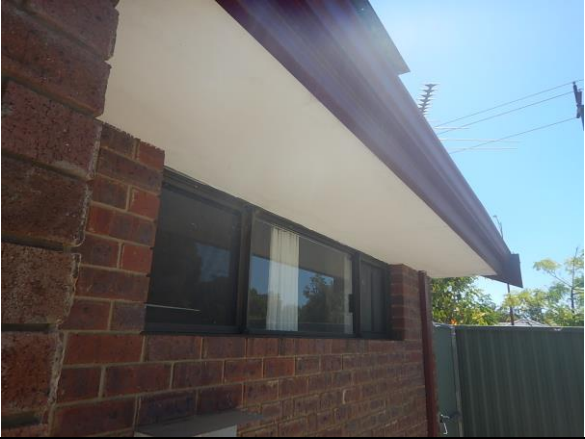
ID 2:- Fibre Cement Eaves Lining (Suspected Asbestos Containing Material)

Material	Suspected asbestos containing material.	
Lab No.	Unable to obtain suitable sample [sample restrictions].	
QED Sample No.	ID: Observed.	
Locations	External – Property perimeter, eaves lining.	
Condition	Good, sealed, non-friable.	
Signage	Labelled.	
Potential for Disturbance	Low.	
Risk	<p>The ACM are not friable and are in stable condition. Ensure that they remain clearly labelled and regularly inspect to ensure they are not deteriorating or otherwise contributing to an unacceptable health risk.</p>

Management Actions	<p>May remain in-situ until replacement is required. Manage as per Asbestos Management Plan. Administrative – Follow safe work procedures during removal and maintenance. Personal protective equipment – P2 facemask and coveralls required when working on material.</p>	
References (See Appendices)	<p>Safe Work Australia, Code of Practice: How to Manage and Control Asbestos in the Workplace. WHS Appendix G—Recommended safe working practices Safe work practice 1—Drilling of ACM Safe work practice 2—Sealing, painting, coating and cleaning of asbestos cement products</p> <p>Safe Work Australia, Code of Practice: How to Safely Remove Asbestos Appendix E—Examples of asbestos removal work Asbestos cement products</p>

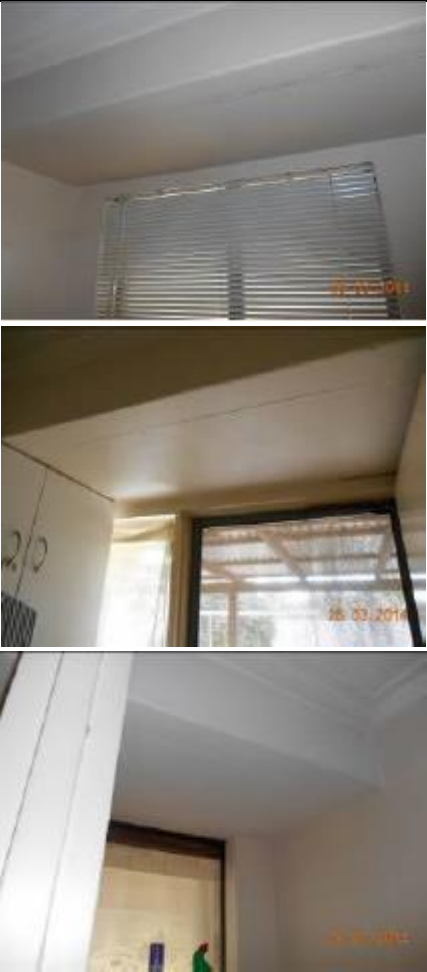
ID 3:- Fibre Cement Ceiling Panels (Suspected Asbestos Containing Material)

Material	Suspected asbestos containing material.	
Lab No.	Unable to obtain suitable sample [sample restrictions].	
QED Sample No.	ID: Observed.	
Locations	Internal – Bathroom, Laundry and Toilet ceiling panels.	
Condition	Good, sealed, non-friable.	
Signage	Labelled.	
Potential for Disturbance	Low.	
Risk	<p>The ACM are not friable and are in stable condition. Ensure that they remain clearly labelled and regularly inspect to ensure they are not deteriorating or otherwise contributing to an unacceptable health risk.</p>	
Management Actions	<p>May remain in-situ until replacement is required. Manage as per Asbestos Management Plan. Administrative – Follow safe work procedures during removal and maintenance. Personal protective equipment – P2 facemask and coveralls required when working on material.</p>	
References (See Appendices)	<p>Safe Work Australia, Code of Practice: How to Manage and Control Asbestos in the Workplace. WHS Appendix G—Recommended safe working practices Safe work practice 1—Drilling of ACM Safe work practice 2—Sealing, painting, coating and cleaning of asbestos cement products</p> <p>Safe Work Australia, Code of Practice: How to Safely Remove Asbestos Appendix E—Examples of asbestos removal work Asbestos cement products</p>

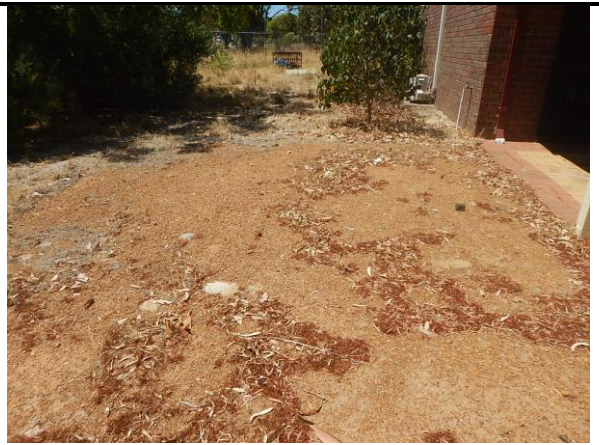
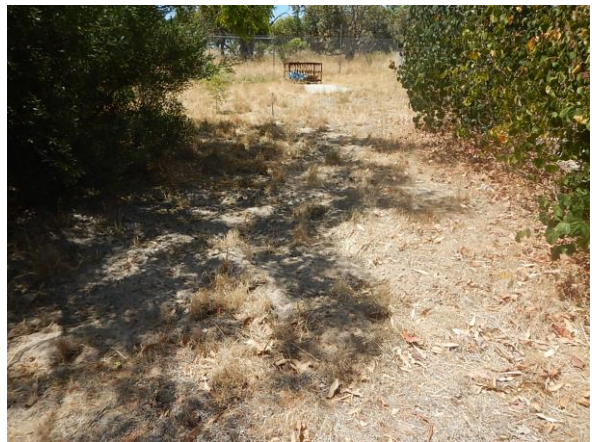
ID 4:- Asbestos Cement Fragments (Asbestos Detected)	
Material	Suspected asbestos containing material.
Lab No.	N/A.
QED Sample No.	ID: Observed.
Location	External – North-western elevation, to ground.
Condition	Debris, unsealed, non-friable.
Signage	Labelling not practicable.
Potential for Disturbance	Medium.
Risk	<p>IMMEDIATE ACTION REQUIRED. The ACM are not friable however, due to their location there is a risk that they could be easily disturbed. It is recommended that the debris is removed.</p>
Management Actions	<p>The cement fragments should be removed via hand picking, including if practical, gently fine raking of wetted soil to 10 cm depth. Raking action required to expose ACM fragments as per Management of Small-Scale Low-Risk Soil Asbestos Contamination and to be conducted by a removalist with a Class B asbestos removal licence.</p> <p>Further investigation should be conducted to determine the extent of any soil contamination to establish appropriate remediation recommendations.</p> <p>Personal protective equipment – P2 facemask and coveralls required when working on material.</p> <p>Manage as per Asbestos Management Plan.</p> <p>Administrative – Follow safe work procedures during removal and maintenance.</p> <p>Personal protective equipment – P2 facemask and coveralls required when working on material.</p>

ID #	Product	Location
4	Asbestos Cement Fragments.	External – North-western elevation, to ground.
<i>Recommendations: Removal of material is recommended. Refer to Management Actions for further information.</i>

1. ID#4 requires removal. Planning for these works to be complete should occur. For further information, please refer to Management Actions.
2. All remaining materials identified may remain in situ until requiring replacement although, where practicable, asbestos containing materials should be removed, consistent with the Federal Government’s stated ultimate goal of the prohibition of asbestos, which is for “all workplaces to be free of asbestos”.

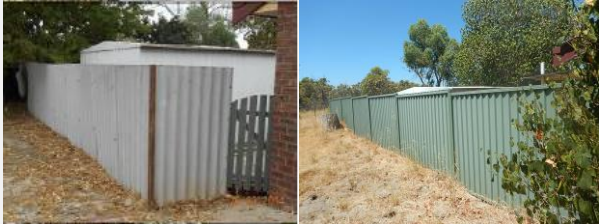
Item Description	Lab No.	Location	Photo	Comments
Corrugated Fibre Cement Panels.	N/A.	External – Boundary fence to rear left of property.
